DOT/FAA/AR-11/3

Evaluating the Flammability of Various Magnesium Alloys During Laboratory- and Full-Scale Aircraft Fire Tests

Timothy R. Marker

Final Report

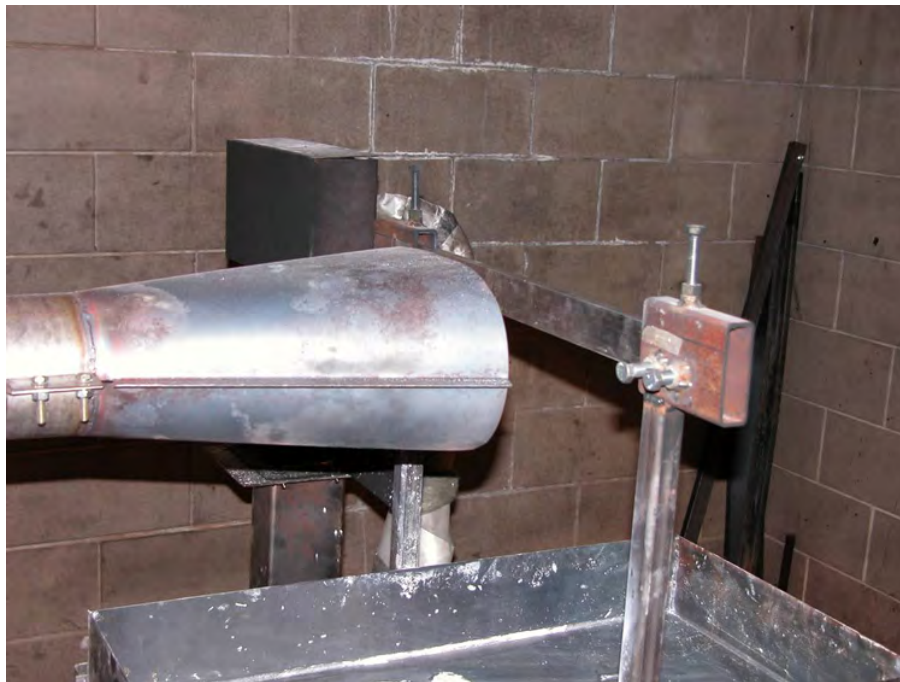
Figure 2. Magnesium Alloy Bar Sample Mounted in Test Apparatus Prior to Test

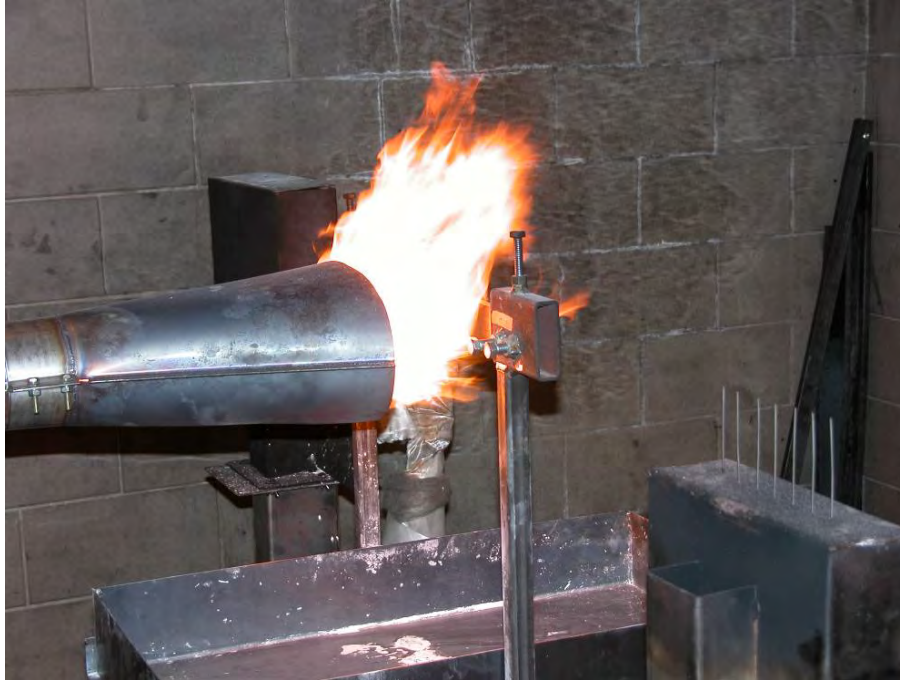
Figure 3. Magnesium Alloy Bar Sample Exposed to Burner Flames

During a typical test, the burner was turned on and allowed to warm for a period of 2 minutes. Following this step, the rolling cart assembly holding the magnesium alloy bar sample was moved in front of the burner (figure 3). The samples were exposed to the burner for 3, 4, or 5 minutes, depending on the thickness of the bar sample being tested. Within this exposure

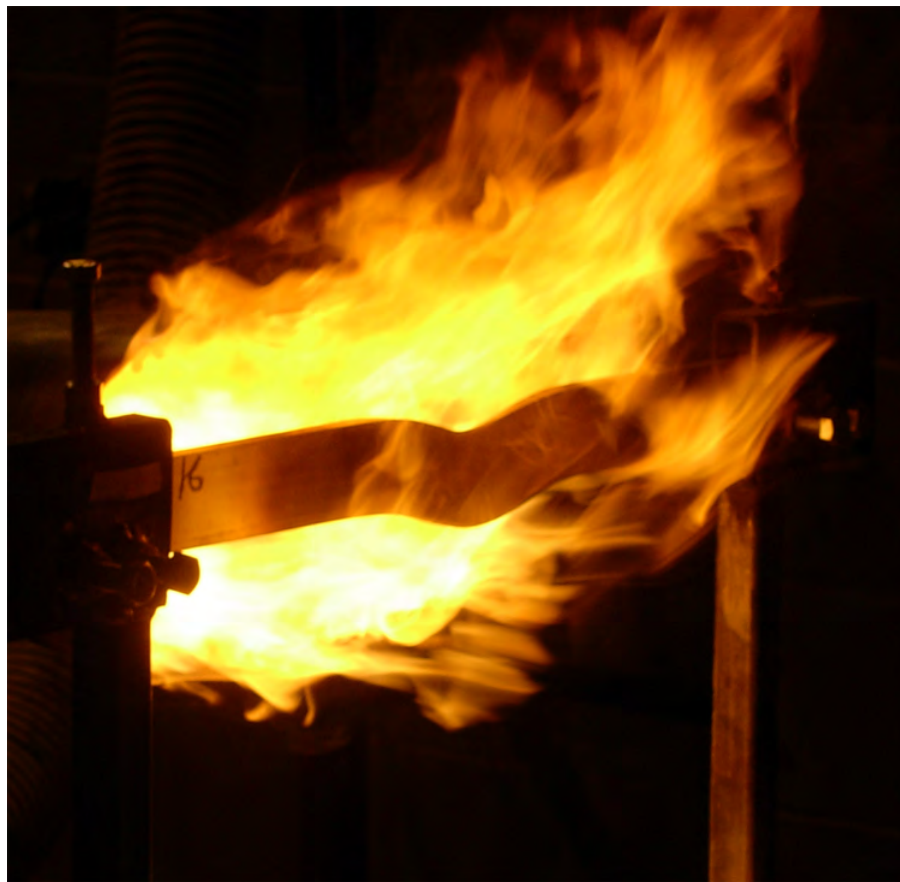
Figure 4. Magnesium Alloy Bar Sample Immersed in Flames, Just Prior to Melting

period, the bar samples would typically droop or distort just prior to melting, and often, a large center section of the bar sample would fall into a catch pan mounted below (figures 4 and 5). In these instances, the molten pieces in the catch pan continued to burn for varying periods of time. Once the bar sample melted and a portion of it fell into the catch pan, the remaining pieces attached to the sample holder would either ignite and continue to burn (figure 6), or depending on the type of alloy, they would quickly self-extinguish.

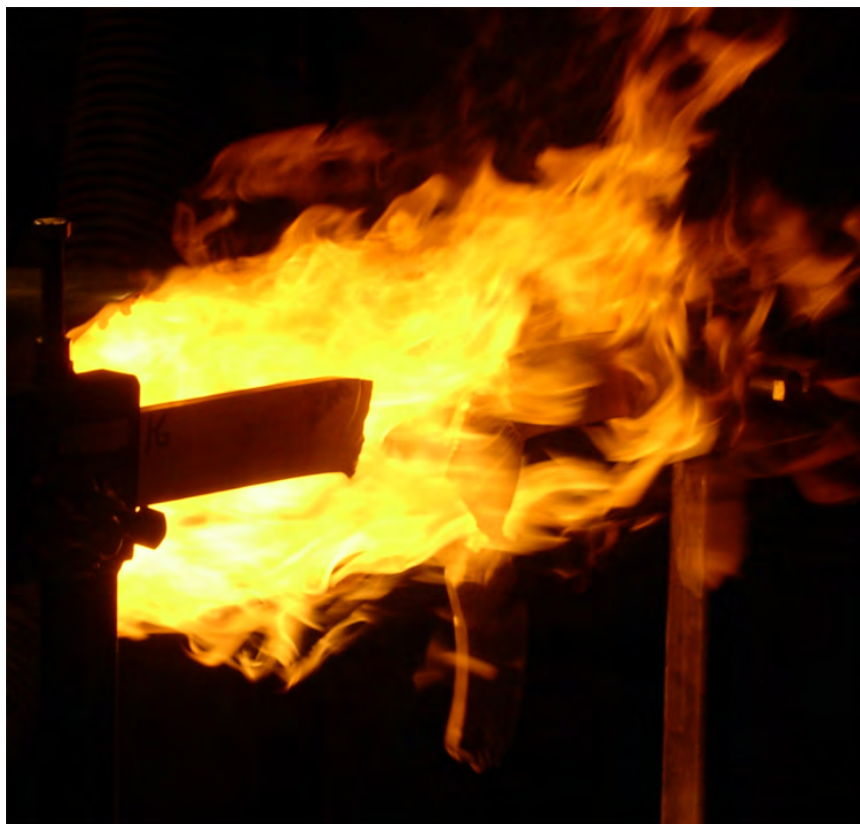
Figure 5. Center Section of Bar Sample Falling Into Catch Pan After Melting

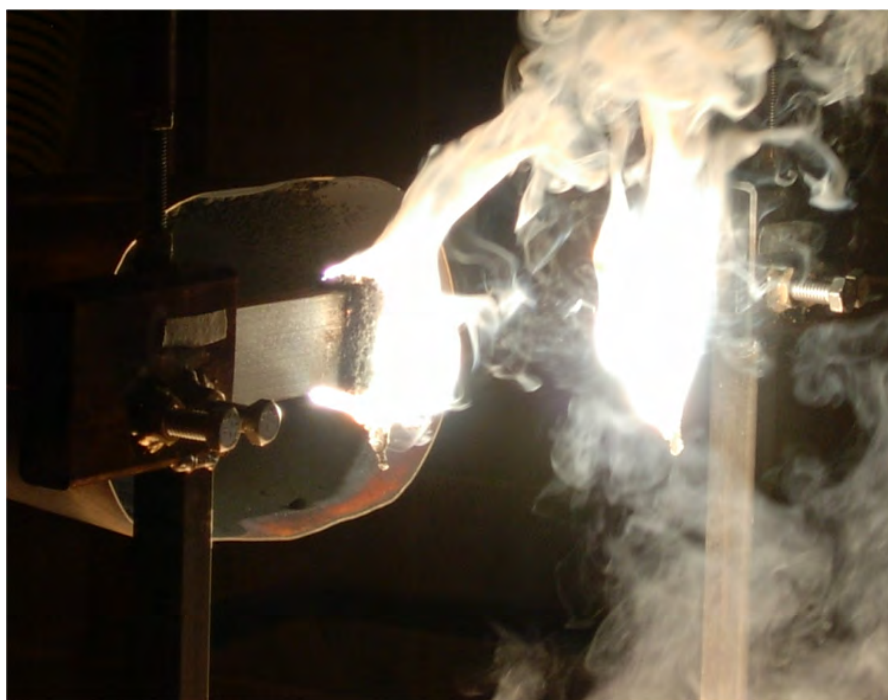
Figure 6. Ignition of Magnesium Alloy Following Burner Flame Exposure

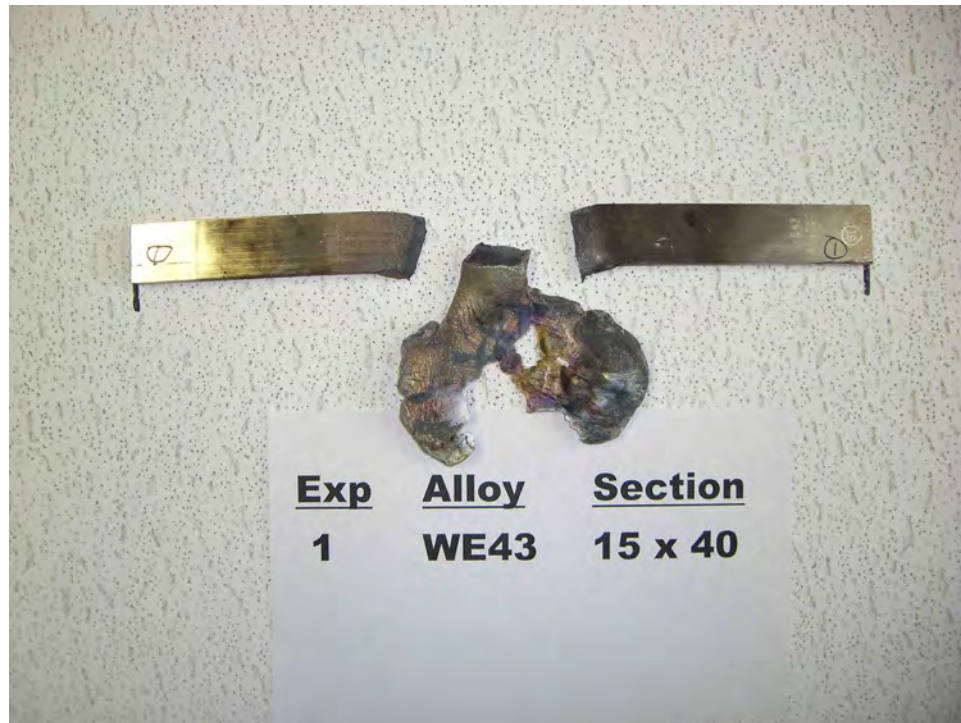
Figure 7. Posttest Inspection Showing Molten Center Section Removed From Catch Pan

The catch pan was filled with dry talc to prevent any splattering of molten materials and to aid in the safe extinguishment of burning samples. After the burner was shut off and all burning had subsided, the sample pieces were cooled and removed for inspection (figure 7). Various parameters were measured and recorded during the test, including the sample dimensions, the time the burner flame was turned off, the time the sample melted, the time the sample self-extinguished, and whether or not any melted pieces that fell into the catch pan were still burning.

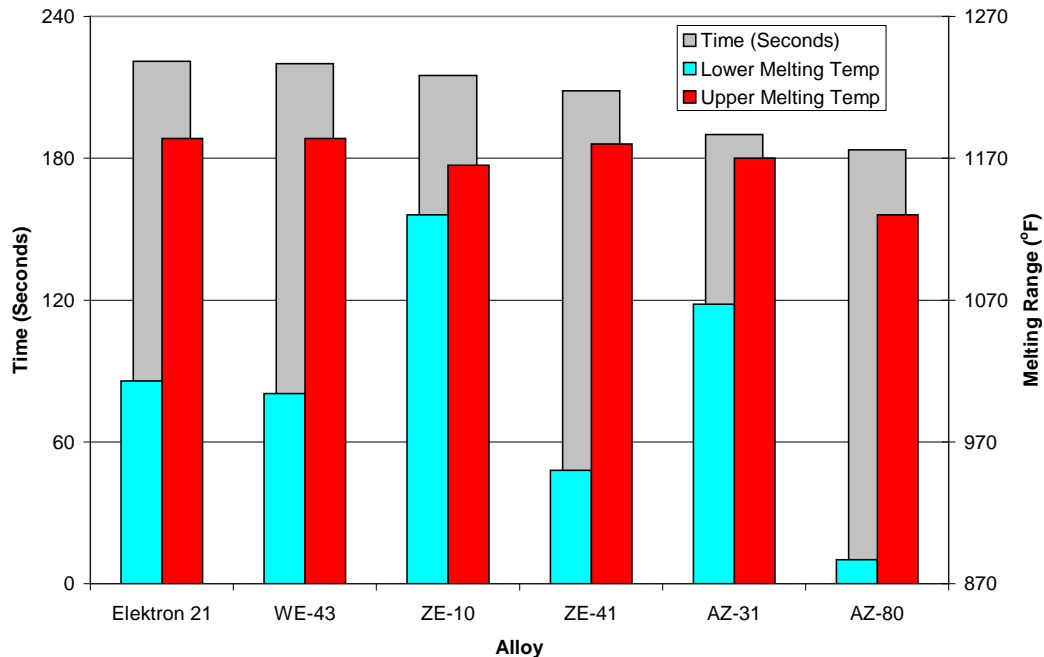
Figure 8. Various 0.59-Inch-Thick Samples and Respective Time to Reach Melting

None of the tested sample bars melted prior to 2 minutes, which was not surprising given the relative thickness of the samples tested. When the exposure time was increased beyond 2 minutes, the samples melted, typically between 3 and 4 minutes for the 0.59-inch-thick samples and approximately 2 to 3 minutes for the thinner 0.39-inch-thick samples. The type of alloy also played a role in the time to reach the melting point. As shown in figure 8, the alloys with higher melting points typically required longer periods of time to melt. The chart shows the time required to melt six different alloys at a thickness of 0.59 inch. Also shown are the lower and upper melting ranges of each of the alloys. With the exception of ZE-10, there is a direct correlation with the alloys' upper melting range and the time required to melt the samples.

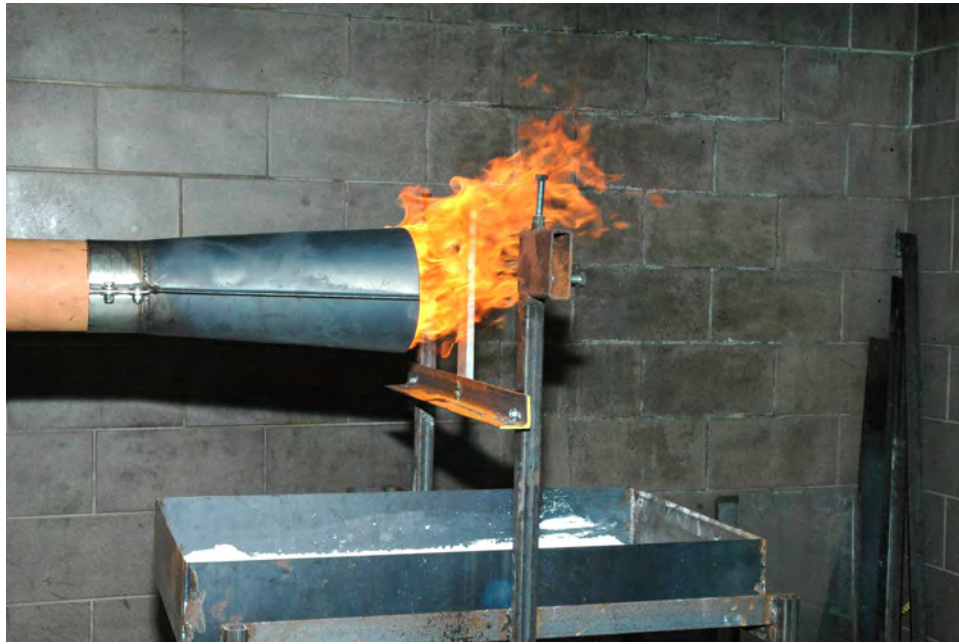
Figure 9. Magnesium Alloy Sample Mounted Vertically

A slightly different approach was also investigated in test 20, where the sample bar was shortened and oriented vertically rather than horizontally (figure 9). It was difficult to determine the exact impact of orienting the sample in this manner since this test was performed on a sample of AZ-31, which had burned consistently after burner removal. It was clear that this orientation prevented the separation of a large mass of the test sample during the melting process, which was common when mounting the samples horizontally. By mounting vertically, the molten section of sample ran down the unmolten section like a candle; this tendency kept the sample hotter, since the molten mass was still in contact with the sample.

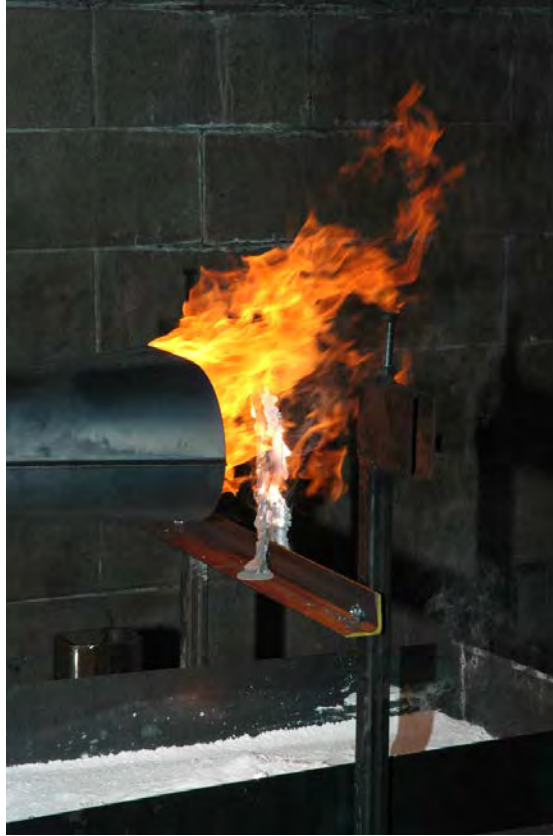
Figure 11. Vertically Mounted Sample Just Prior to Extinguisher Discharge

During the first test series, a Halon 1211 extinguisher was mounted into position, and an AZ-31 sample was mounted to the rolling cart assembly. The burner was warmed for 2 minutes, and then the cart was rolled directly in front of the burner, allowing flame impingement. The cart was kept in this position until the sample had melted sufficiently, and there was evidence of fire (figure 11). At this point (approximately 4 minutes), the burner was shut off, and the cart was immediately rolled in front of the fire extinguisher stand.

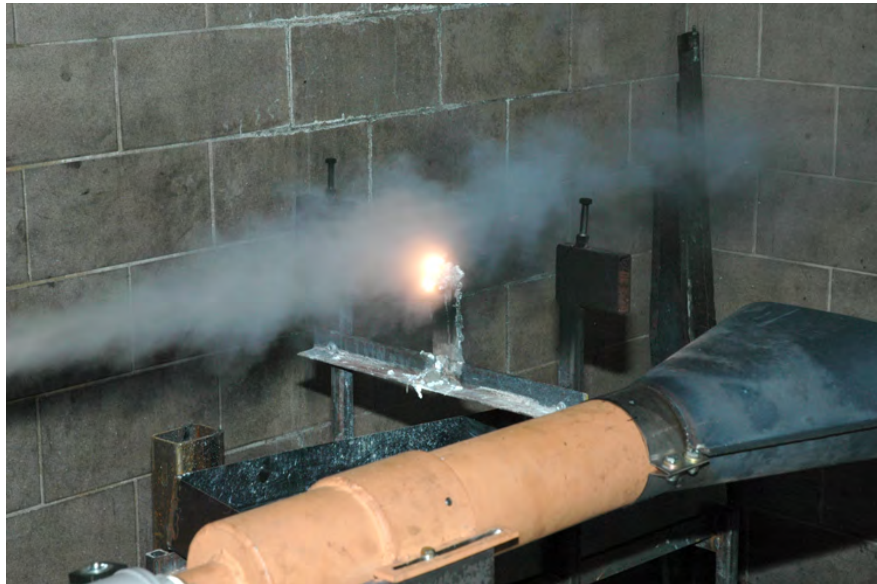
Figure 12. Extinguisher Stream Being Directed Across Burning Magnesium Alloy Sample

Once the cart abutted its prepositioned stop, the extinguisher was activated, producing a directed stream across the burning test sample (figure 12).

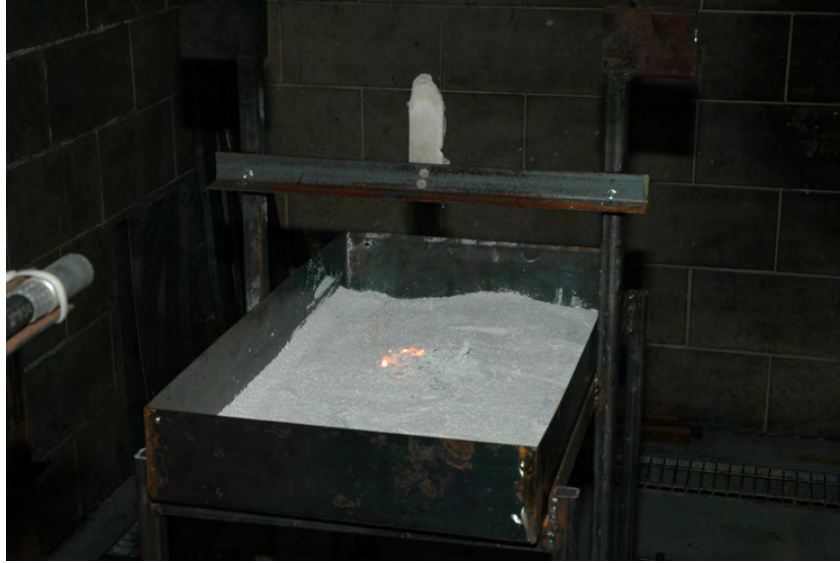
Figure 13. Section of Molten Test Sample in the Catch Pan After Extinguisher Discharge

The extinguisher activation typically caused a large piece of the burning test sample to fall into the catch pan (figure 13). This was problematic, as the extinguishing agent stream was initially aimed at the upper section of the test sample where the burning was taking place. Once this upper section fell into the catch pan, the agent was no longer directed at any burning material, so it was difficult to determine the impact of the extinguishing agent on the sample.

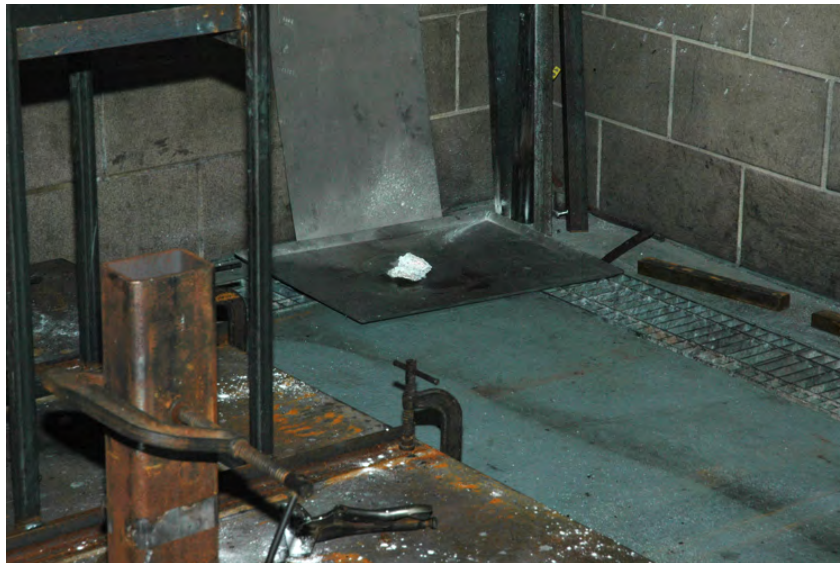
Figure 14. Molten Mass of ZE-10 Alloy Removed From the Catch Pan and Placed on the Floor

To obtain a more accurate assessment of the extinguisher capability, a burning piece of the ZE-10 alloy was removed from the catch pan during the second test and positioned on a sheet of aluminum on the floor of the test area. This allowed a stream of agent to be manually directed into the burning mass of material (figure 14).

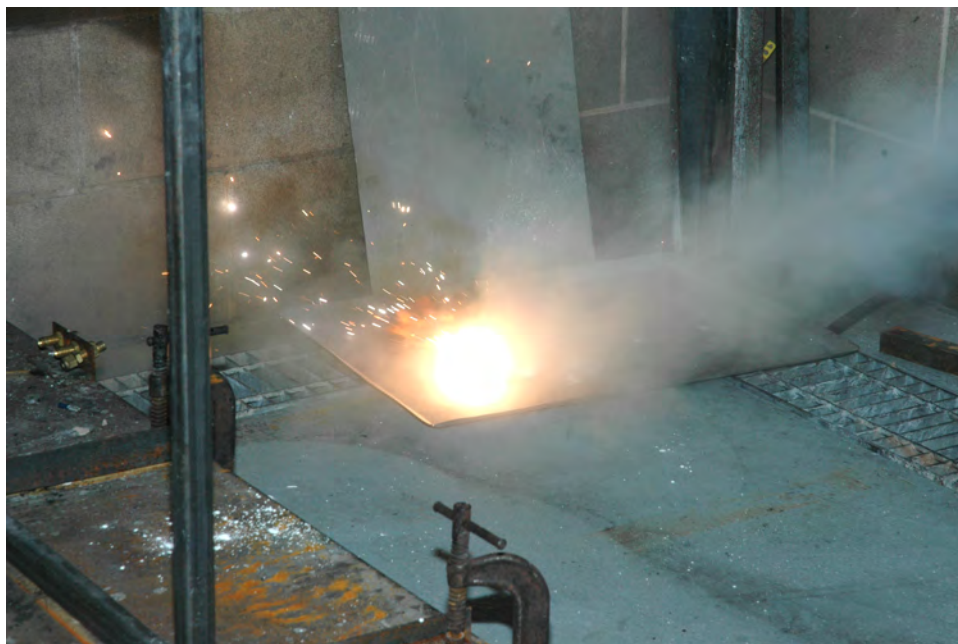
Figure 15. Molten ZE-10 Reacting to Stream of Halon 1211

A Halon 1211 extinguisher was discharged directly at the burning material, which flashed violently upon contact (figure 15). This confirmed that the Halon 1211 extinguishing agent had no effect on the burning material, and perhaps, exacerbated it.

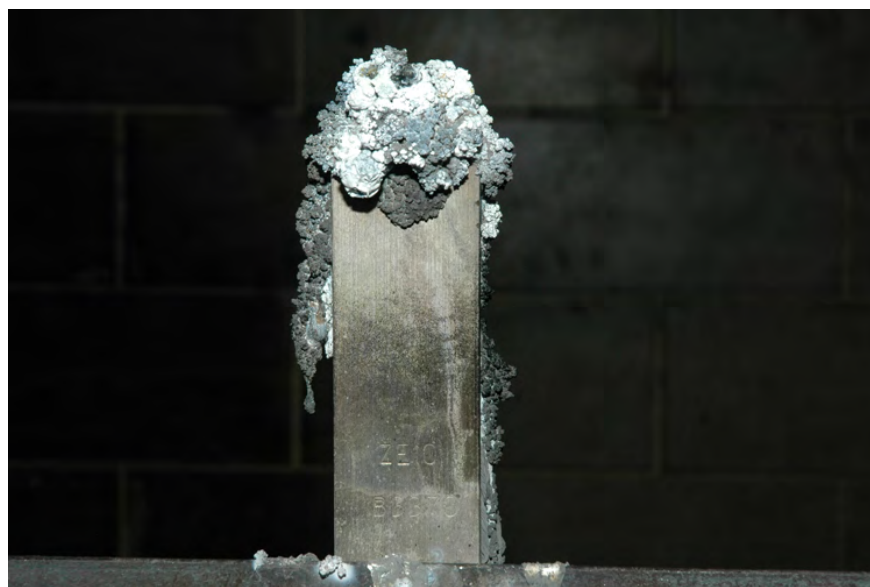
Figure 16. Strange Oxidation on ZE-10 Sample Following Agent Application

During the final three tests with the FE-36 extinguishing agent, a peculiar oxidation formed on the vertical sample following agent discharge (figure 16). The formation occurred quickly, as the flames subsided and the sample cooled.

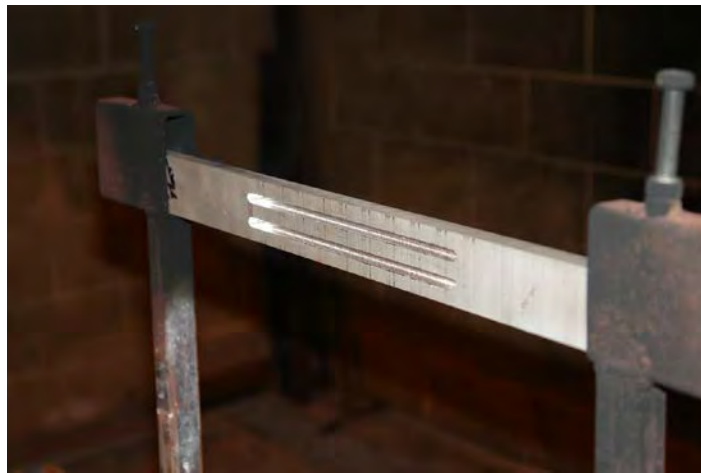
Figure 17. Magnesium Alloy Test Sample Bar With a Milled Cross Section

Figure 18. Close-Up of Test Sample Bar With a Milled Cross Section

To create a more realistic test condition mimicking a machined leg or spreader, one of the thinner WE-43 test sample bars was modified using a milling machine. Two 10-inch-long longitudinal channels were milled into the test sample bar to create a thinner cross-sectional area where the heat from the burner was concentrated (figures 17 and 18). The longitudinal channels were square in shape, approximately 0.25 inch wide by 0.25 inch deep.

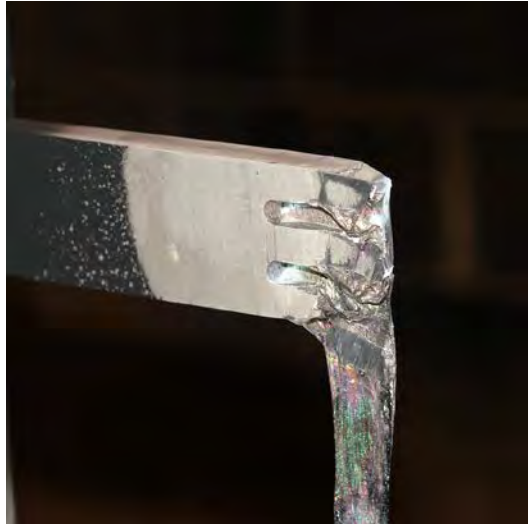
Figure 19. Posttest Photograph of Milled Bar Test Sample

Following burner warm-up, the test samples were exposed for a period of 4 minutes, at which point the burner was switched off. Melting occurred at approximately 2 minutes 30 seconds. The machining did not appear to cause the test sample to become more flammable, as the melting process was similar to previous tests of nonmilled samples (figure 19).

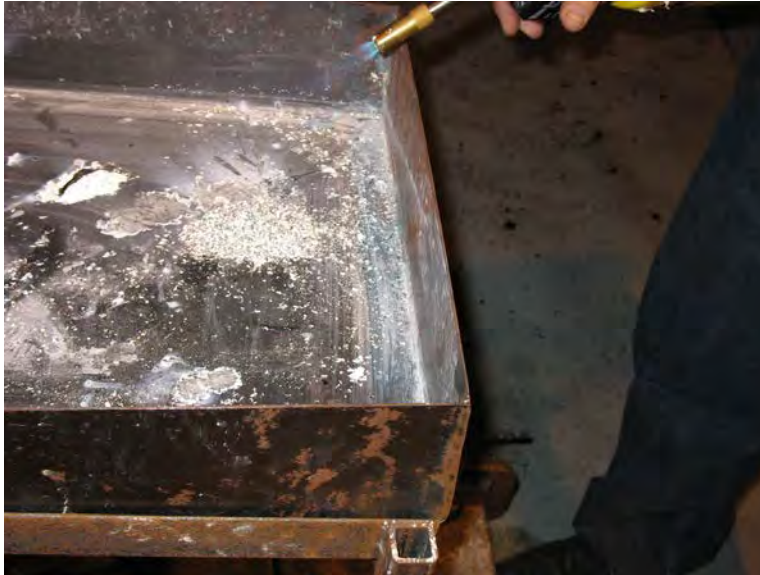
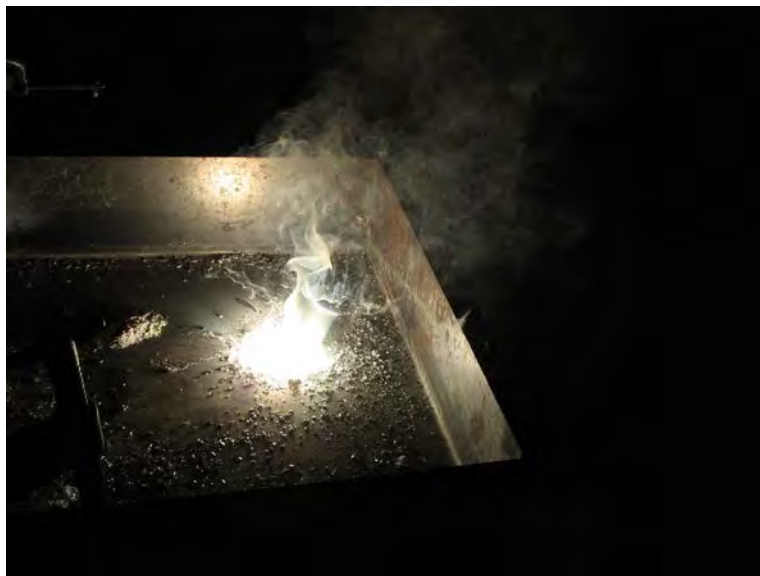
Figure 21. Torch Used to Ignite a Small Pile of Magnesium Alloy Millings

Figure 22. Small Pile of Magnesium Alloy Millings on Fire

During the first test, the magnesium alloy millings captured from the milling process in the previous test were piled into a small mound in the catch pan (figure 21). A hand-held methylacetylene-propadiene propane (MAPP) gas torch was used to ignite the pile of material. The millings were relatively easy to ignite with the torch, due to their high surface-area-to-volume ratio (figure 22). This high ratio allowed the millings to heat quickly and melt rapidly, providing the proper conditions for ignition. A second test was run in which a pile of millings was placed on top of a piece of aircraft-grade carpeting in the catch pan. The millings were ignited with the torch as in the previous test. Despite the intense light given off by the material, the resulting fire did not spread beyond the diameter of the pile of millings.

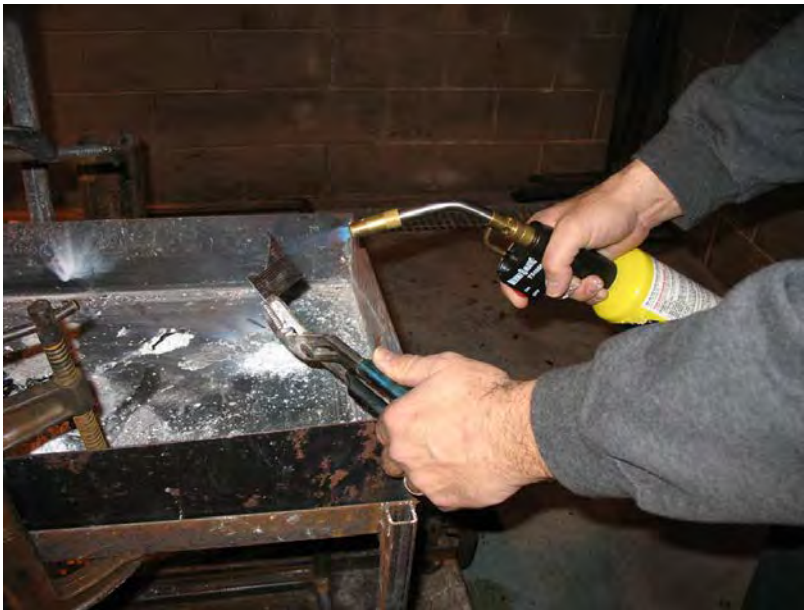
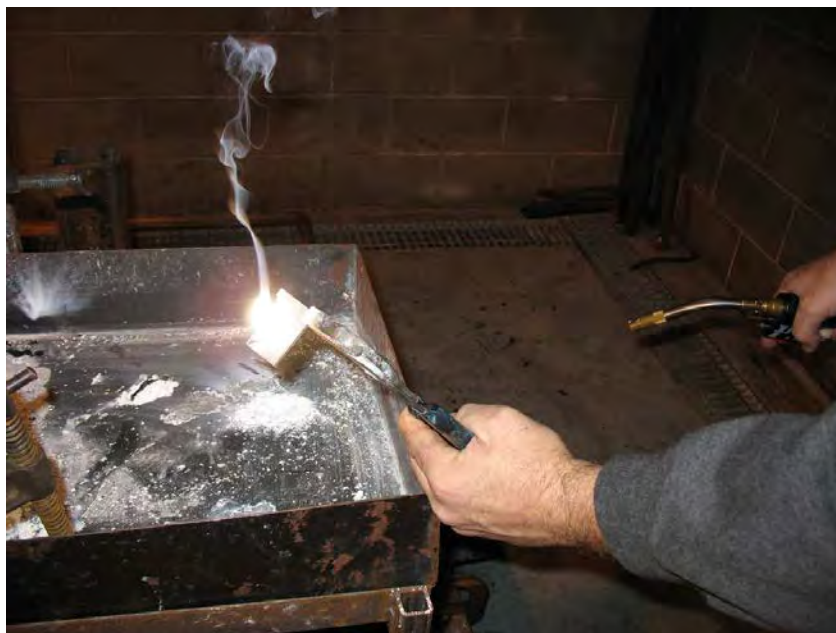
Figure 23. Thin Sliver of Magnesium Alloy Being Heated With Torch

Figure 24. Thin Sliver of Magnesium Alloy on Fire After Being Heated With Torch

Another series of tests were run using small slivers of magnesium alloy sawn from a bar sample. An industrial band saw was used to produce the thin slivers, in both crosswise and lengthwise fashion. It was difficult to obtain uniformly sawn samples, as they measured approximately 0.0625 to 0.125 inch in thickness. The slivers were held using a pair of pliers, and heated using the MAPP gas torch (figure 23). Similar to the pile of millings, the sliced samples had high surface-area-to-volume ratios, making them easy to ignite. Once ignited, the samples would continue to burn until nearly or completely consumed (figure 24).

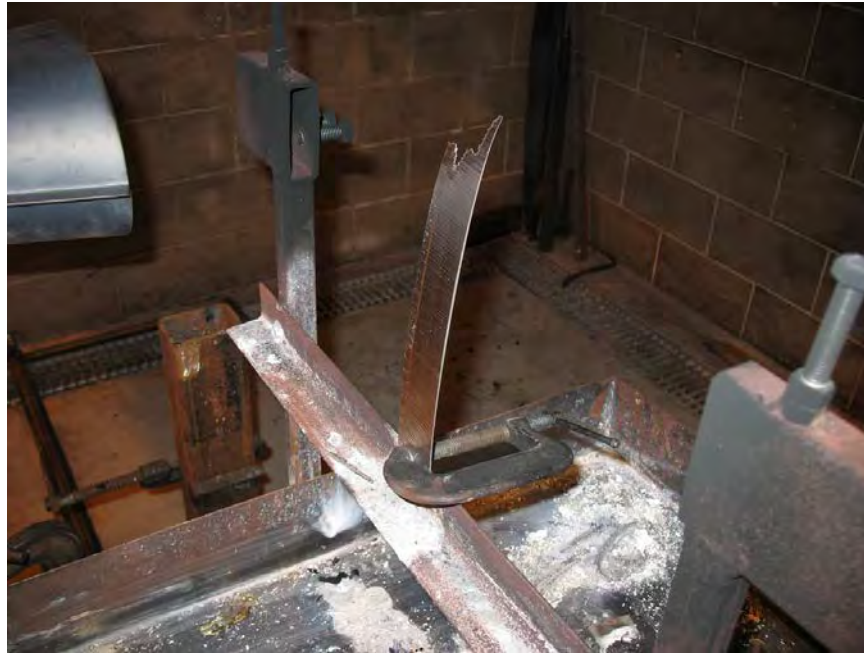
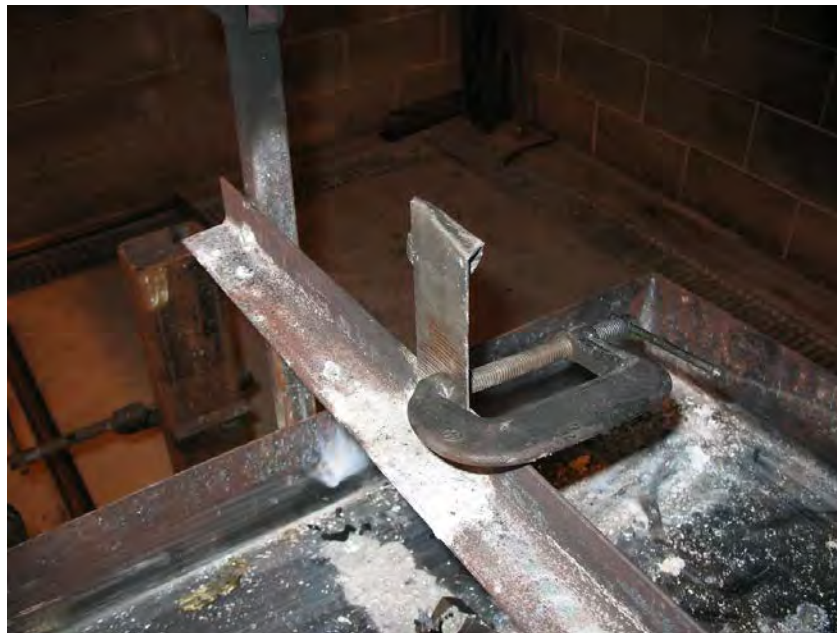
Figure 25. Longitudinal Slice of Magnesium Alloy Positioned Vertically in Front of the Burner

Figure 26. Vertically Mounted Slice After Self-Extinguishment

A longitudinal slice of the magnesium alloy was sawn from the length of a sample bar and clamped vertically in front of the oil burner (figure 25). Following burner warm-up, the sample was exposed until melting began (approximately 1 minute). The melting caused the sample to slump downward at which point the burner was turned off (figure 26). Although a significant percentage of the sample had melted during exposure, it did not ignite.

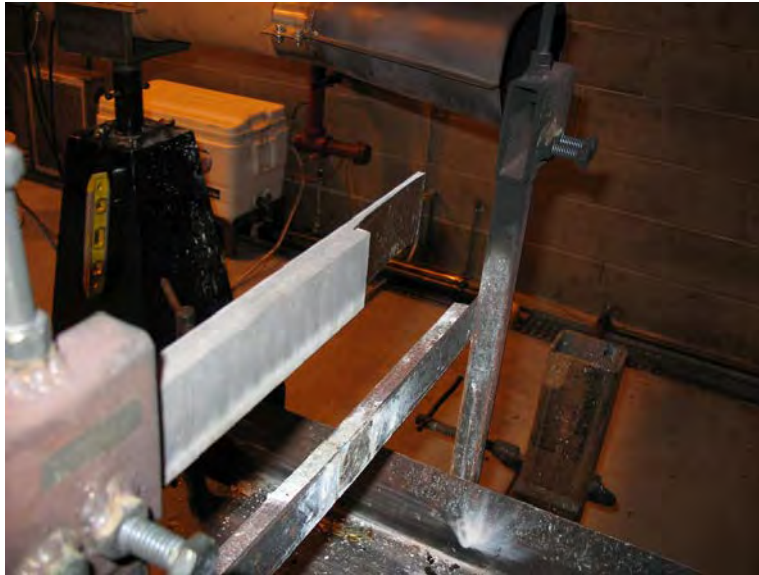
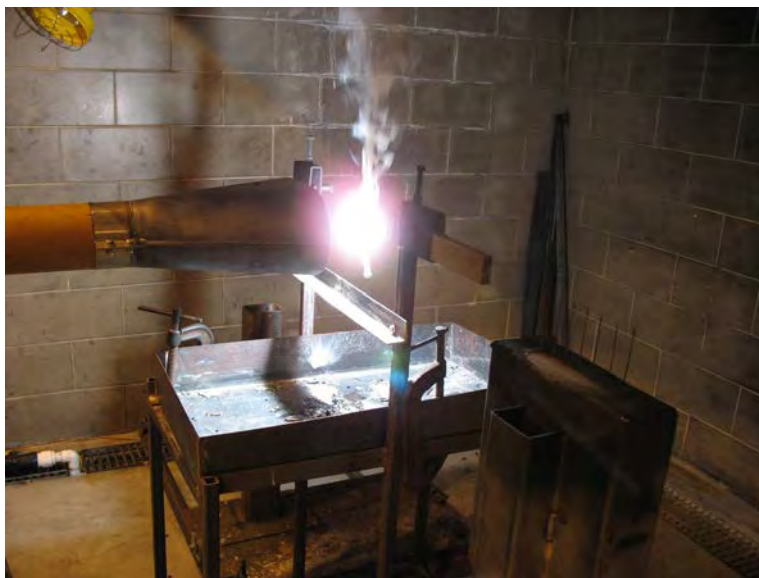
Figure 27. Sectioned Bar Sample Positioned Horizontally in Front of the Burner

Figure 28. Sectioned Magnesium Alloy Bar Sample Ignited Using Oil Burner

A final laboratory test was conducted on a modified bar sample. The sample was sliced lengthwise and sectioned, removing approximately 25% (figure 27). The sample was clamped in place horizontally, with the sectioned area positioned in front of the burner. The sectioned area was approximately 0.125 to 0.1875 inch in thickness. Following burner warm-up, the sample was exposed for approximately 2 minutes, at which point it melted and ignited (figure 28). The burner was subsequently turned off.

The sample continued to burn for several minutes, with molten pieces of the sample falling into the catch pan. This was an unexpected result, as the previous test series using the vertically mounted slice did not ignite following melting.

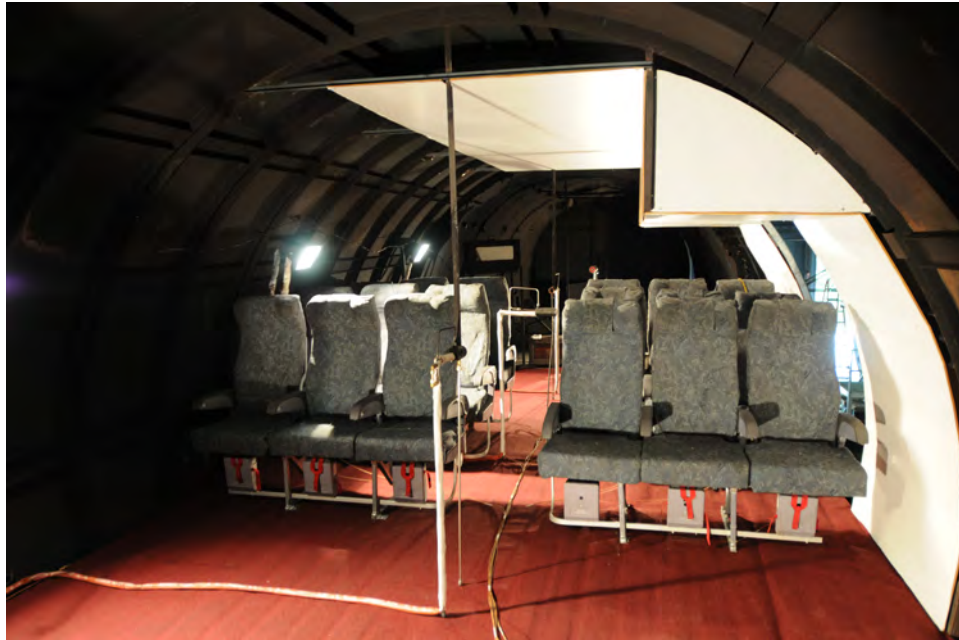
Figure 33. Typical Full-Scale Test Configuration With Seats, Panels, and Carpet Installed

Aircraft-grade wool/nylon carpet was used in all tests. The carpet covered approximately 20 feet of the length of the cabin, centered at the fuselage opening. Aircraft-grade, fiberglass-faced, Nomex crushed-core honeycomb panels were used to mock-up the cabin in the immediate area of the fuselage fire opening. The honeycomb panels were used in the sidewall area, the ceiling, and overhead stowage bin areas, and met the current FAA flammability requirements (figure 33).

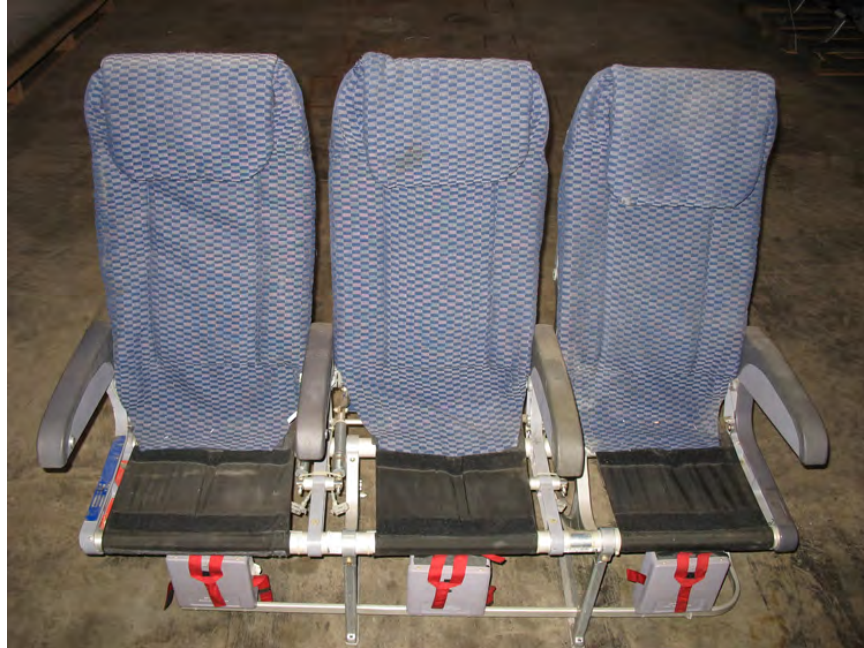
Figure 34. Original B/E 990 Seats

As mentioned previously, four full-scale tests were originally planned for the study: a baseline test, a good-performing magnesium alloy test, a poor-performing magnesium alloy test, and a test in which the primary and additional secondary components would be machined from a good-performing magnesium alloy. The test configuration would consist of three rows of aircraft triple seats situated inside the fuselage, centered around the fire opening. A total of 24 triple seats were purchased from an aircraft interior spares dealer, The Avianor Group, of Mirabel, Montreal, Canada (6 triple seats were used for each of the four tests). The purchased seats were B/E model 990, manufactured by B/E Aerospace of Wellington, Florida. Although the purchased seats contained the necessary structural components, they arrived without the bottom seat cushions (figure 34).

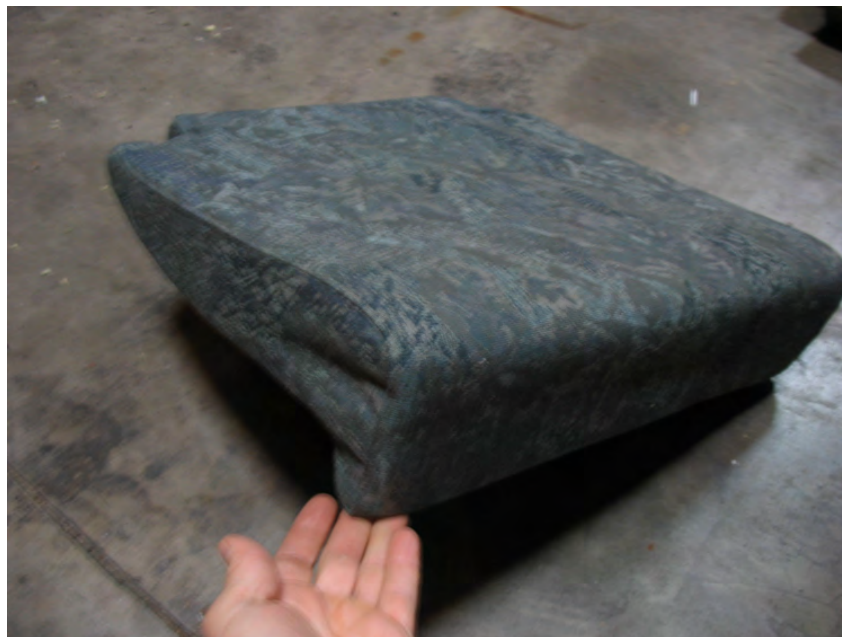
Figure 35. Bottom Seat Cushions With Olive-Colored Air Canada Dress Cover Pattern

Since the bottom seat cushions were an integral part of the overall test program, it was necessary to obtain these components from an aircraft spares dealer. However, the bottom cushions obtained from the dealer did not match the existing seatback design (figure 35). The supplied bottom cushions and accompanying seatback dress covers (figure 36) were an olive-colored pattern used by Air Canada, while the blue dress cover pattern on the supplied seat frames appeared to be Continental Airlines livery.

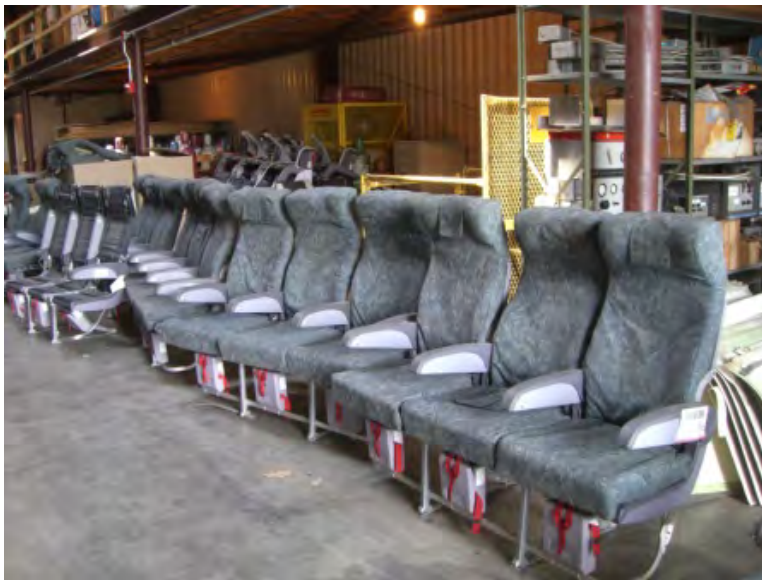
Figure 37. Completed B/E 990 Assemblies With Olive-Colored Cushion Materials

The supplied blue dress covers were removed, and the olive dress covers and bottom seat cushions were installed on the B/E 990 seats in preparation for the full-scale test (figure 37).

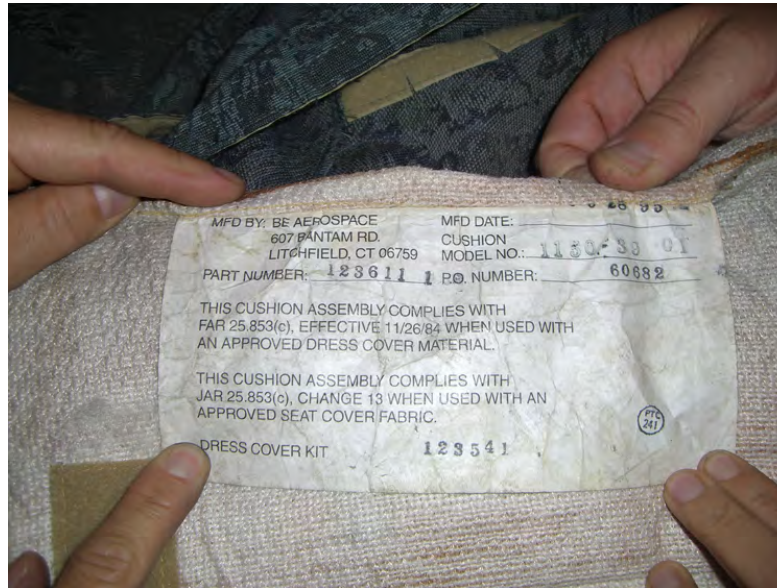
Figure 38. B/E 990 Triple Seatback Cushion Inspection Tag

During assembly of the seats, it was discovered that the B/E 990 seatback component was not typical of a conventional seatback, which usually contained a substantial urethane foam cushion mounted to an aluminum back frame. The B/E 990 seatbacks consisted of a carbon/epoxy frame hoop, with a stretched fabric acting as a suspension system. The seatback cushioning contained no urethane foam, and consisted only of a dress cover, cotton muslin, and fiberfill. A close-up of the inspection tag on the seatback materials indicates compliance with FAR 25.853 (c), the seat cushion flammability standard (figure 38). The suspension system was likely for additional

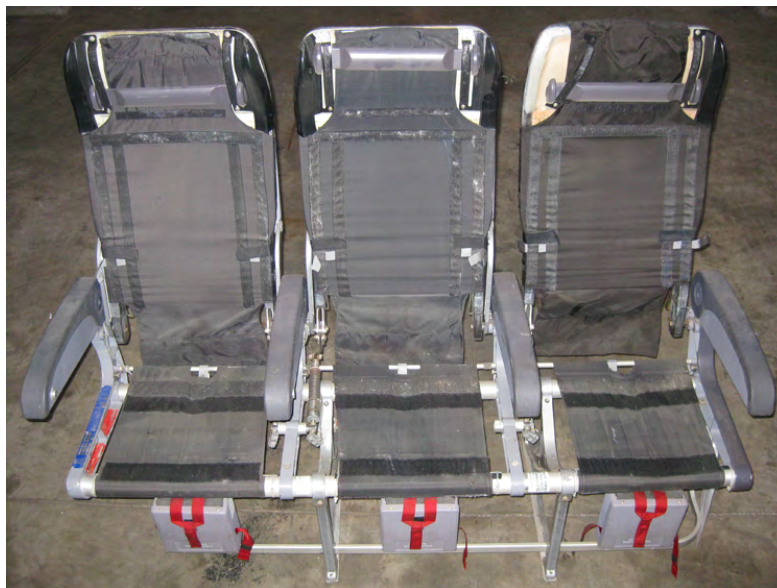
Figure 39. B/E 990 Triple Seat With Cushions and Covering Removed Revealing Bolsters

cushioning not offered by the very thin fiberfill used. The seatback frame also contained numerous plastic parts, including bolsters in the headrest area (figure 39). The high percentage of plastic parts in the seatback structure, in combination with the carbon/epoxy frame and limited fire-retardant foam, was not typical of conventional aircraft seat construction and had not been previously evaluated in full-scale tests.

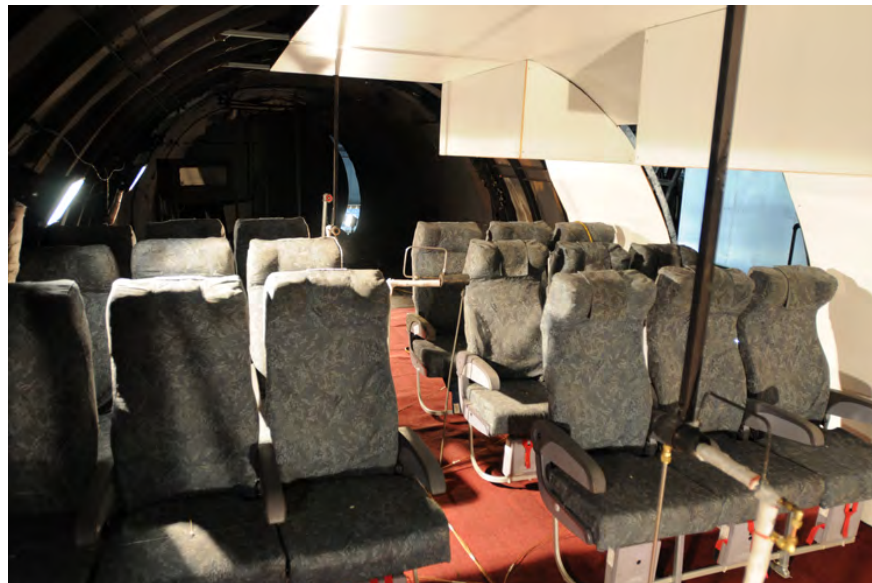
Figure 41. Baseline Test 1 Cabin Configuration

After all three rows of triple seats were installed in the test fuselage, thermocouples were mounted on the top surface of each of the bottom seat cushions (figure 41). The thermocouples were used to track the fire spread, in the event the internal cameras became obscured during the test. The thermocouples were held in place with steel safety wire.

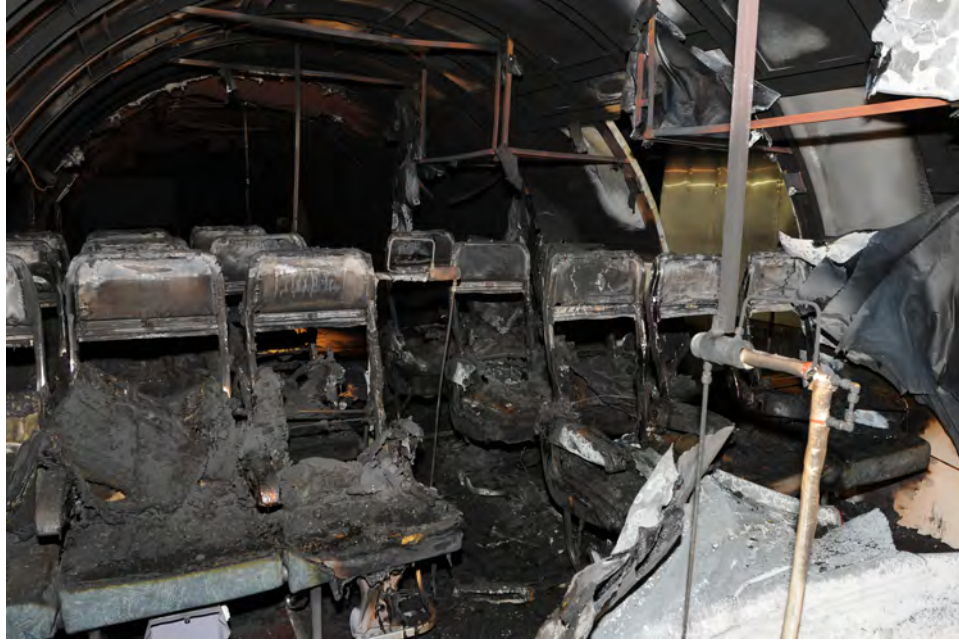
Figure 42. Baseline Test 1 Cabin Materials Following Test Fire

A posttest inspection revealed significant damage to the interior materials (figure 42). A majority of the honeycomb sidewall and ceiling panels were consumed, and significant damage to the seat assemblies was evident, particularly in the seatbacks. The damage clearly showed the fire was able to jump the aisle and involve the seat materials farthest from the fire entry point.

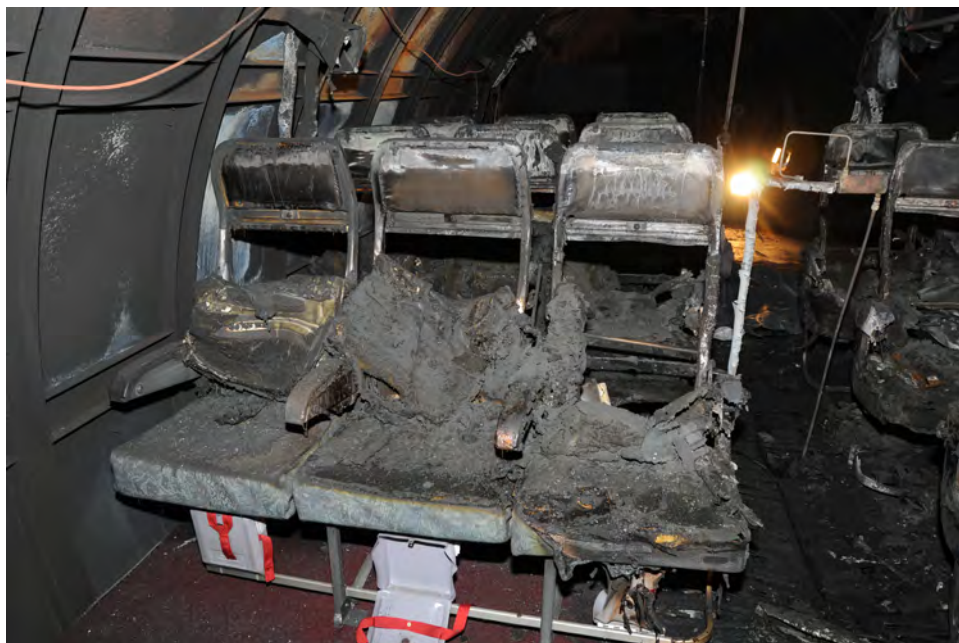
Figure 43. Seatback Materials Consumed and Cushioning Remnants Displaced

A closer inspection of the seating materials revealed that the seatback assemblies played a significant role in the spread of fire. The stretched nylon suspension system and miscellaneous thermoplastic parts were completely consumed in all seat places. The cushioning materials on the seatback assemblies were largely consumed, with remnants indicating the materials had collapsed onto the surface of the bottom cushion (figure 43). A large percentage of the bottom seat cushions were consumed on the seat assemblies closest to the fire opening; the bottom cushions on the far side of the fuselage were burned on the top, but remained intact. In general, it appeared the bottom seat cushions were not the cause of the rapid fire spread, but had burned more out of consequence from the seatbacks igniting quickly and collapsing onto the bottom cushions.

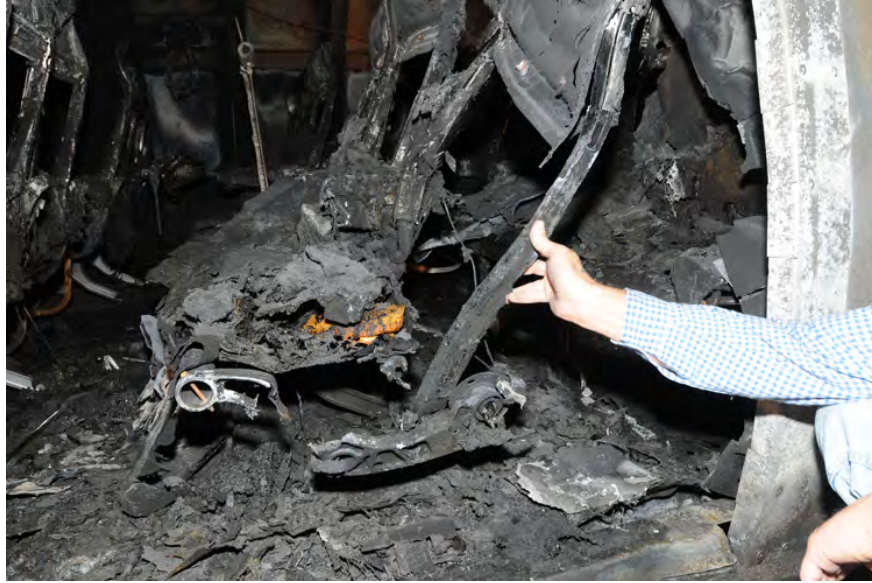
Figure 44. Portside Row 2 Seat Primary Spreader Component

Despite the large amount of seating materials consumed during the fire, it was interesting to note that only a very small amount of the primary aluminum components had melted. The outboard spreader on the port side, row 2 seat sustained the most melting (figure 44). The forward half of the spreader component was still attached to the forward cross tube, which had warped from the heat, but did not melt through. The aft cross tube on this seat had clearly melted through, with an end piece still connected to part of the melted spreader.
