DOT/FAA/AR-11/3

Evaluating the Flammability of Various Magnesium Alloys During Laboratory- and Full-Scale Aircraft Fire Tests

Timothy R. Marker

Final Report

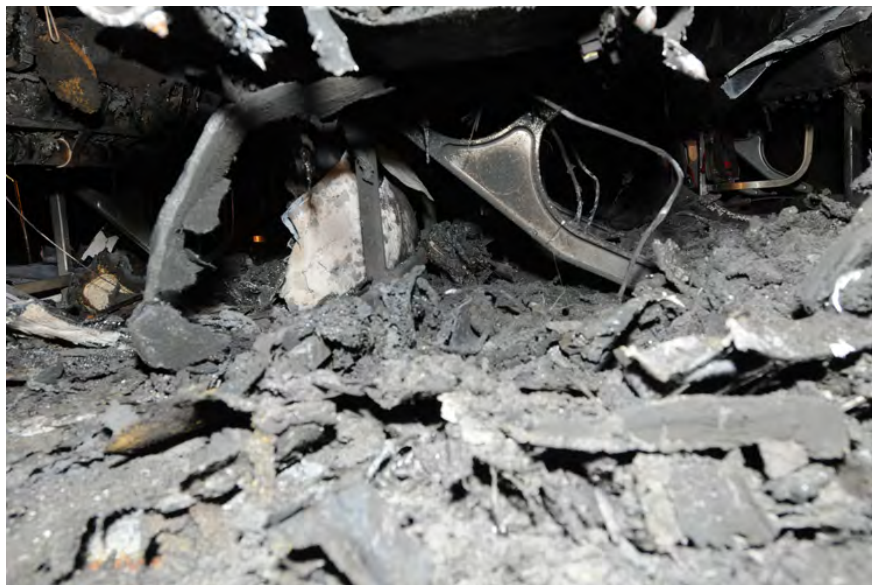
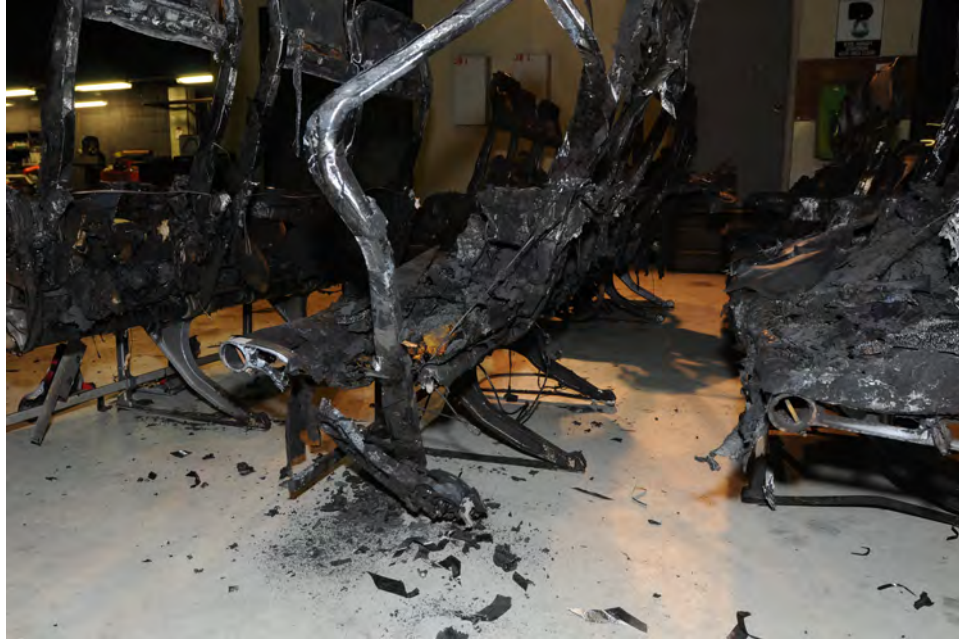
Although the outboard spreader was a fairly massive component, the cross tubes were very thin-walled by comparison and were anticipated to melt during the test. Most surprisingly, the leg assembly experienced no melting (figures 45 and 46). This indicated that the test was not run for a sufficient duration, which would be a concern for subsequent tests involving an evaluation of magnesium alloys. Laboratory-scale tests showed conclusively that the alloys were required to be in a molten state before any ignition would occur. Since the amount of melting in this Baseline 1 test was minimal overall, it was questionable whether this would be a good basis for evaluating the magnesium alloys.

Figure 45. Close-Up View of Outboard Leg Assembly of the Portside Row 2 Seat

Figure 46. Close-Up of Portside Row 2 Seat Assembly

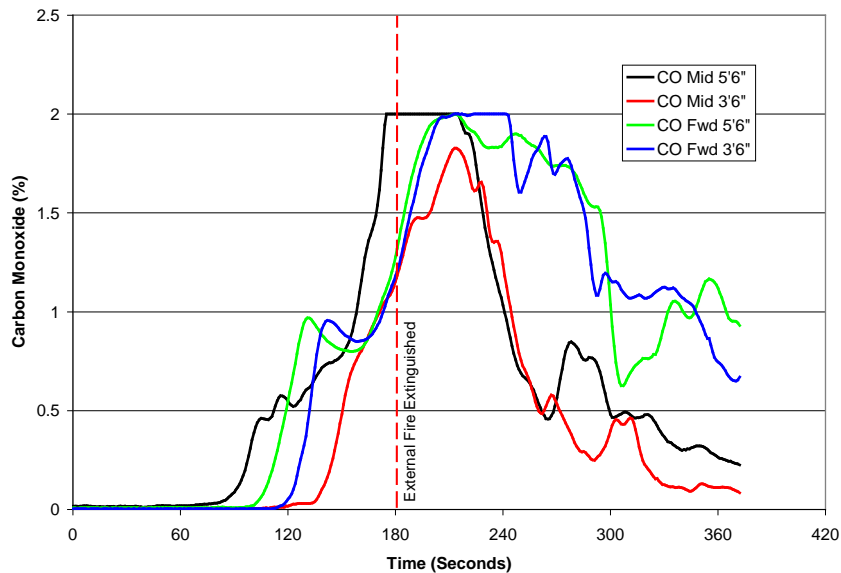
Figure 49. Carbon Monoxide Levels vs Time for Baseline Test

The continuous gas analyzers also recorded elevated levels of carbon monoxide (CO) and carbon dioxide (CO₂), along with oxygen depletion. The CO levels clipped at the maximum 2% recording limits at approximately 3 minutes (figure 49). These are high levels of CO, indicative of a flashover condition. A closer look at the CO traces reveals the timing of events, with the mid cabin station (upper) first experiencing the rise in gas measured, followed by the forward cabin station (upper). The gases then appeared to collect at the forward end, as the next rise is indicated at the forward cabin station (lower). The final rise is shown at the mid cabin station (lower). These traces corroborate the observed smoke plume in the cabin prior to video camera obscuration.

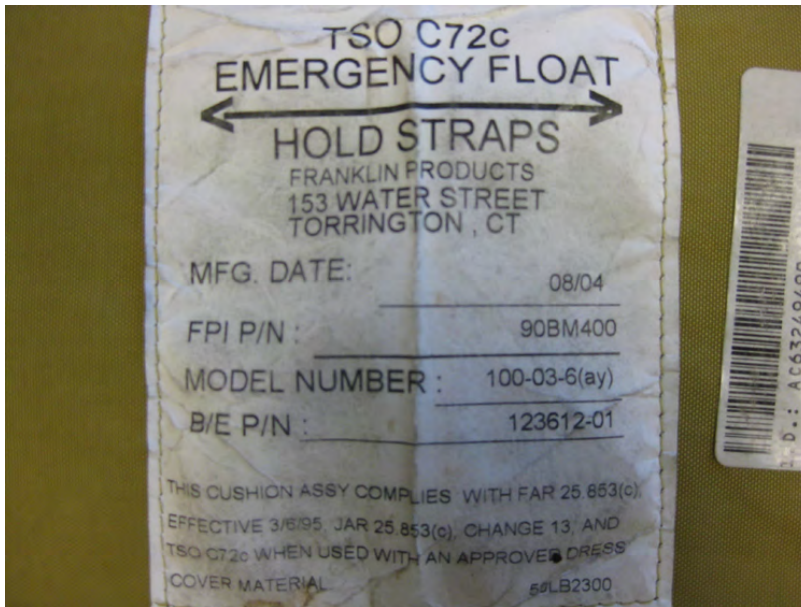
Figure 55. Franklin Products Manufacturer's Plate on Bottom Seat Cushion
Used in Baseline Test 1

Because the test resulted in flashover conditions being reached so quickly, there was concern over the test configuration and materials used. Since the panels and carpet had been used in previous full-scale tests with no adverse affect, they were ruled out. This focused the attention on the seating materials and the use of the exhaust fan to draw the fire into the test fuselage. Upon removing the burned materials from the test fuselage, the bottom seat cushions were inspected with greater scrutiny, revealing inconsistent construction. In some cases, the bottom cushions included a felt-type, fire-blocking layer, while others appeared to lack a fire-blocking layer, indicating they were fire-hardened foam (blocking layer not used). Since there was some concern over the performance of the seat materials, the untested cushions were removed from the remaining seat assemblies in storage. The inspection revealed a number of different types of bottom cushions, including the (presumably) original units manufactured by B/E Aerospace (figures 50 and 51). A close-up photograph of the inspection tag on the bottom side reveals the manufacturing details, including the statement that it complies with FAR 25.853 (c), which is the flammability test using the oil burner (figure 52). Other units were manufactured by Franklin Products (figures 53 and 54). The Franklin Products inspection tag revealed a similar statement of compliance with FAR 25.853 (c) (figure 55).

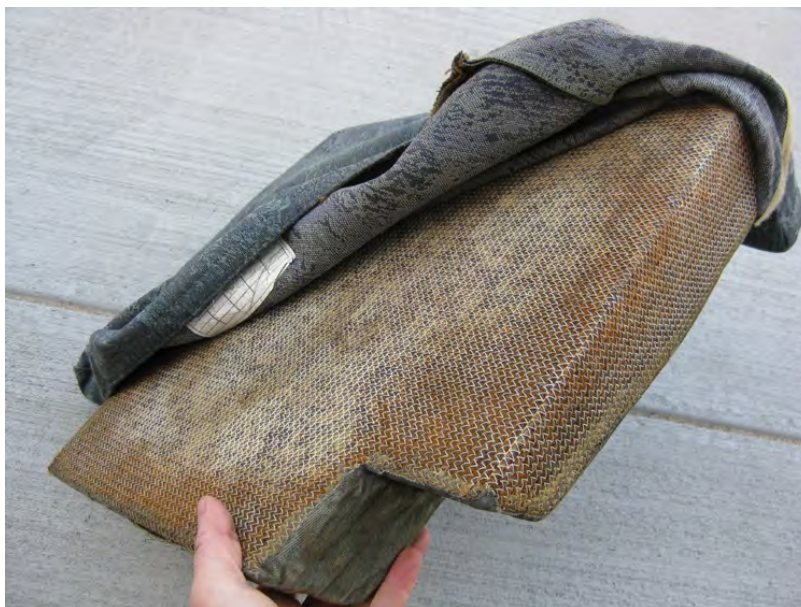
Although these two types of bottom seat cushions appeared to meet the current flammability requirements, a third cushion type was found that did not include any fire-blocking layer (figure 56). Furthermore, this particular unit had no inspection tag or other information identifying it or its compliance level (figure 57). It can only be assumed that this unit was a fire-hardened foam cushion, but this information could not be confirmed, since the seats were purchased from an aircraft spares dealer who did not keep any compliance records.

Figure 56. Side Angle View of Bottom Seat Cushion Used in Baseline Test 1 With no
Fire-Blocking Layer or Inspection Tag

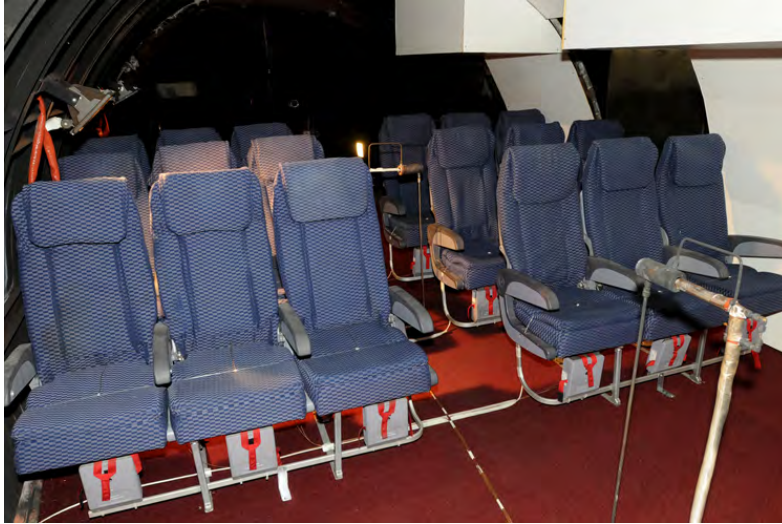
Because of the poor performance of the seatback configuration in Baseline Test 1, a change was also made to the fiberfill cushion material for Baseline Test 2. The seat cushion backs were cut open in the back, and the original fiberfill was removed. The material was replaced with DAX Foam™, a flexible, closed-cell polymeric foam that contains expandable graphite as a fire retardant². The foam material is the U.S. version of a Kay-Metzeler foam produced in the United Kingdom. Reports from industry indicate the combination of DAX Foam and upholstery fabric meets FAR 25.853 (c), with a resulting weight loss of approximately 6% (10% is the maximum allowable per the requirement). All other B/E 990 seat structures and hardware remained identical to those used in Baseline Test 1. The completed B/E 990 seats with backs containing DAX Foam were installed in the test fuselage identical to Baseline Test 1 (figure 59).

Figure 59. Baseline Test 2 Configuration

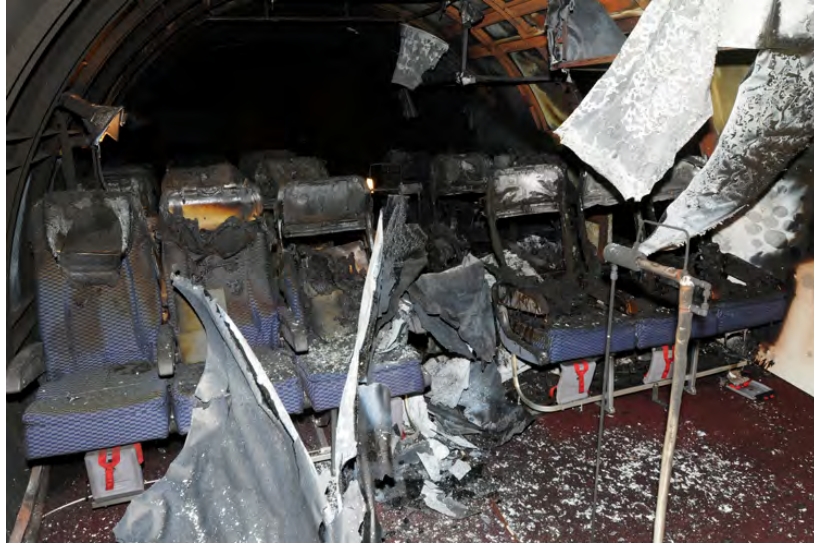
The pan fire was extinguished at 5 minutes 30 seconds with AFFF, and the interior fire self-extinguished a few minutes later. A posttest inspection of the fuselage revealed significant fire damage to the materials, similar to the previous baseline test. A majority of the honeycomb sidewall and ceiling panels were consumed with remnant pieces suspended from steel safety wire at various places in the ceiling and stowage bin areas (figure 60). Again, substantial damage to the seat assemblies was evident, particularly the seatbacks. The damage clearly showed the fire was able to jump the aisle and involve the seat materials farthest from the fire entry point.

Figure 60. Baseline Test 2 Cabin Materials Following Test Fire

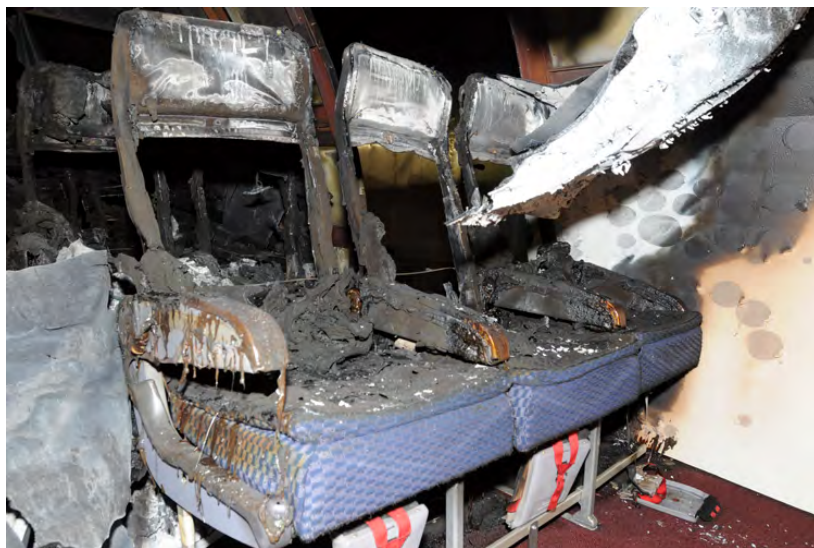
A closer inspection of the seating materials revealed that the seatback assemblies, including the stretched nylon suspension system and miscellaneous thermoplastic parts, were completely consumed in all of the portside seats (figure 61). The seatback cushion materials were largely consumed, with remnants collapsed and piled onto the upper surface of the bottom cushion. The portside row 2 and 3 bottom seat cushions were largely consumed, while the portside row 1 seats did not appear as damaged. However, upon examination of these cushions, it was discovered that they were deplete of foam, as if the inside had burned and the fire-blocking layer did not. Also of note were the thermoplastic life vest boxes, which were largely intact and unburned, except in the direct impingement areas. This result indicated the materials near the floor (seat cushion and lower) were in a zone of lesser severity than the materials higher up in the cabin during this particular postcrash scenario.

Figure 61. Close-Up View of Portside Triple Seat in the Baseline 2 Test

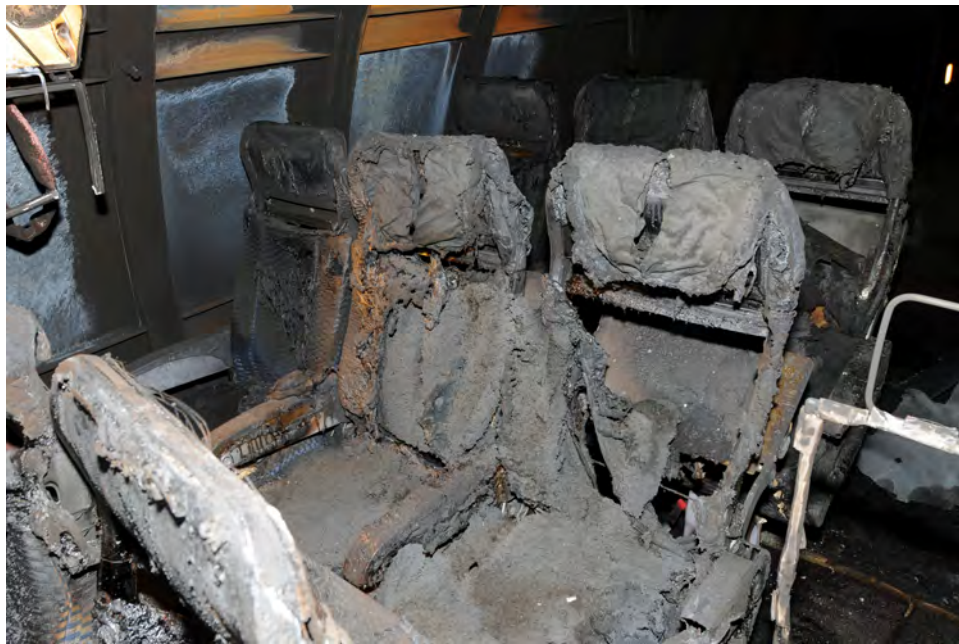
The seatback cushions on the starboard side were noticeably less fire damaged than the portside materials (figure 62). Only the starboard-side aisle seats showed similar slumping of the seatback materials onto the bottom seat cushions. Although heavily fire damaged, the materials were still in place on the seatbacks, in contrast to the portside seatbacks, which were largely void of materials. The bottom seat cushions on the starboard side also exhibited signs of being hollow, where the interior foam was consumed, leaving a shell of fire-blocking layer and charred dress cover.

Figure 62. Close-Up View of Starboard-Side Triple Seat in the Baseline 2 Test

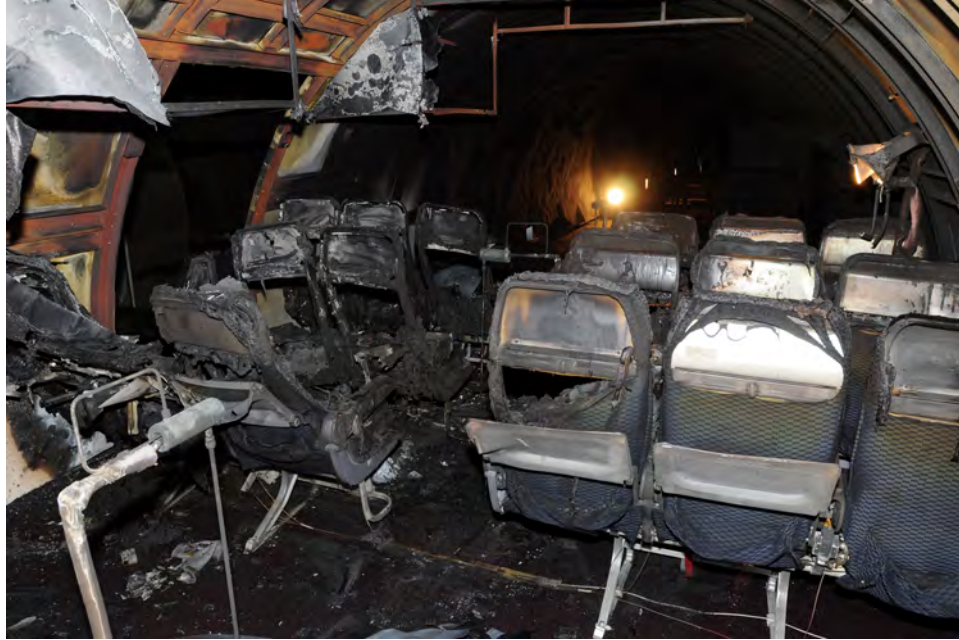
A view from the aft cabin revealed a noticeable dividing line between the portside and starboard-side damage (figure 63). Although the fire had crossed the aisle at some point during the test, there was a noticeable difference in the level of damage on either side. The portside seatback assemblies were extensively damaged, with all cushion materials consumed. The carbon frame was also heavily damaged on all portside seats, and in some cases, it had collapsed. In contrast, the seatbacks on the starboard side were relatively intact, with the dress cover still visible from the aft view of the triple seat in row 3.

Figure 63. Aft Cabin View, Showing Portside and Starboard Seat Damage

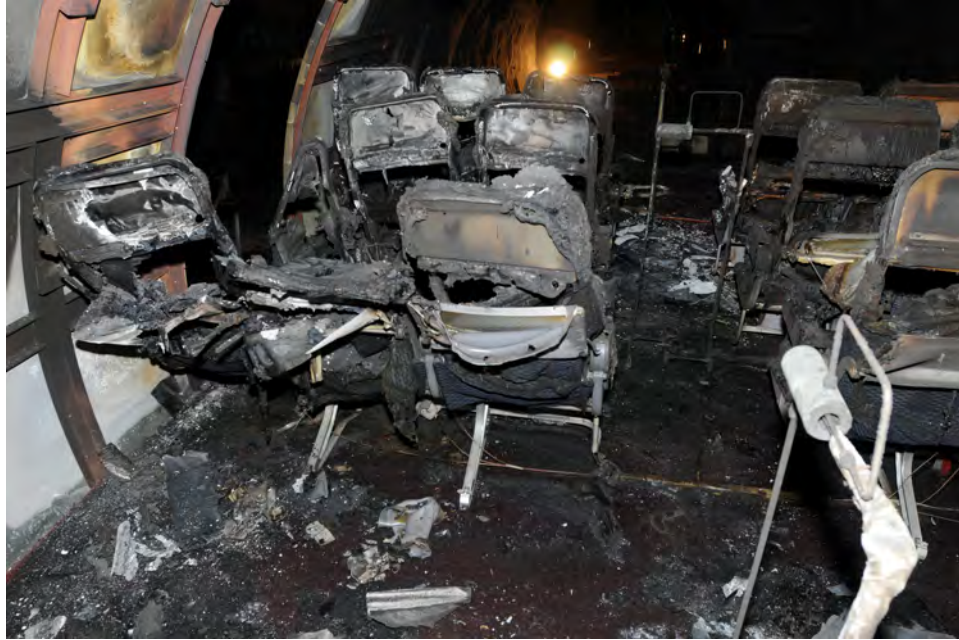
A closer view of the portside seats revealed several of the carbon seatback frames had collapsed, as the frame appeared to lose structural integrity once the epoxy resin was consumed in the fire (figure 64). The collapse of the structure likely aided in the spread of fire, as the seatbacks were observed igniting early in the fire sequence via fuselage-mounted cameras. Once the structure collapsed, it could have fallen into an adjacent material, causing it to ignite and spread the fire. The seatback structure collapse also impacted the performance of the DAX Foam used there. This foam is a polyurethane with graphite added, and when hit by a flame, the polyurethane burns down until the outer layer is predominantly graphite. In a laboratory setting, a static performance state is quickly reached, since there is no structural collapse of the steel test frame. However, occasional failures of this material can occur during a laboratory test, when the dress cover (typically leather) contracts and breaks apart the foam. This progression exposes new polyurethane foam, which then has to burn down to form a new graphite barrier. In the Baseline Test 2, the burning and failure of the seatback structure would have broken apart the DAX Foam in the cushion as it fell. This likely caused substantially more of the DAX Foam to burn than if it were held in a static position³. Also of note were the thermoplastic tray tables, which were almost completely consumed on the portside seats.

Figure 64. Aft Cabin View of Portside Seats Showing Back Assembly Structure Collapse

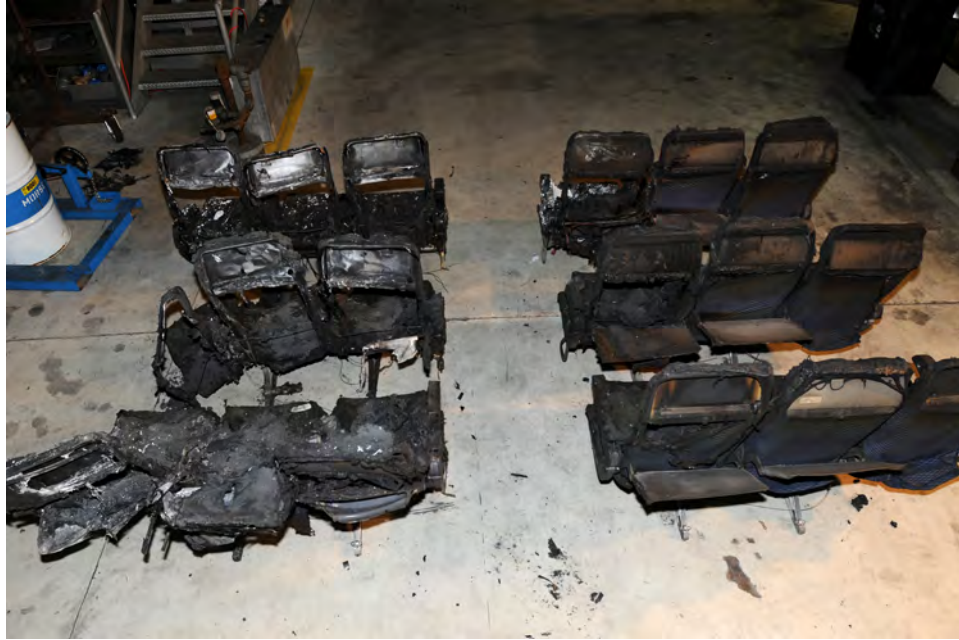
Following a thorough inspection of the materials in the cabin, the seats were removed and placed on the test facility floor for further examination (figure 65). With the exception of the triple seat located adjacent to the fire opening, there was no melting of the primary components on any of the other seats. The portside row 2 seat assembly sustained the majority of the fuel fire heat and experienced rear cross tube and left-side leg melting (figure 66). Although this melting was not considered widespread, it was similar to the extent of melting experienced on the magnesium alloy bar samples tested in the laboratory and, therefore, had the potential to allow the magnesium components to ignite in subsequent full-scale tests.

Figure 65. Seats Placed on Test Facility Floor for Inspection

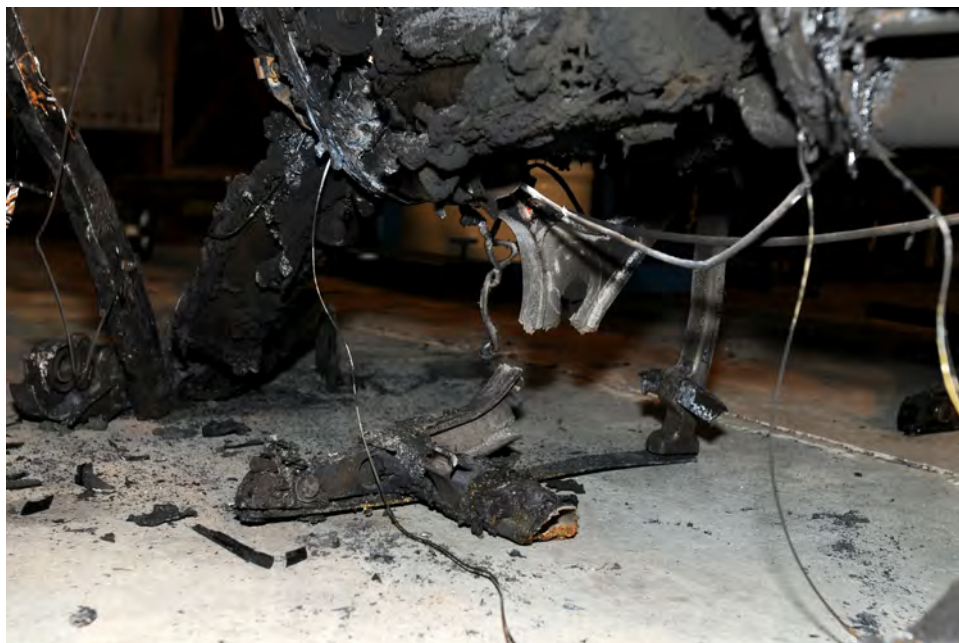
Figure 66. Close-Up View of Melted Leg and Cross Tube Structure on Entry Door Seat

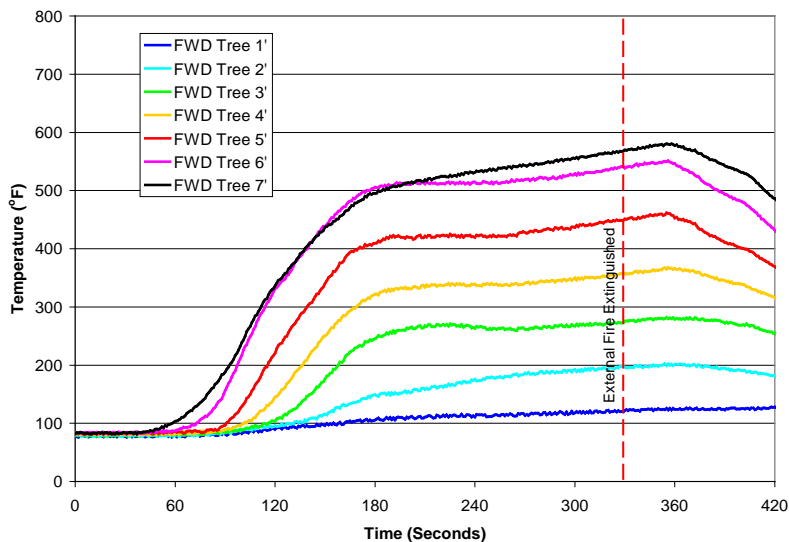
A review of the data corroborated the video recording of the test, as temperatures at the forward cabin station climbed quickly, starting shortly after 60 seconds (figure 67). Ceiling temperatures at this station reached 570°F at the point of external fire extinguishment. At the mid cabin station closer to the fire, the temperatures reached approximately 900°F at this point in time (figure 68). A quick comparison revealed that these temperatures were much lower than the temperatures observed during Baseline Test 1, despite the test being 2 minutes 30 seconds

longer. This indicates that the DAX Foam substituted for the fiberfill used in the seatback cushions had a positive impact on the test and resulting fire growth. The temperature profiles also show a plateau effect, in which the temperatures initially rose at a steep rate, but leveled off and remained fairly constant for several minutes prior to the external fire being extinguished.

Figure 67. Plot of Forward Cabin Temperature vs Time for Baseline 2 Test

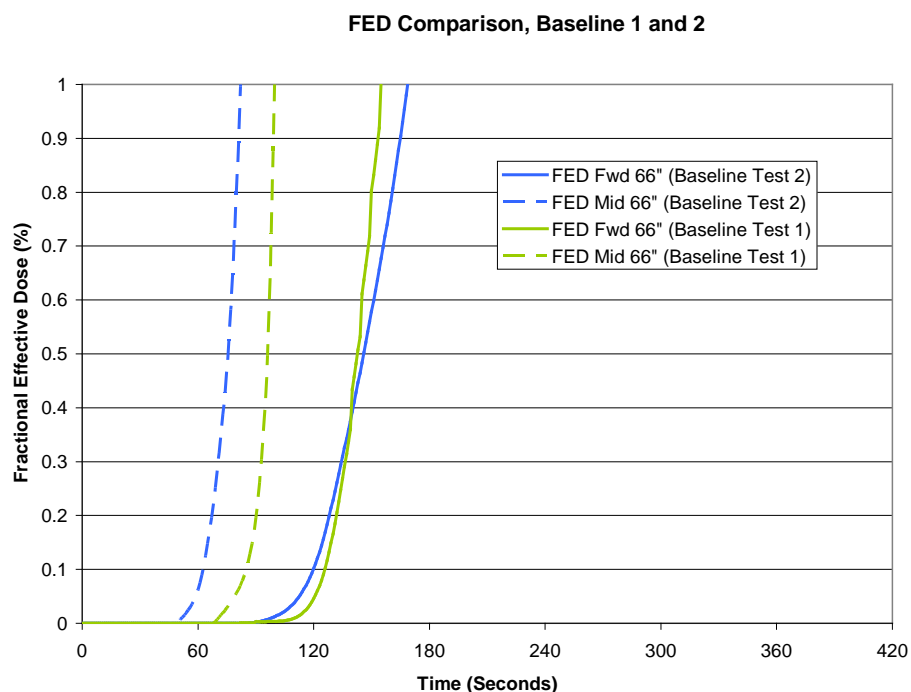
Using the temperature and gas data obtained in the two baseline tests, the survivability model calculated similar results for each (figure 70). Not surprising was the nearly 3-minute time to reach incapacitation at the forward location in the cabin for both tests, with the second baseline

showing a marginally better result. This result corroborated the video obtained during each test, in which a rapid burning of the materials culminated in complete camera obscuration by 2 minutes 30 seconds. Most notable was the relatively short period of time required to reach incapacitation at the mid cabin station for both tests, with the initial baseline test yielding a slightly more favorable result. Although the two test results were close, a cursory review of the data indicated more favorable conditions existed at all locations inside the cabin during Baseline Test 2.

Figure 70. Survivability Calculations for Baseline Tests 1 and 2

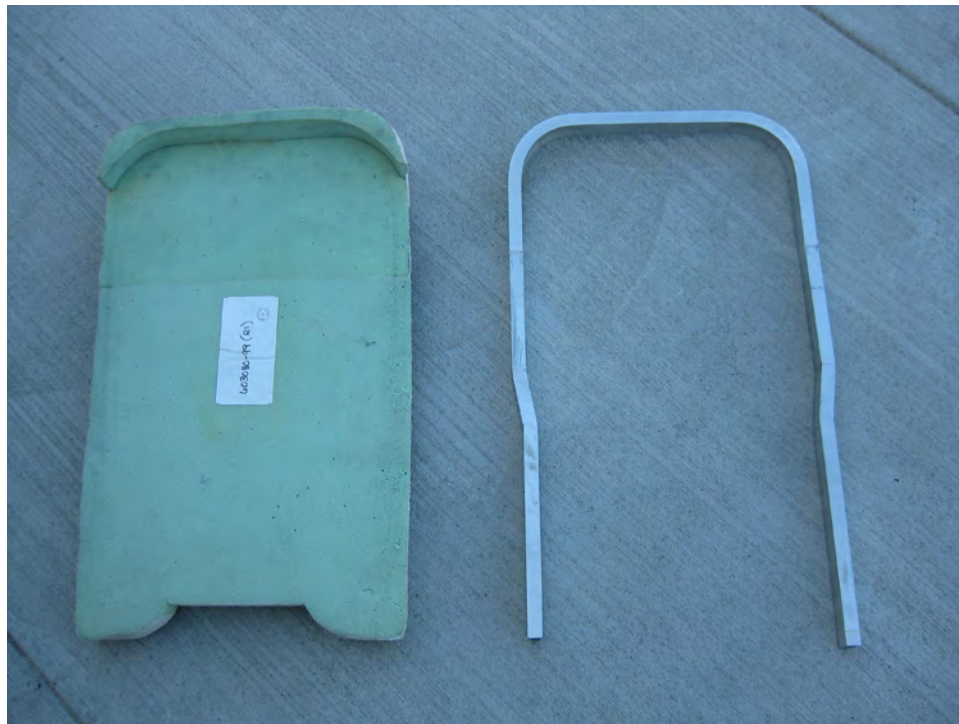
The new seatback concept was simple, yet retained the original shape and size of the B/E 990 seatback. Chestnut Ridge Foam, Inc. had previously retrofitted a shipset of B/E 990 seatbacks for a business-jet customer, and as a result, they had a back cushion available, which simplified the selection process. This eliminated the need for a costly design and development process. A sample of this cushion was sent to the FAA, and an aluminum box frame was developed to fit the pattern (figure 71). To bend the aluminum tubing to the correct pattern, a special hydraulic tube-bending machine was purchased.

Figure 71. Fire-Hardened Foam and Fabricated Aluminum Frame

The aluminum used for the frame was Al 2024-T3, and measured 0.75 by 1.5 inches. Chestnut Ridge also had available a dress cover for this particular assembly that was supplied for test fitting the prototype assembly (figure 72).

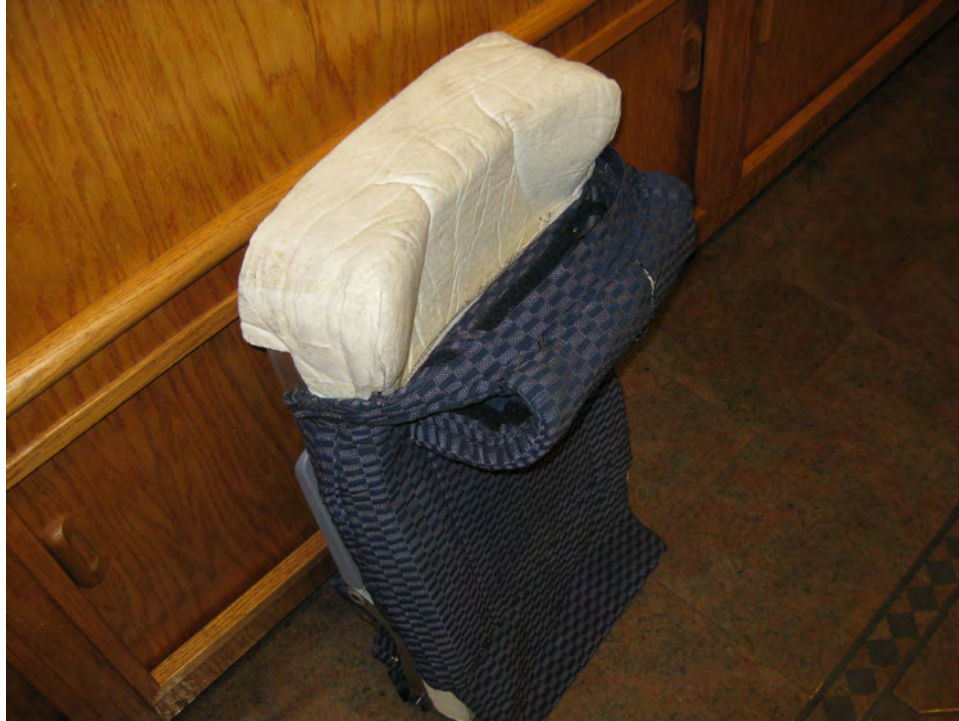
Figure 72. Dress Cover Being Test Fitted to Prototype Cushion Assembly

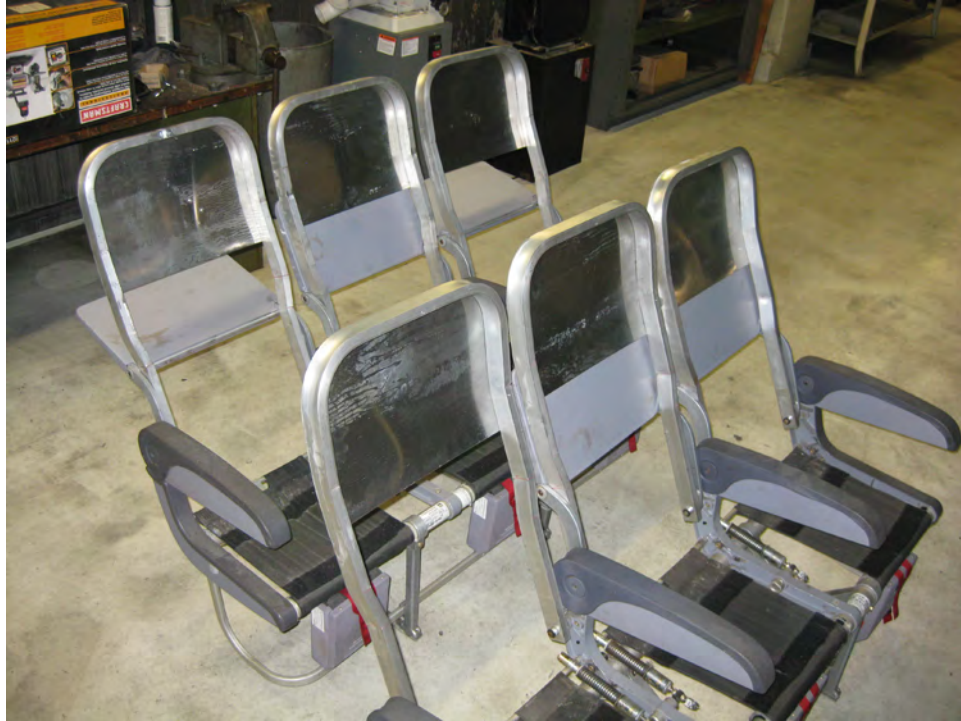
Figure 73. Seatback Assemblies Being Fabricated and Mounted on B/E 990 Seats

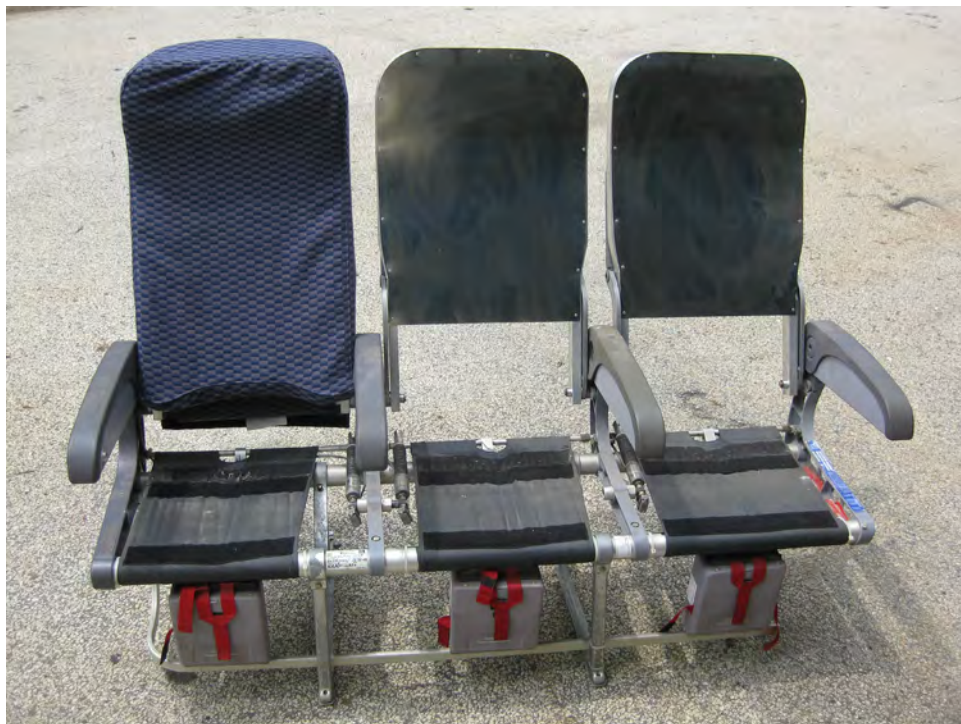
Figure 74. Partially Fabricated Seatbacks Showing Front Aluminum Pan

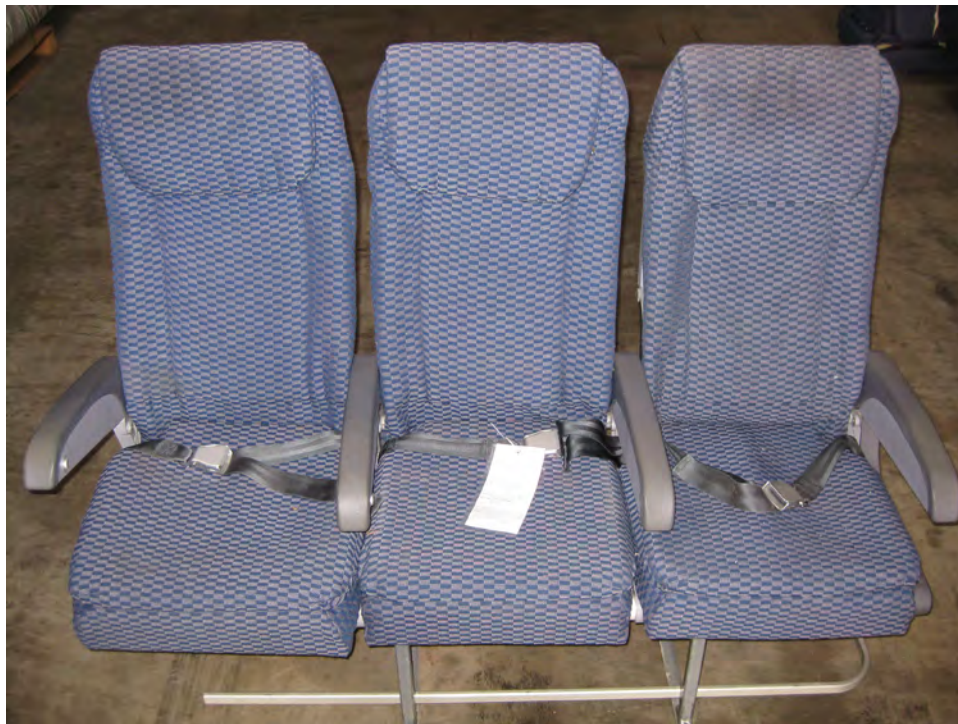
Aside from the materials purchased for the seatback fabrication, additional B/E 990 seats needed to be purchased, since the original order contained only enough to conduct four tests. Since two additional baseline tests were conducted, at least 12 additional triple seats were needed. An order was placed with a different aircraft spares dealer. Universal Asset Management, Inc. of Memphis, Tennessee, supplied 24 additional B/E 990 seats. The seats received were in very good condition and contained all the necessary cushion materials, including the fire-blocked bottom seat cushions. The seats were outfitted with Continental Airlines livery (figure 75).

Figure 75. Additional B/E 990 Seats

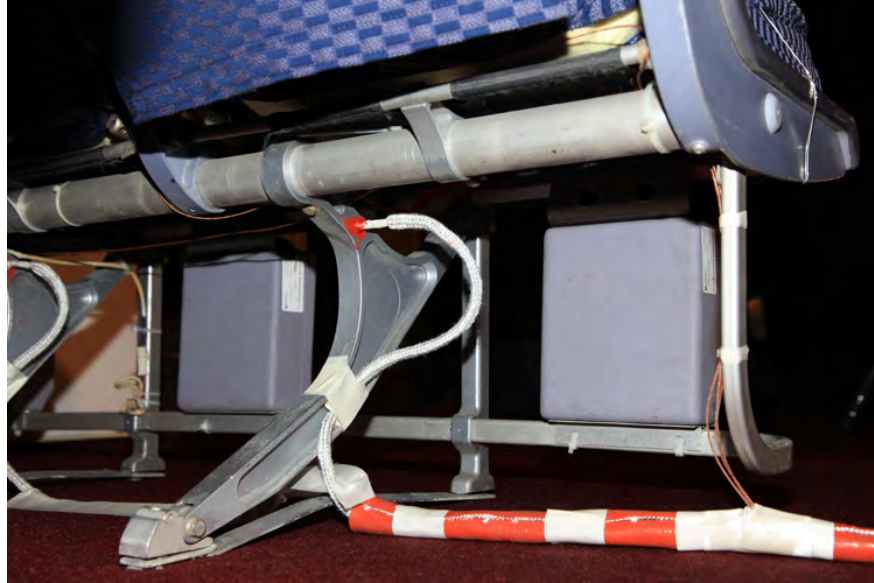
As shown in the earlier laboratory-scale tests, it was necessary for the magnesium alloy materials to melt before any ignition would occur. To determine if the magnesium alloy seat components reached their melting temperatures during the full-scale tests, thermocouples were embedded into the seat leg components. The most practical method for doing this was to drill a small-diameter hole and insert a metal-sheathed thermocouple into the borehole. As a safety measure, the thermocouples were held in place using high-temperature, room-temperature vulcanizing (RTV) silicone (figure 77). The RTV silicone also prevented the thermocouple from inadvertently measuring air temperature from the surrounding area by sealing the sensor in the borehole, thereby measuring only the core metallic temperature. This measurement technique was not perfected until Baseline Test 3. The lead wires from the thermocouples were also wrapped in a heat-resistant sheath to protect them from fire damage.

Figure 77. Typical Embedded Thermocouple Arrangement in Seat Leg

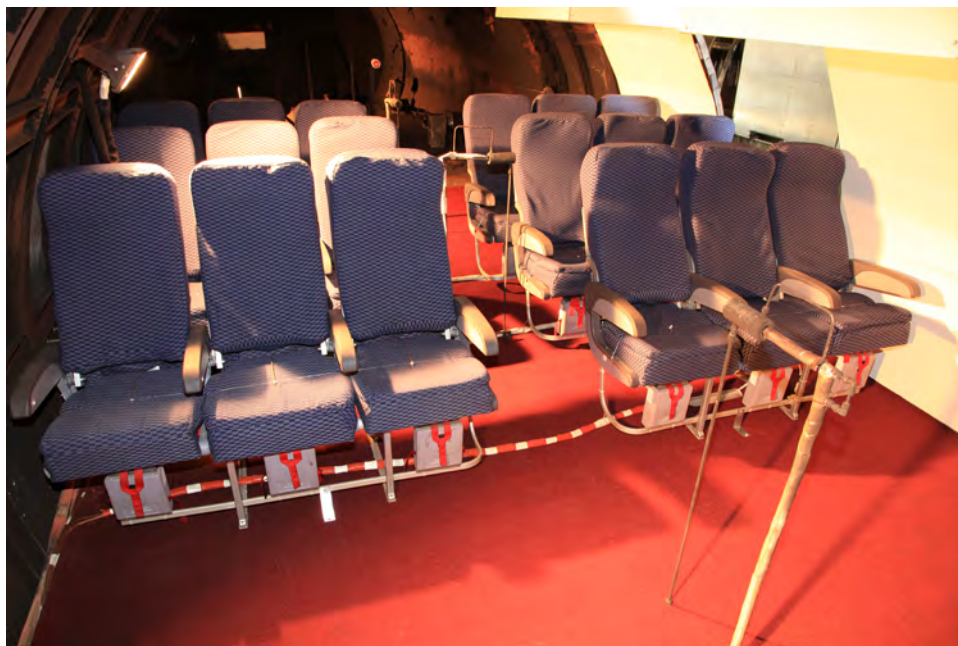
All seatback construction was completed, and the fully dressed seats were installed in the test fuselage, which had been previously outfitted with honeycomb sidewalls, ceiling panels, and stowage bins, and carpeting (figures 79 and 80). The fuel pan was loaded with 55 gallons of JP-8 fuel, and a final check of the instrumentation was performed. All cabin doors were checked to ensure there were no other openings except the aft L3 door, which was partially open as in previous tests, to allow the entrance of make-up air for combustion. The data collection system was initiated just prior to fuel pan ignition, and the fire was started. In contrast to the previous two baseline tests, the fire did not appear to spread into the cabin as quickly. There was excellent visibility from all cameras at the 1-minute point, with only localized burning on the seat directly in the fire opening. The visibility remained clear at the 2-minute point, as the fire began to spread on the sidewall panels around the periphery of the fire opening and progressed forward and aft on the stowage bin panel surfaces. The aft upper camera clearly showed less visibility and greater quantities of smoke compared with the aft lower camera. At 3 minutes, the aft lower camera was moderately clear, with smoke density beginning to rise. Forward cameras showed the seatbacks on all portside seats were on fire near the tops, but there was no evidence of involvement on the starboard-side seats at this point. By 3 minutes 40 seconds, flashover conditions began to develop, with increased turbulence in the smoke at the ceiling, and visible flames on much of the ceiling surface. Flashover continued, with complete obscuration of the cameras at 4 minutes 15 seconds. The test continued unabated for another 45 seconds after camera obscuration in an effort to cause more extensive melting. The extended test time and component melting would be necessary during subsequent magnesium alloy tests, as the previous laboratory-scale results indicated the materials had to melt first before ignition would occur.

Figure 79. Baseline Test 3 Configuration

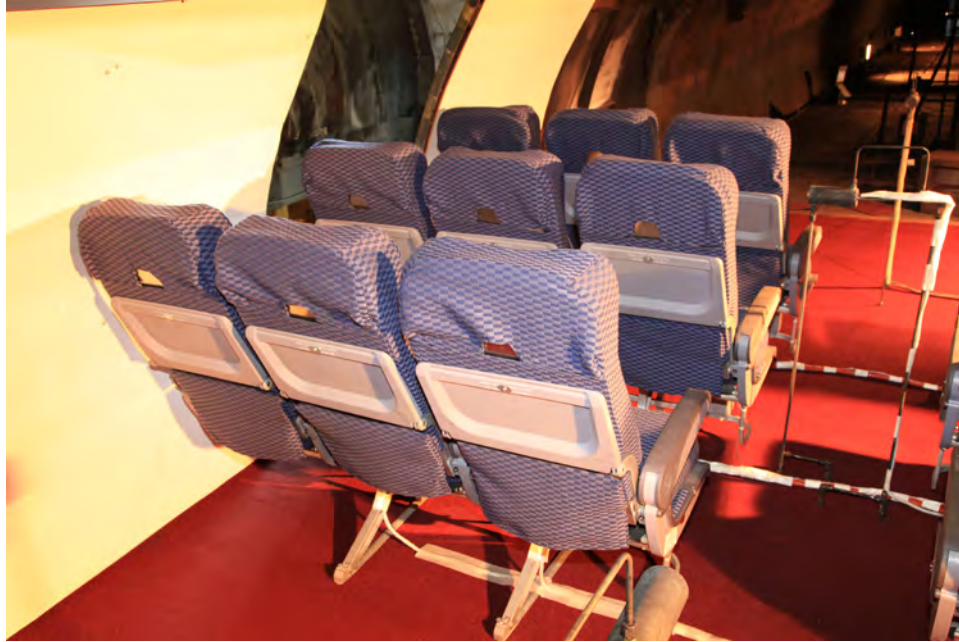
Figure 80. Aft View of New Seatback Assemblies Used in Baseline Test 3

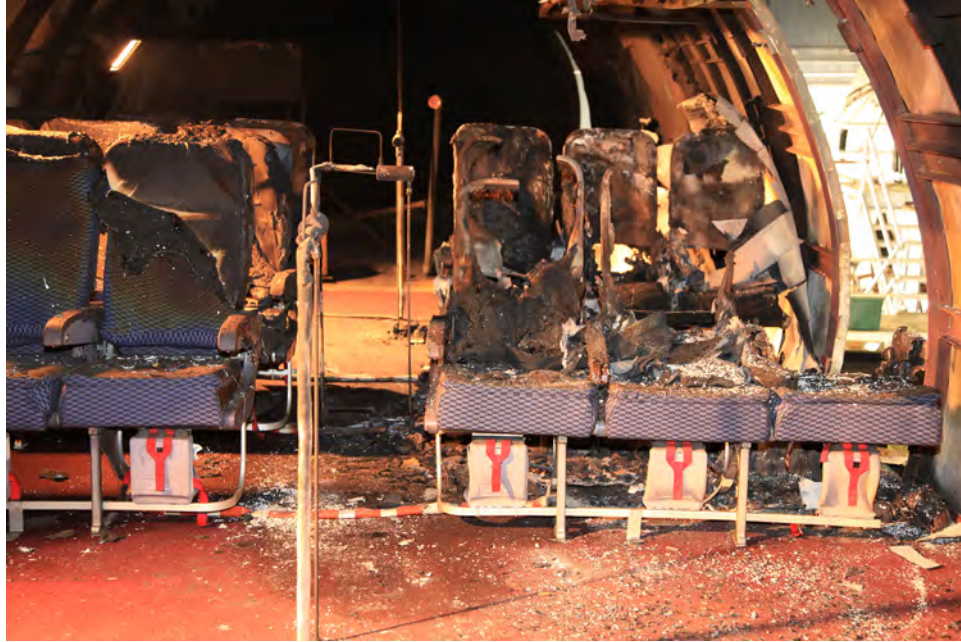
A posttest inspection revealed a number of the portside seatbacks were consumed, including the aluminum frames (figures 81 and 82). The starboard-side seatbacks were largely intact, with only surface burning and charring of the fabric dress cover (figures 83 and 84).

Figure 81. Baseline Test 3 Damage to Portside Seats

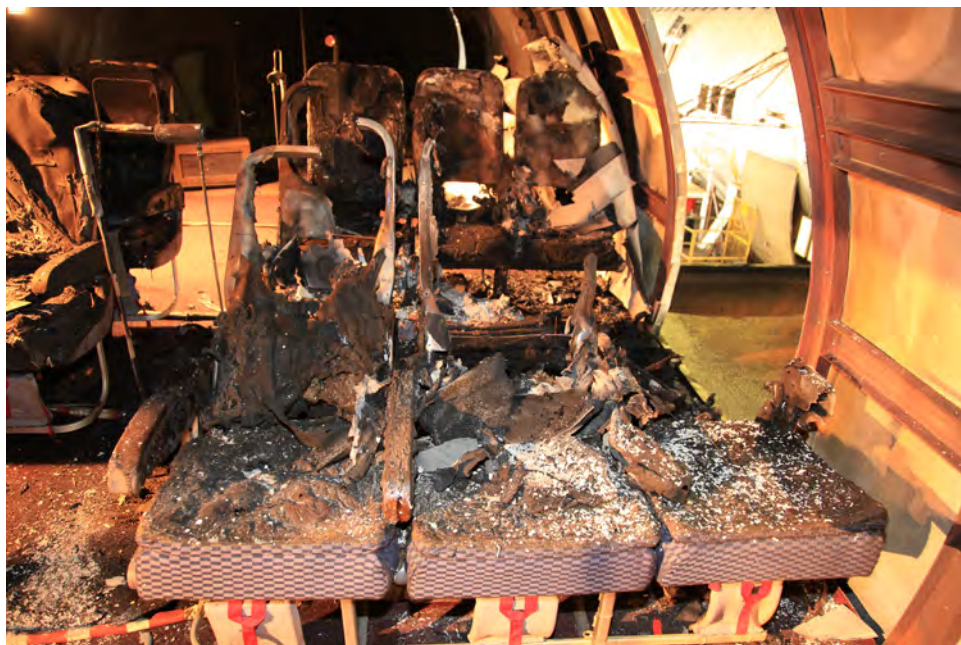
Figure 82. Close-Up of Portside Triple Seats Showing Melted Aluminum Seatbacks

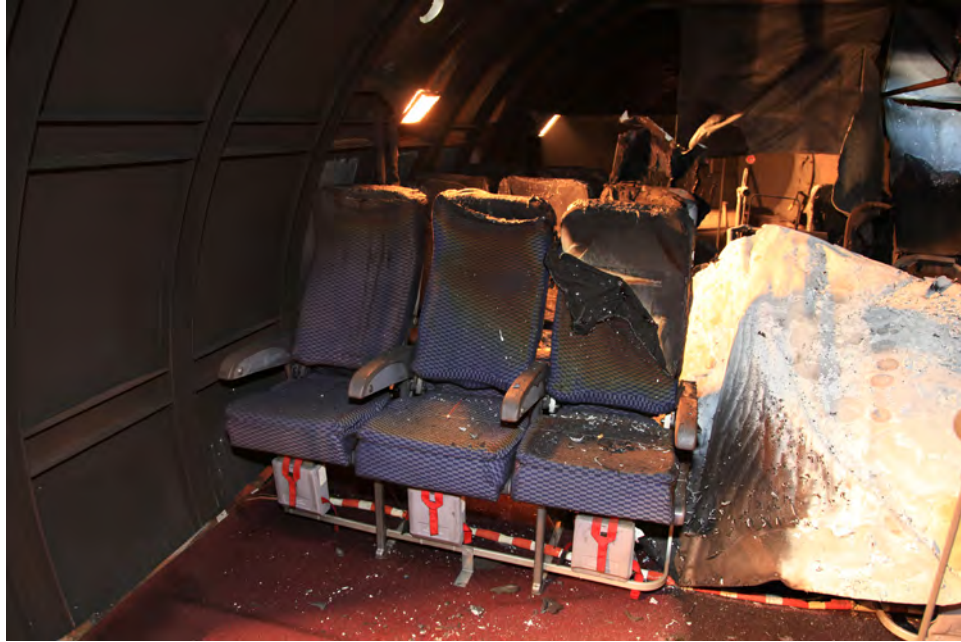
Figure 83. Posttest Starboard-Side Seats in Baseline Test 3

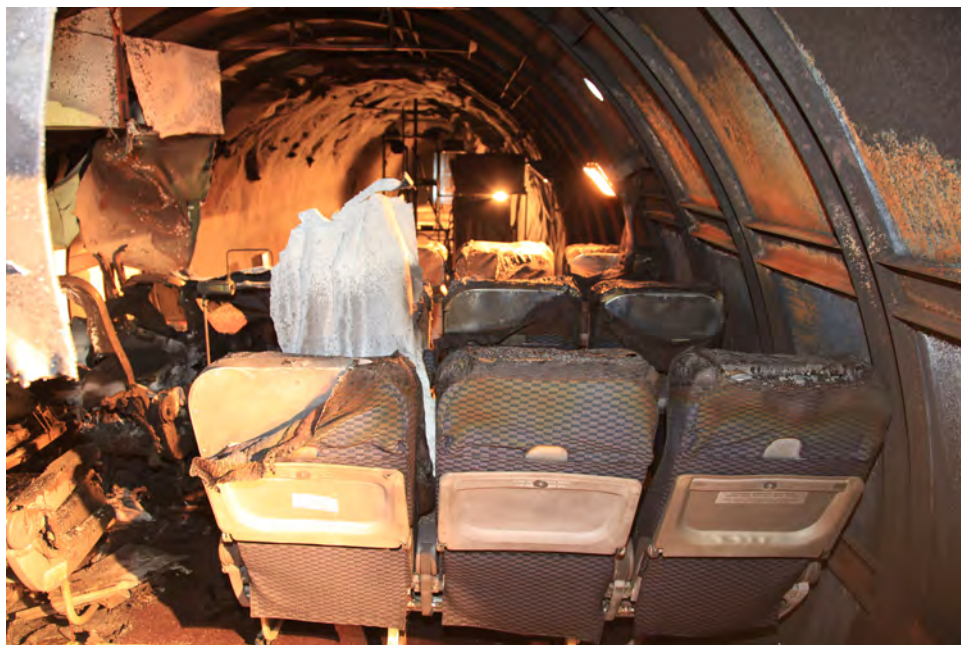
Figure 84. Aft View of Starboard-Side Seats

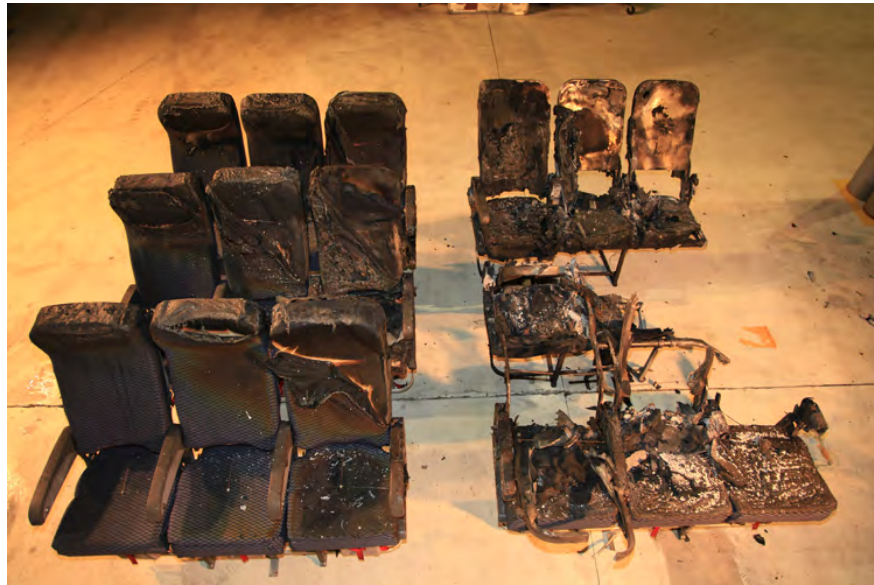
To facilitate a closer inspection of the burned materials, the seat structures were carefully removed from the fuselage and put on the floor of the test facility, positioned in the same orientation as in the test (figure 85). The damage clearly indicated the newly designed seatbacks had prevented extensive flame spread, as the starboard-side seats were heavily charred but the seatback materials were still intact. The 5-minute test duration appeared sufficient, as there was thorough melting of the seat frame near the fire opening, which was the desired result

Figure 85. Seats Removed From Fuselage Following Baseline 3 Test

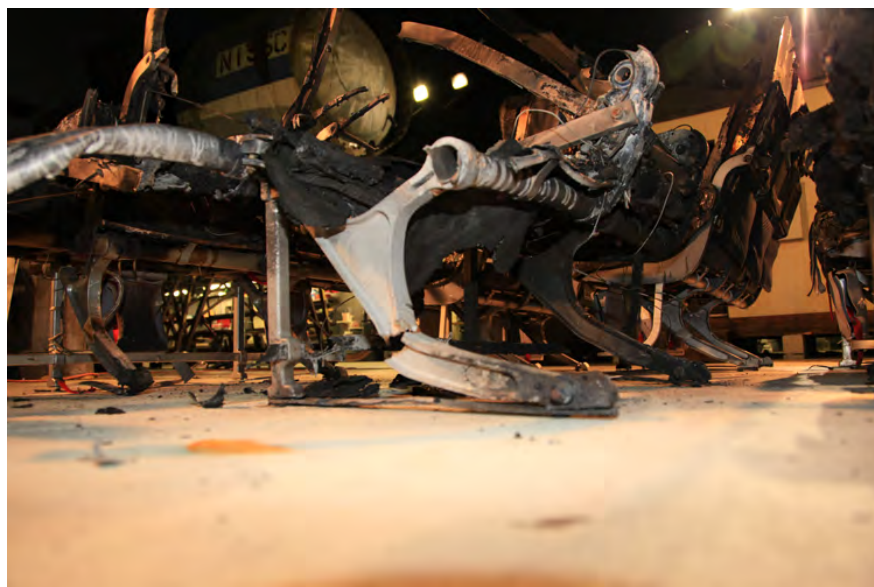
(figure 86). The close-up photographs show that both cross tubes were melted, along with the outboard leg component and outermost spreader assembly. The next inboard spreader assembly had partially melted and was lying on the fuselage floor. Although they were not primary components, the seatback frames and most of the lower baggage bar on this triple seat were also completely melted. These results indicated a successful test condition had been established. The conditions resulted in thorough melting of the primary components, but the overall atmospheric conditions were not so severe that subsequent magnesium alloy materials could not be effectively evaluated.

Figure 86. Close-Up of Melted Seat Structure Primary Components
