DOT/FAA/AR-11/3

Evaluating the Flammability of Various Magnesium Alloys During Laboratory- and Full-Scale Aircraft Fire Tests

Timothy R. Marker

Final Report

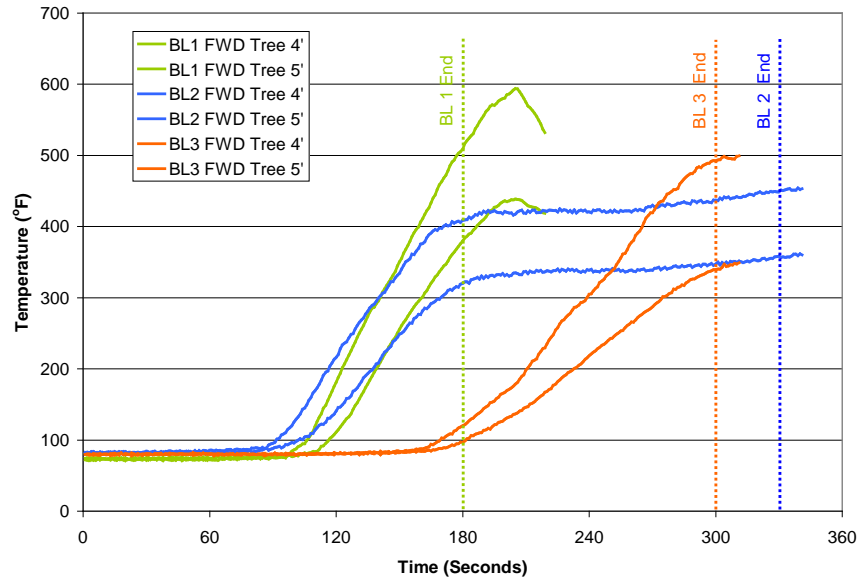
The data from all three baseline tests were compared to confirm the observed results. Temperature data from the tests indicated a much earlier rise during the initial two baseline tests with the carbon/epoxy seatback structure. For clarity, only the 4- and 5-foot temperature data is shown (figure 87). In the forward cabin, there is an approximate 2-minute lag in temperature when comparing Baseline Test 3 to the previous two tests. This data gives a very rough estimate that the newly designed seatback provided approximately 2 more minutes before nonsurvivable conditions were reached. A similar trend was observed in the aft cabin (figure 88).

Figure 87. Baseline Temperature Comparison in Forward Cabin Area

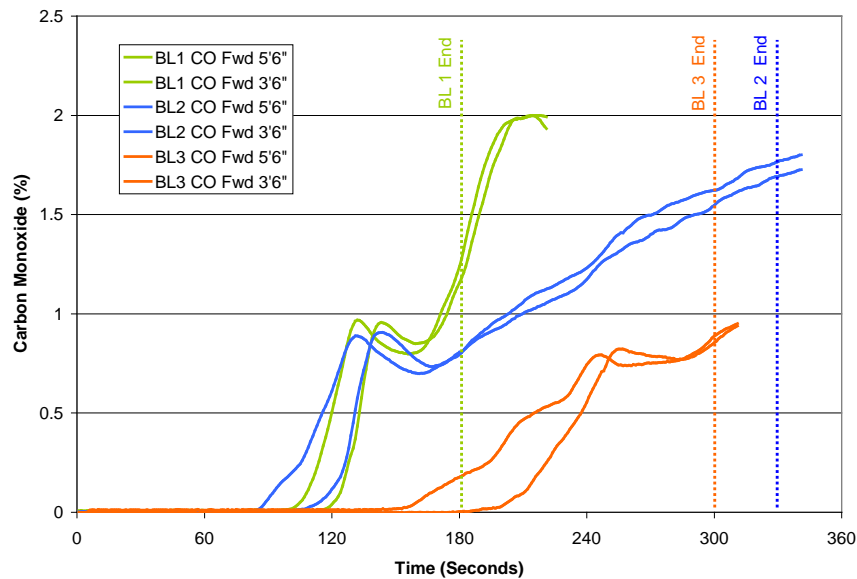
The data obtained for the CO levels followed the same trend as the temperature data. During Baseline Tests 1 and 2, the forward gas-monitoring station (3 feet 6 inches to 5 feet 6 inches) indicated a nearly identical result, with both tests reaching a level of approximately 0.8% at the 2-minute mark (figure 89). Baseline Test 3 reached a level of approximately 0.8% at the 4-minute mark. Similar results were obtained at the mid cabin station, closer to the fire opening (figure 90). Oxygen depletion was also recorded and showed much the same result of delay between Baseline Tests 1 and 2 and Baseline Test 3 (figures 91 and 92).

Figure 89. Baseline CO Comparison in the Forward Cabin Area

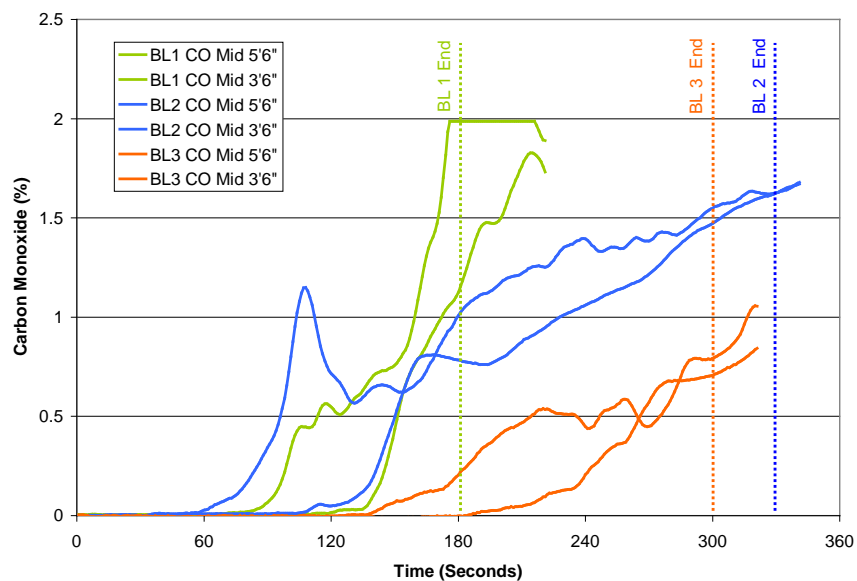
Figure 90. Baseline CO Comparison in the Mid Cabin Area

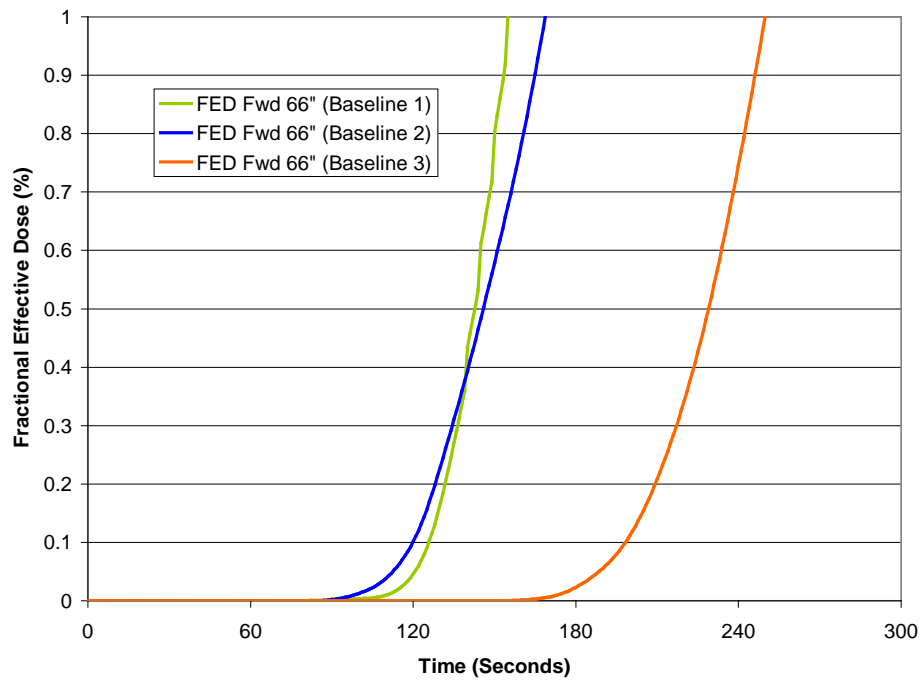
As in Baseline Tests 1 and 2, a survivability model was used to predict the theoretical time at which a person would become incapacitated, based on the levels of temperature and gases measured during the test. As expected, Baseline Test 3 yielded close to 2 additional minutes before incapacitating conditions were reached in the forward cabin, compared to Baseline Tests 1 and 2 (figure 94). This result was expected based on the delay in buildup of temperature and toxic gases, as shown in figures 87-93. Incapacitation for Baseline Test 3 was reached at 250 seconds at this location, which was the initial desired result of the test series, prior to the discovery of the poorly performing materials in the seatback assembly. The model was also used for predicting incapacitation at the mid cabin station, which was closer to the fire opening. Although incapacitation was reached much sooner due to the closer proximity to the fire and burning materials, there was still an increase of 70 and 88 seconds beyond the first two baseline tests, respectively (figure 95).

Figure 94. Comparison of Baseline Tests FED for the Forward Cabin

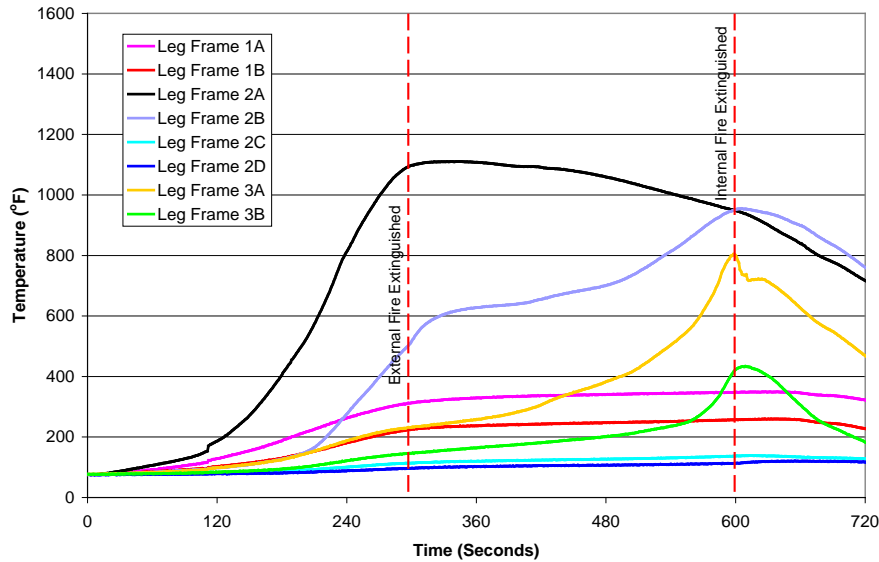
During Baseline Test 3, the leg frame temperatures increased the most on the row 2 seat assembly, which was expected, as this seat was positioned directly in front of the fire opening. The outer leg thermocouple, which was nearest to the fire, climbed into the melting range of aluminum by the time the external fire was extinguished. The melting range of Al 2024-T3, which was used to fabricate the leg assemblies, is 935° to 1180°F. This data was corroborated by a posttest inspection of the leg frame, which showed it had melted and fractured during the test. It was noteworthy that no other leg components reached temperatures high enough to cause melting, including the inner leg component in the row 2 seat assembly (figure 96). These were the largest of the primary components, so it was expected that the other lower-mass assemblies (spreaders and cross tubes) would sustain more melting, which they did.

Figure 96. Leg Frame Temperatures During Baseline Test 3

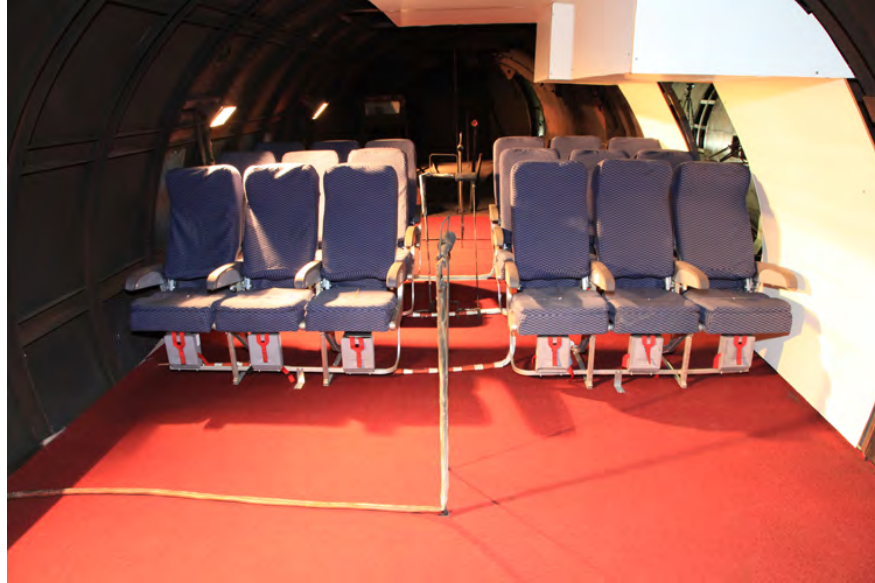
The WE-43 alloy had shown excellent resistance to ignition during the laboratory-scale tests. For this reason, it was selected as the good-performing material for the full-scale test evaluation. The good-performing WE-43 alloy was chosen for the first test, since it would be pointless to continue with the study if this material did not perform well under full-scale, realistic conditions. The machined WE-43 parts were received, and the seats were assembled. This was a difficult task, as it was necessary to first disassemble each B/E 990 triple seat, and then reconstruct it using the WE-43 alloy components (legs, spreaders, and cross tubes). Since no assembly diagrams were available, the process was slow, with technicians continually referring to a fully assembled B/E 990 triple seat. The newly designed seatback assembly, identical to that used in Baseline Test 3, was added to each leg frame assembly. The completed assemblies were installed in the furnished test fuselage, and the thermocouples were installed on the leg frames as in the previous test. All other instrumentation was checked prior to the test (figures 97 and 98).

Figure 97. Pretest Configuration for WE-43 Magnesium Alloy Test

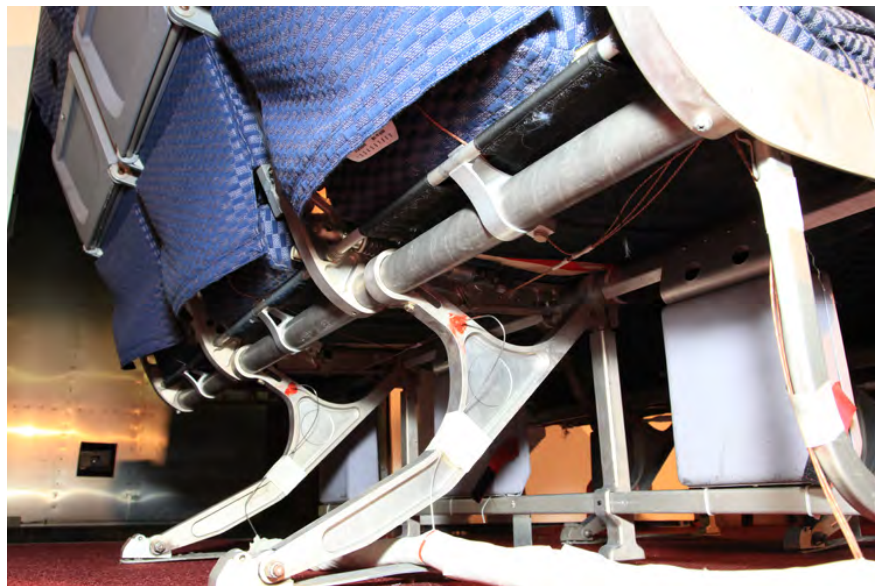
Figure 98. The WE-43 Primary Components With Thermocouples Embedded in the Legs

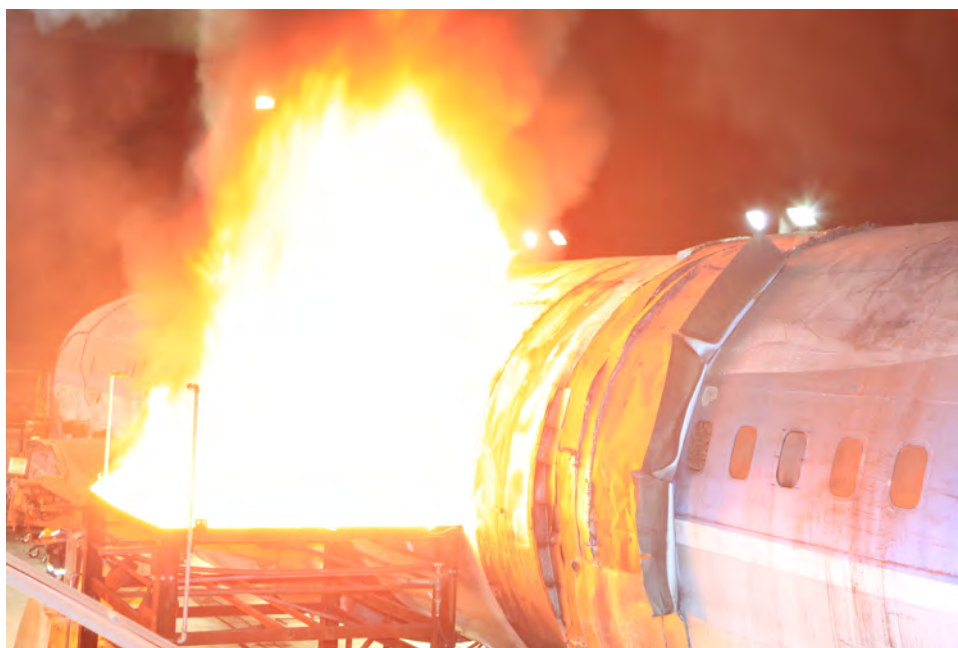
The fuel pan was loaded with 55 gallons of JP-8 fuel, and a final check of the instrumentation was performed. All cabin doors were set as they were in previous tests, to create identical pretest conditions. The data collection system was initiated just prior to fuel pan ignition, and the fire was started (figure 99). As in Baseline Test 3, the fire did not appear to spread into the cabin as quickly, with excellent visibility from all cameras at the 1-minute point, and only localized burning on the seat directly in the fire opening. The visibility remained clear at the 2-minute point, as the fire began to spread on the sidewall panels around the periphery of the fire opening and progressed forward and aft on the lower surface of the stowage bins. By 2 minutes 30 seconds, the fire started to involve the ceiling panel in the fire opening, while the visibility of

Figure 99. External Pan Fire During WE-43 Magnesium Alloy Test

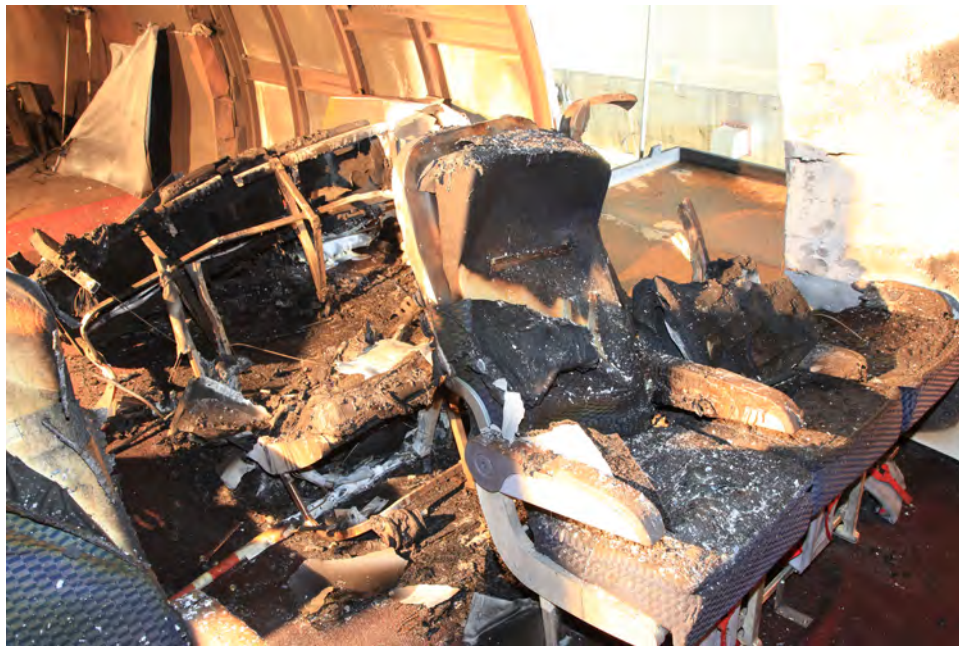
A posttest inspection revealed that a number of the portside seatbacks were consumed, including the aluminum frames (figure 100). The fire had also caused the hold-down straps on the portside row 3 seat to melt, allowing the seat to tip over backwards (figure 101). It is not clear at what point during the fire sequence this occurred, but it does not appear to have impacted the test results in any way. It is also possible that this occurred much later in the test, perhaps as a result of the water nozzle stream, which was concentrated in the row 2 seat area. Although it was directed at the row 2 seat, the stream could have deflected off the remaining seat structure, causing the row 3 seat to become unstable. The starboard-side seatbacks were largely intact, with only surface burning and charring of the fabric dress cover (figure 102).

Figure 100. The WE-43 Magnesium Alloy Posttest Results

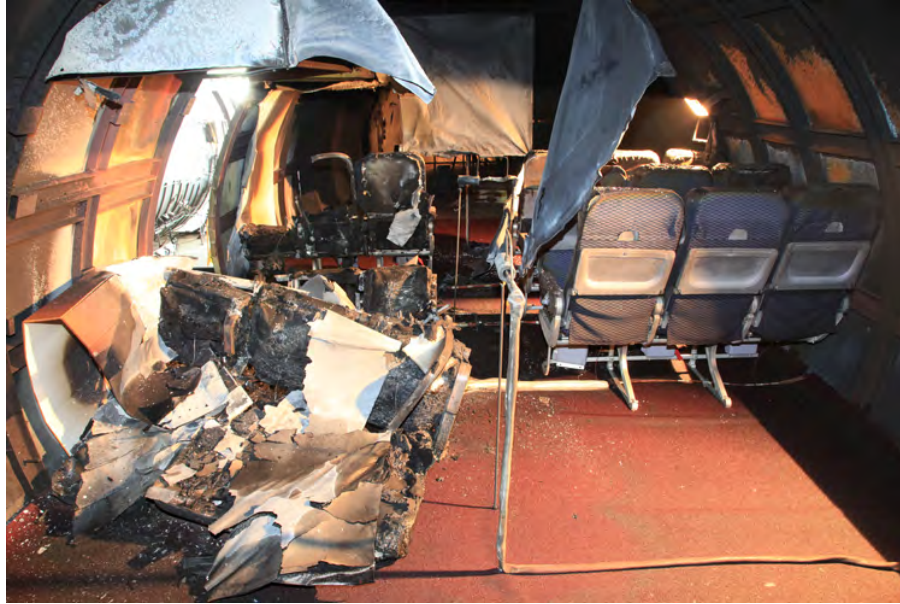
Figure 101. The WE-43 Magnesium Alloy Test Showing Portside Row 3 Seat Tipped Over

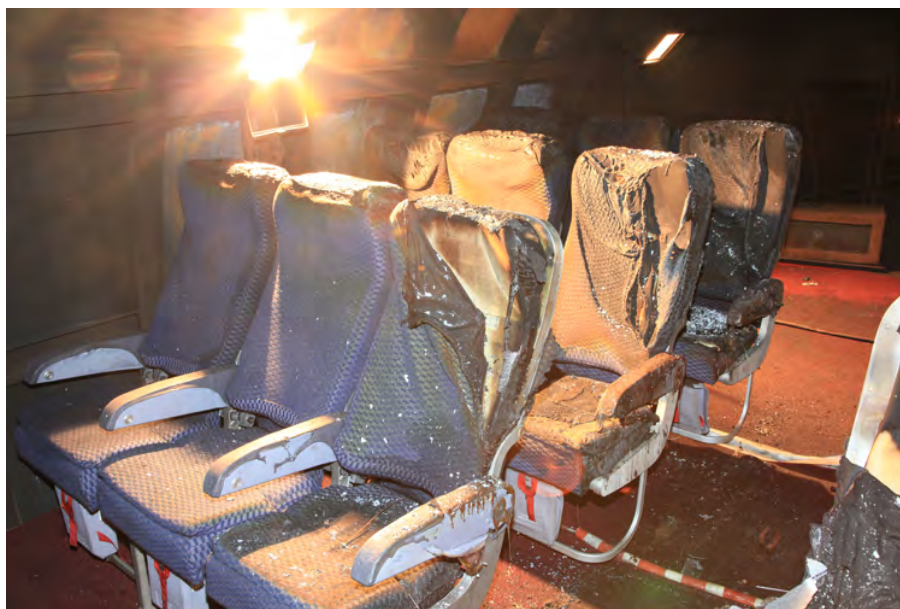
Figure 102. Starboard-Side Seats Showing Minimal Damage

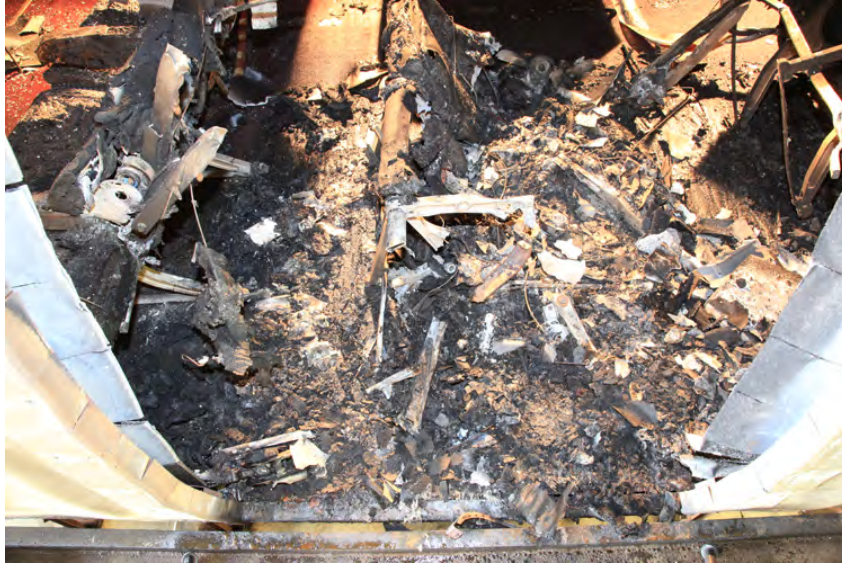
A closer look at the portside seats indicated there was considerable melting of the row 2 seat assembly's primary components (figure 103). The two outer spreaders, both cross tubes, and the outer leg experienced melting during the test. This result was similar to Baseline Test 3, in which several primary seat components had also melted. This and the results from Baseline Test 3 confirmed that the test conditions were ideal, with thorough melting of the primary components while survivable conditions remained for approximately 4 minutes.

Figure 103. View Through Fire Opening Showing Row 2 Frame Remnants

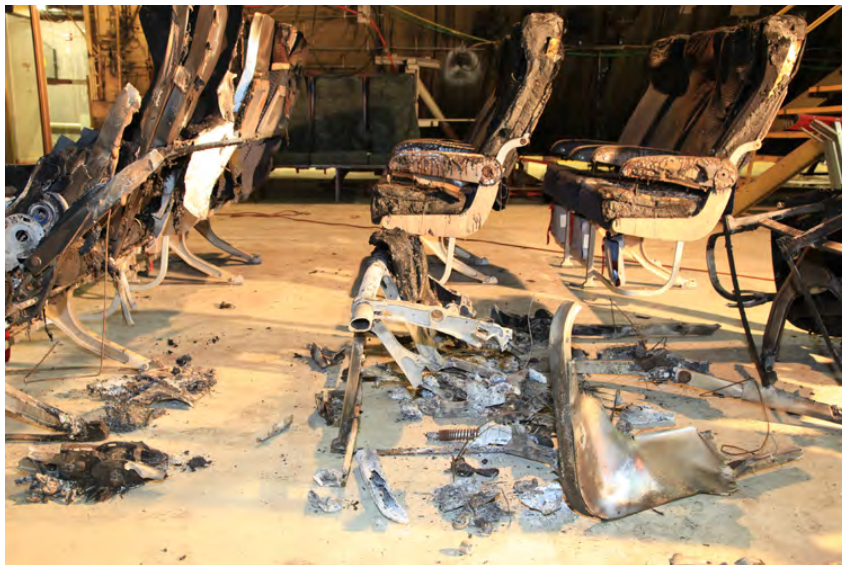
The seats were carefully removed from the test fuselage and placed on the test area floor for further inspection. After removing some of the melted cushioning and dress cover, it was clear that the magnesium alloy was involved in the fire, as several pieces showed signs of ignition (figure 104).

Figure 104. Seat Frames on the Floor of the Test Facility Showing Evidence of Magnesium Burning

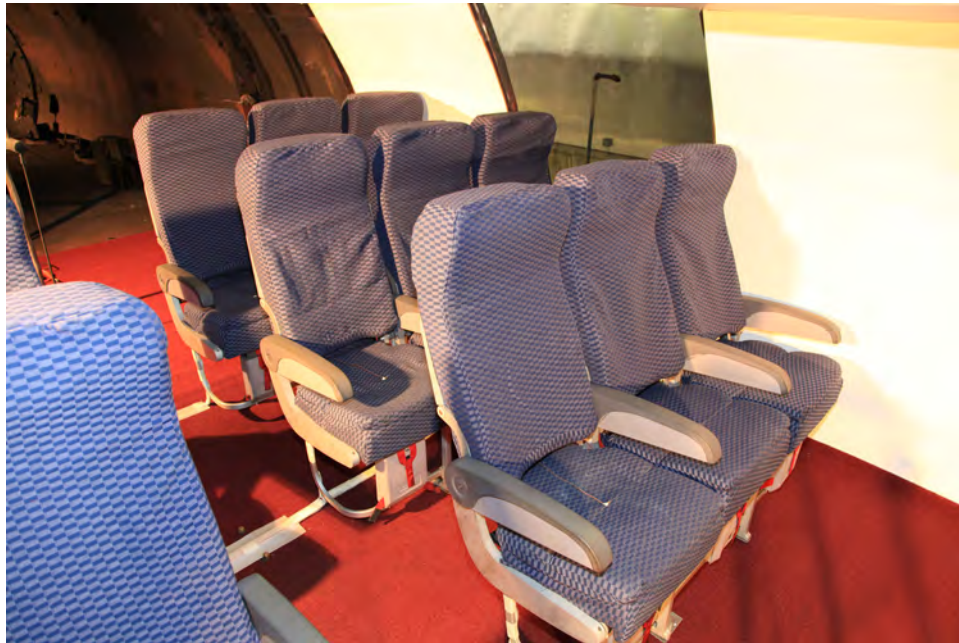
The machined AZ-31 parts were received and the seat assemblies were constructed. This process was much easier the second time, as the technicians were more familiar with the seat construction and the required disassembly/reassembly. As in the WE-43 test, it was necessary to first disassemble six standard B/E 990 seats, and then reconstruct them using the AZ-31 alloy components supplied by Magnesium Elektron and Wonder Machine. The newly designed seatback assemblies (identical to those used in Baseline Test 3 and the WE-43 magnesium alloy test) were added to each leg frame assembly. The completed assemblies were installed in the furnished test fuselage, and the thermocouples were installed on the leg frames as in the previous tests. All other instrumentation was checked prior to the test (figures 105 and 106).

Figure 105. Pretest Configuration for AZ-31 Magnesium Alloy Test

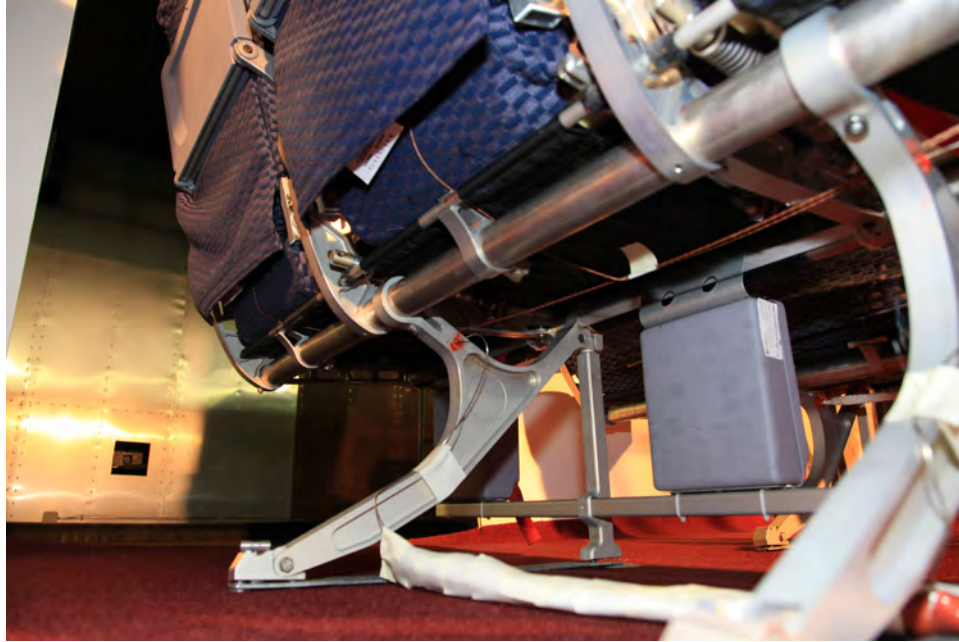
Figure 106. The AZ-31 Components Showing Thermocouple Installed on the Leg Component

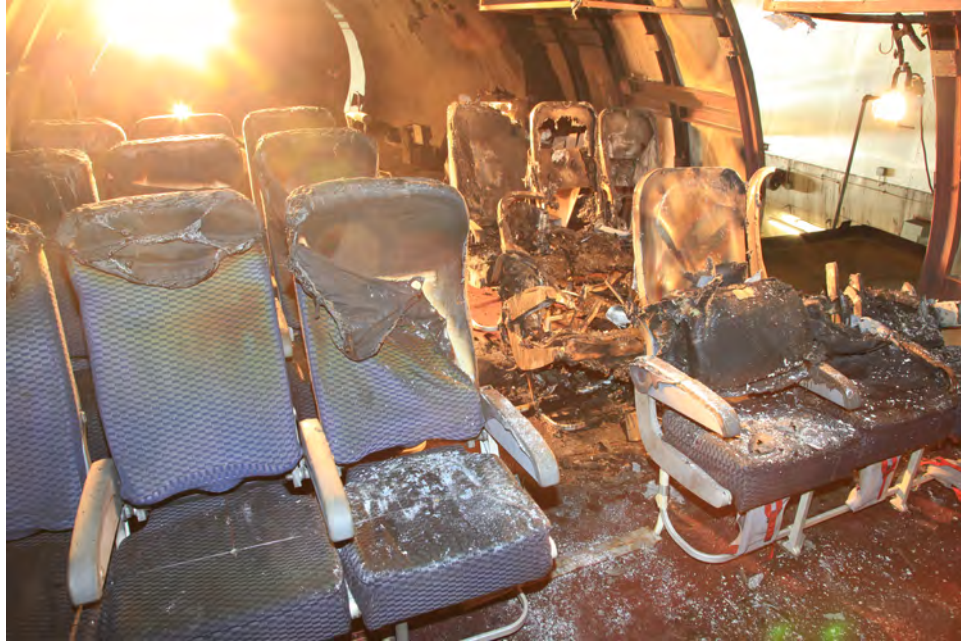
A posttest inspection revealed that a number of the portside seatbacks were totally consumed, including the aluminum frames (figure 107). The portside row 2 seat assembly sustained the most damage, as expected, with no visible evidence of any remaining seatback frames. Although the fire had severely impacted this seat assembly, the portside row 1 seat assembly still contained a visible seatback, as well as a partial seatback frame in the middle seat position (figure 108). It was difficult to determine how much of the row 2 seat assembly damage was from the initial fuel fire or from the subsequent magnesium fire during the observation period.

Figure 107. Posttest Conditions for AZ-31 Magnesium Alloy

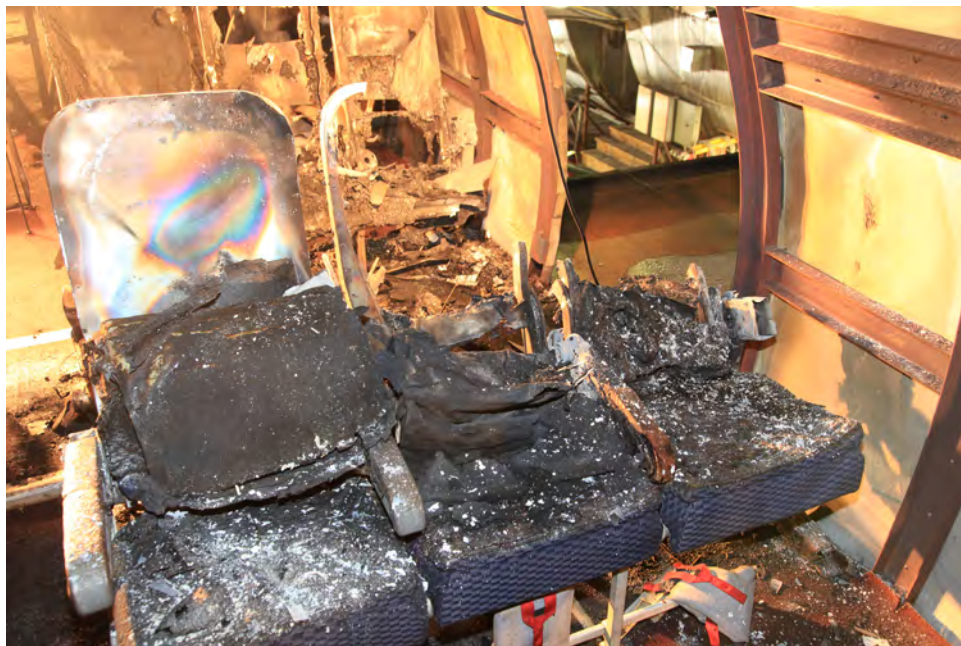
Figure 108. Portside Row 1 Seat Assembly Posttest for the AZ-31 Magnesium Alloy Test

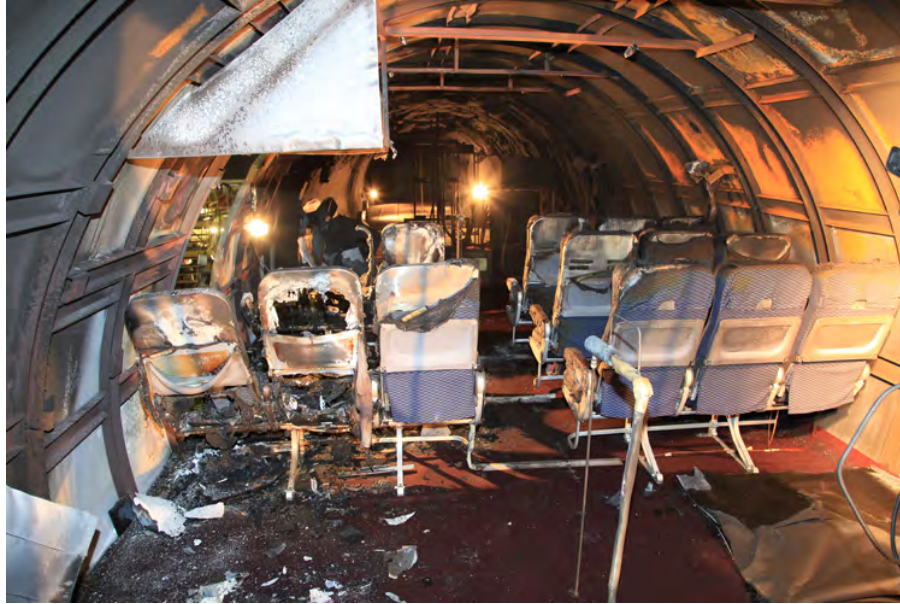
The starboard-side seatbacks were largely intact, with only surface burning and charring of the fabric dress cover and aisle-side arm rests. The thermoplastic tray table assemblies from all starboard-side seats were still intact, with no other damage observed (figure 109).

Figure 109. Aft View of Fire Damage for AZ-31 Magnesium Alloy Test

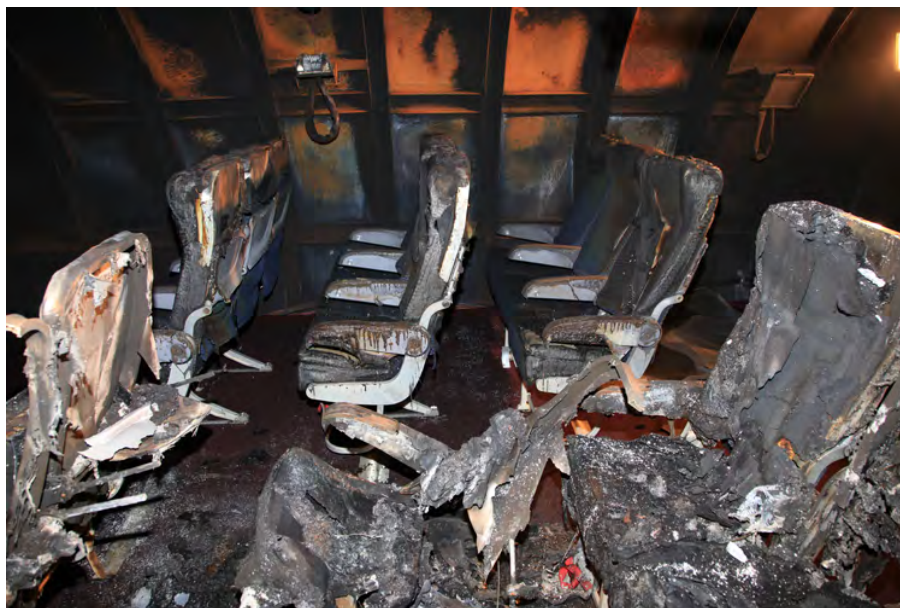
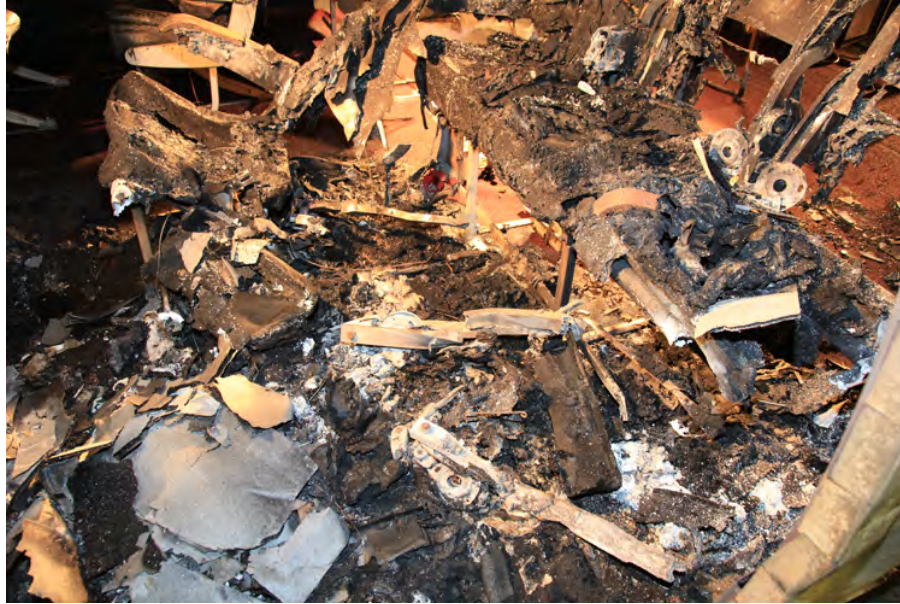
A closer inspection of the portside row 2 seat showed the extent of the damage (figures 110 and 111). The cross tubes and three of the four spreaders sustained heavy damage, with only small remnants of these components remaining on a small section of the unconsumed seat structure. The more massive leg assemblies also showed signs of fire involvement, with patches of whitish, magnesium oxide remaining on certain areas near the leg components. The magnesium oxide resulted from the reaction of the burning magnesium alloy with the water spray. The portside row 3 seat also exhibited fire damage, with the outboard spreader plate and part of the forward cross tube melted, leaving similar patches of magnesium oxide on the fuselage floor.

Figure 110. Portside Row 2 Seat Frame Damage Following AZ-31 Magnesium Alloy Test

Figure 111. Portside Row 2 Seat Frame Remnants

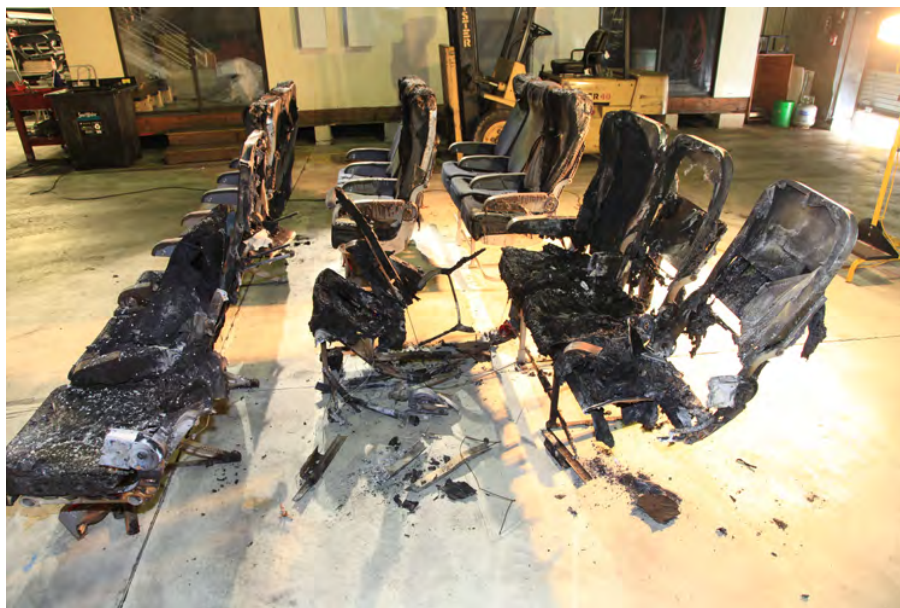
The seats were carefully removed from the test fuselage and placed on the test facility floor for further inspection. After removing some of the melted cushioning and dress cover, it was clear that a significant amount of AZ-31 magnesium alloy from the portside row 2 seat was involved in the fire because the remaining structure showed signs of ignition (figure 112). Additional pieces of magnesium alloy recovered from the vicinity of this seat assembly also showed signs of burning. A tedious inspection of the remaining parts revealed signs of burning magnesium alloy, which corroborated the video coverage during the observation period, in which several pockets of intense light were observed.

Figure 112. The AZ-31 Magnesium Alloy Seats on the Test Facility Floor

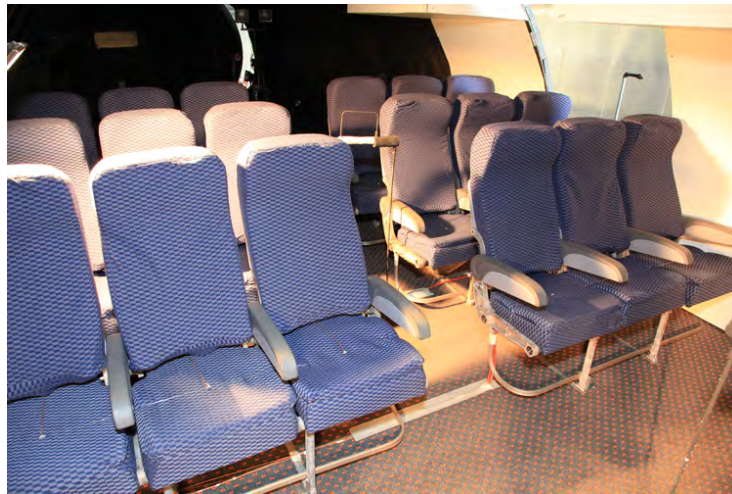
Once the machined WE-43 primary components were received and the fabricated seatback frame and baggage bars were completed, the seat structures were assembled. The newly fabricated WE-43 seatback assemblies were identical in size to those used in Baseline Test 3 and previous magnesium alloy tests. The completed assemblies were then installed in the test fuselage, and the thermocouples were installed on the leg frames, as in the previous tests. All other instrumentation was checked prior to conducting the test (figures 121 and 122).

Figure 121. The WE-43 Test Configuration With Additional Magnesium Alloy Components

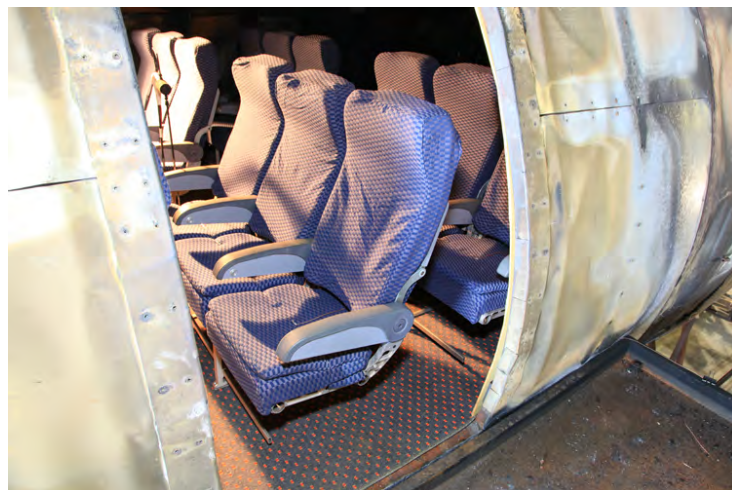
Figure 122. The WE-43 Test Configuration With Additional Magnesium Alloy Components Viewed Through the Fire Opening

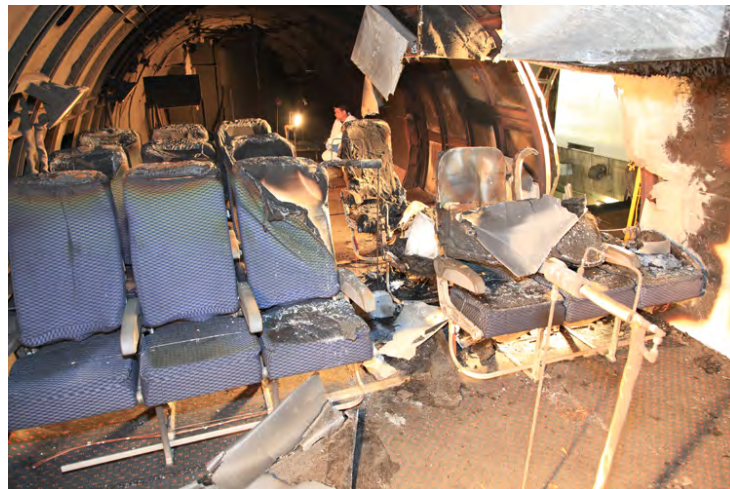
A posttest inspection revealed a number of the portside seatbacks were totally consumed, including the magnesium frames (figure 123). As in the previous test, the portside row 2 seat assembly sustained extensive fire damage, with evidence of substantial melting of the magnesium alloy seatback frames. The remaining portions of these components fell aftward onto the row 3 seat (figures 124 and 125). Although the fire had severely impacted this seat assembly, the portside row 1 seat assembly still contained a visible seatback, as well as a partial seatback frame at the middle seat place. This result was nearly identical to the previous test. It was again difficult to determine how much of the row 2 seat assembly damage was from the initial fuel fire or from the subsequent fire during the observation period.

Figure 123. The WE-43 Test With Additional Magnesium Alloy Components, Posttest

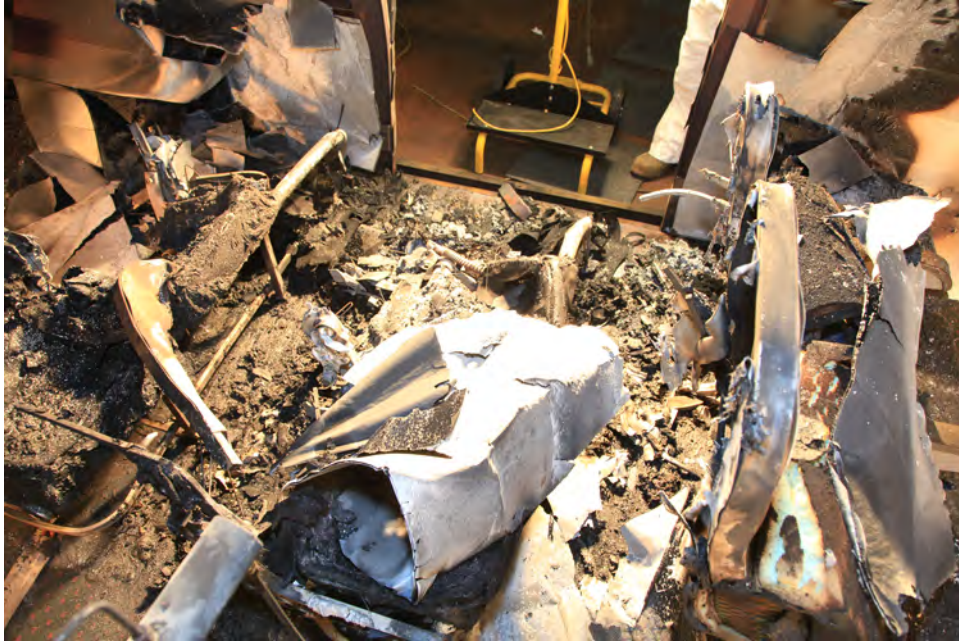
Figure 124. The WE-43 Test With Additional Magnesium Alloy Components, Row 2 Seat

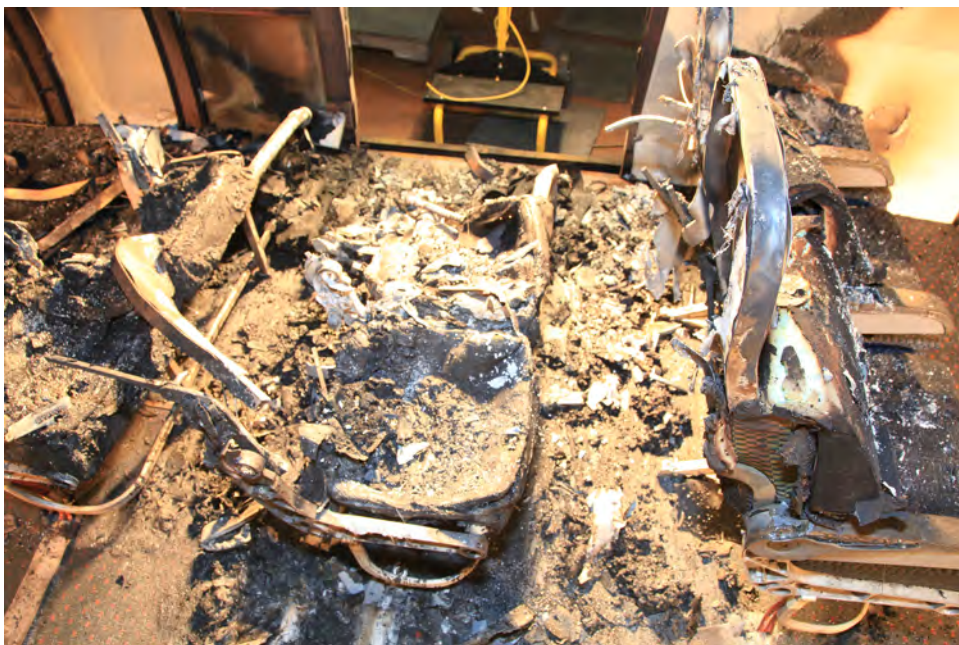
Figure 125. Close-Up of Portside Row 2 Seat (Ceiling Panel Removed)

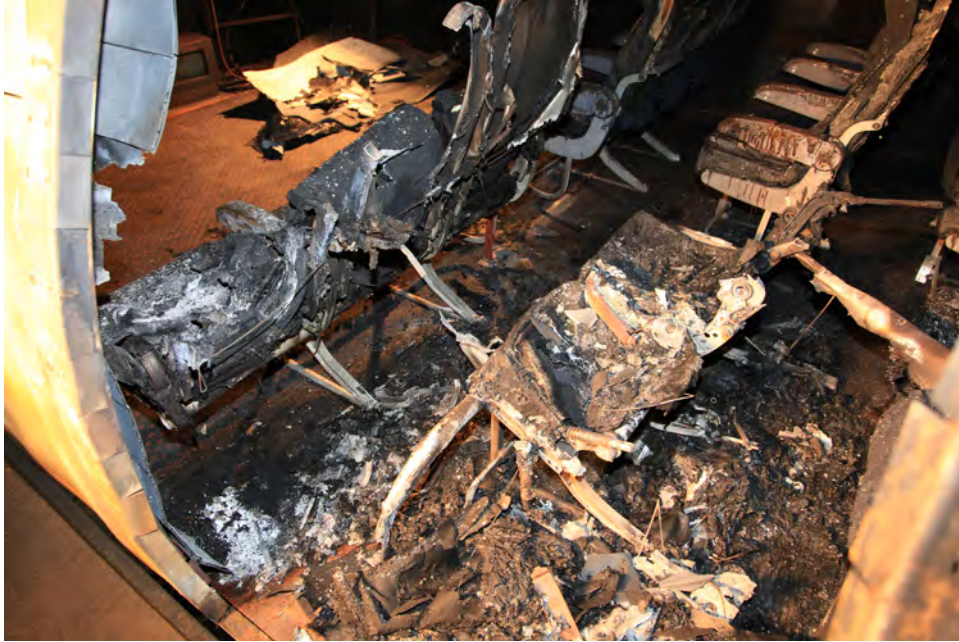
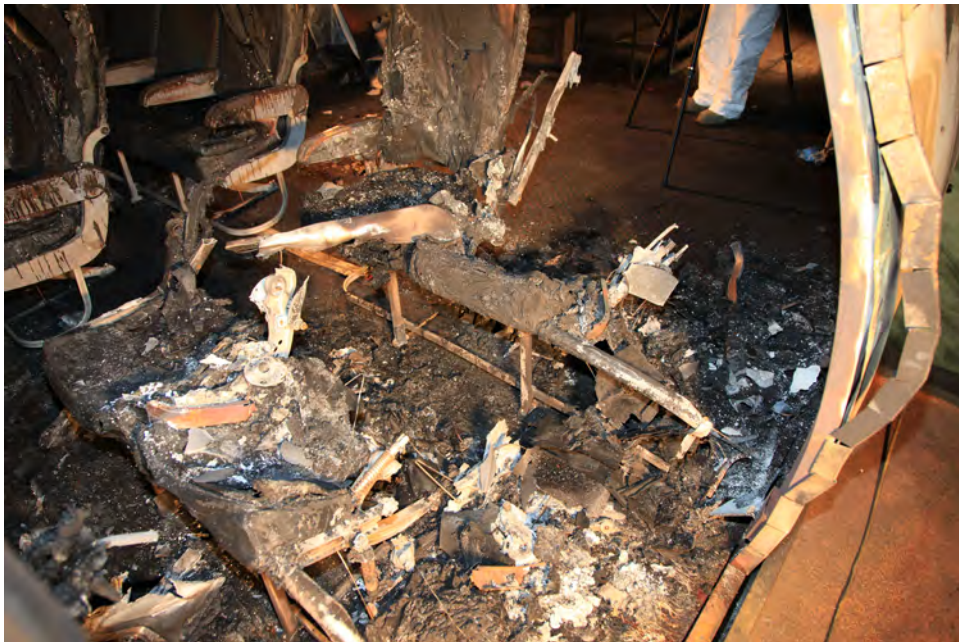
Several additional photographs were taken of the portside seat frames through the fire opening. It appears the fire entered the opening and caused the majority of the damage to the row 2 and row 3 seats, and left the seat structure from row 1 largely intact (figures 126 and 127).

Figure 126. View of Row 1 and Row 2 Seat Assemblies Through Fire Opening

Figure 127. View of Row 2 and Row 3 Seat Assemblies Through Fire Opening

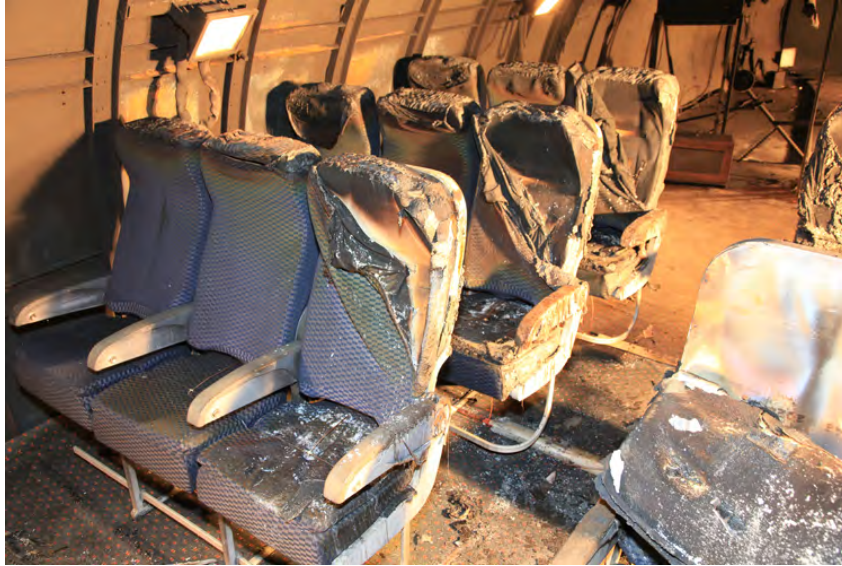
Although the damage to the portside seat assemblies was extensive, the starboard-side seats were relatively intact, with charring of the fabric dress covers on all aisle-side seats (figure 128).

Figure 128. Forward View of Starboard-Side Seat Assemblies

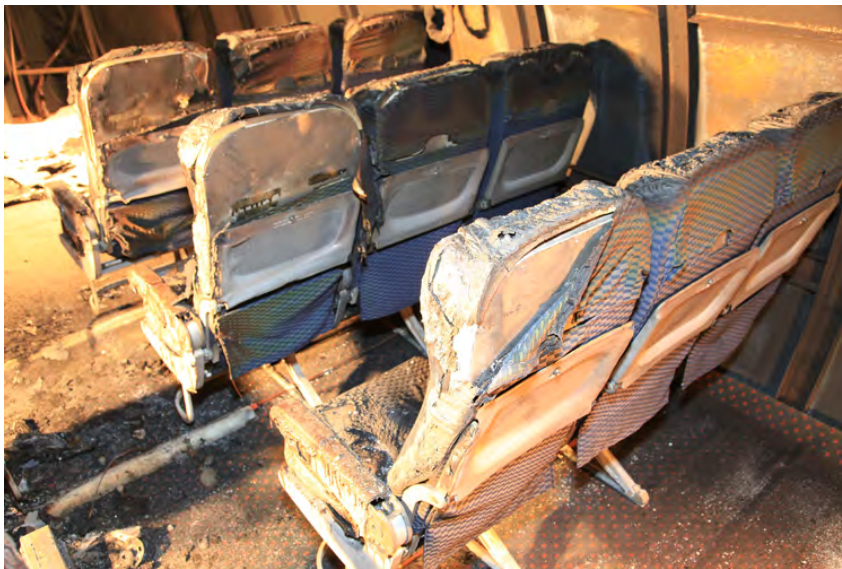
An aft view of the starboard-side seats (figure 129) shows that all thermoplastic tray tables were still in place, although the aisle seat tray tables showed signs of melting.

Figure 129. Aft View of Starboard-Side Seat Assemblies

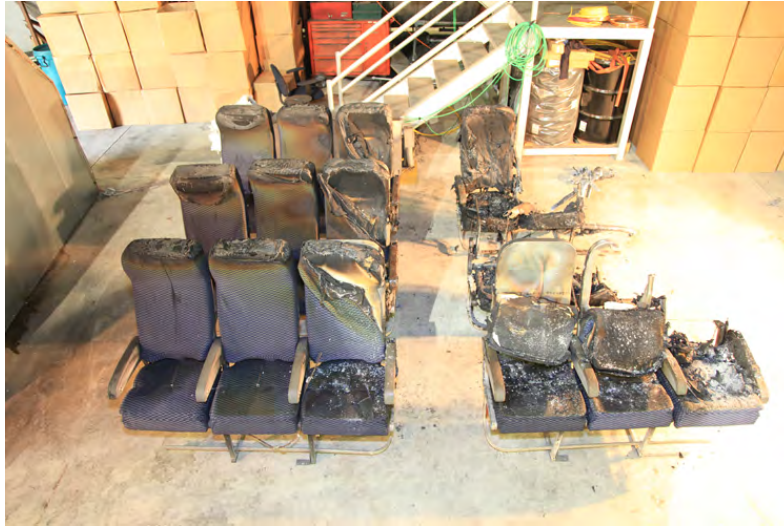
The seats were carefully removed from the test fuselage and placed on the test facility floor for further inspection (figure 130). After removing most of the remaining melted cushioning and dress cover, it was clear that a significant amount of WE-43 magnesium alloy from the portside row 2 seat was involved in the fire. The primary component damage from the row 2 seat included both cross tubes, the outermost spreaders (2), and portions of the outer leg assembly. For the row 3 seat, the damage included both cross tubes and two outermost spreaders. In addition, all but one of the seatback frames from the row 2 and 3 seat assemblies were

completely melted. Additional pieces of magnesium alloy recovered from the vicinity of these two seat assemblies also showed signs of burning. An inspection of the remaining parts attached to the seat assemblies revealed characteristic signs of minor magnesium alloy burning, which corroborated the video coverage of several light bursts during the observation period.

Figure 130. The WE-43 Test With Additional Magnesium Alloy Components, Seats Placed on the Test Facility Floor

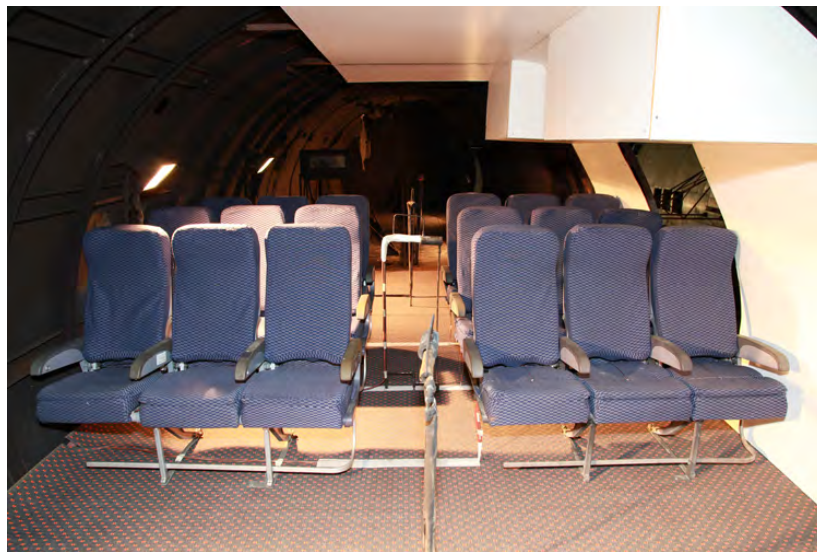
All starboard-side seats containing WE-43 components from the previous test were stripped of their cushion materials, thoroughly cleaned, inspected, and outfitted with new cushion and dress cover materials. These seats were then positioned in the port side of the test fuselage, which contained the typical arrangement of honeycomb sidewall and ceiling panels, honeycomb stowage bins, and carpeting. The seat frames were outfitted with the typical array of thermocouples installed in the seat leg components. Following this, the original B/E 990 seats with FAA-fabricated aluminum seatback assemblies were installed on the starboard side of the test fuselage. All other instrumentation was checked prior to the test (figure 131).

Figure 131. Starboard Seats on Port Side of Test Fuselage (Repeat Test)

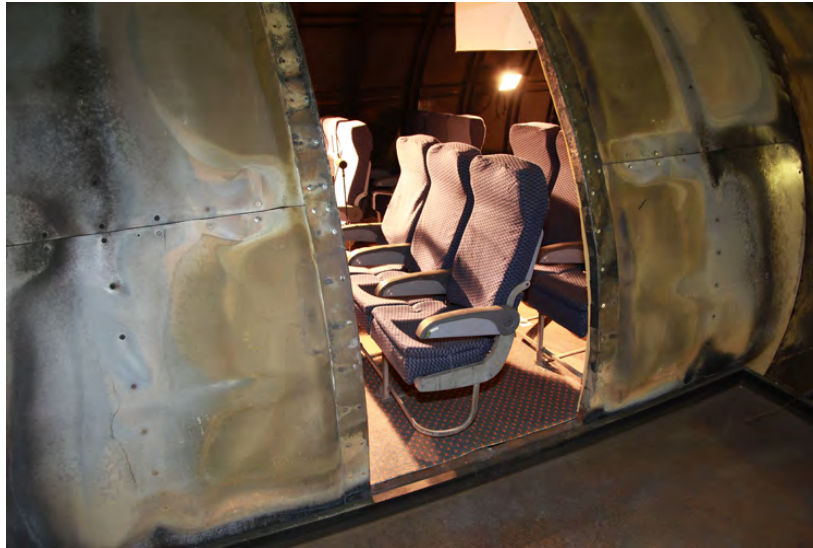
Although the seats positioned in the port side of the test fuselage contained flat spreaders on the outboard side of the seat, the seats were able to be positioned up against the sidewall fairly close with no significant issues. The seat positioned in the fire opening now had the curved portion of the baggage bar exposed to the fire, thus exposing an additional, small and likely insignificant, amount of magnesium alloy (figure 132).

Figure 132. Starboard-Side Seat Assembly in Fire Opening, With Curved Baggage Bar
(Repeat Test)
