DOT/FAA/AR-11/3

Evaluating the Flammability of Various Magnesium Alloys During Laboratory- and Full-Scale Aircraft Fire Tests

Timothy R. Marker

Final Report

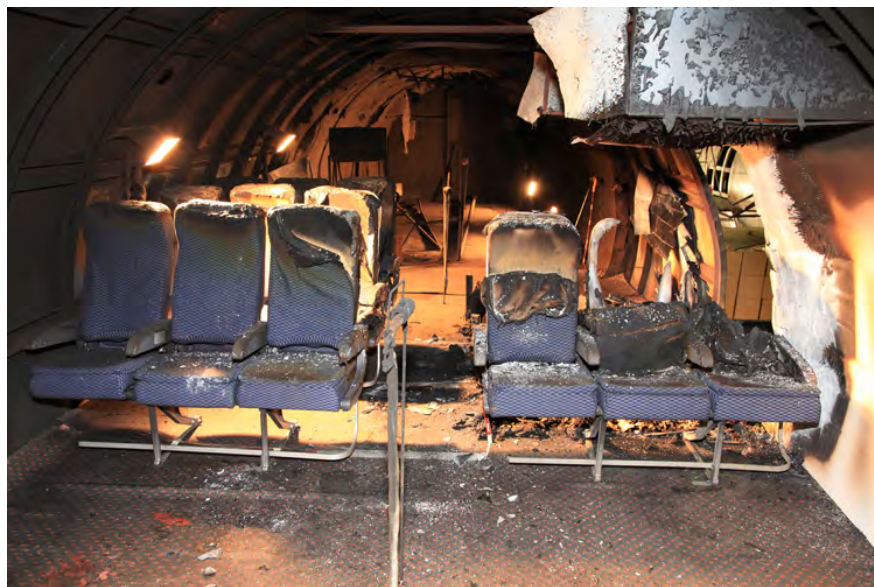
A posttest inspection revealed a number of the portside seatbacks were totally consumed, including the magnesium frames (figure 133). As in the AZ-31 test, the portside row 2 seat assembly sustained extensive fire damage, with evidence of substantial melting of the row 2 and row 3 magnesium alloy seatback frames. The remaining portions of these assemblies had fallen aftward onto the row 3 seat (figures 134 and 135). It appeared that the cross tubes on both the row 2 and row 3 seats had melted, allowing a collapse of a majority of the seat structure (figure 136). Although the fire had severely impacted these seat assemblies, the portside row 1 seat assembly still contained a visible seatback, as well as a partial seatback frame in the middle seat place. This result was nearly identical to the AZ-31 test. It was again difficult to determine how much of the row 2 and row 3 seat assembly damage was from the initial fuel fire or from the subsequent interior fire during the observation period.

Figure 133. The WE-43 Repeat Test With Additional Magnesium Alloy Components, Posttest

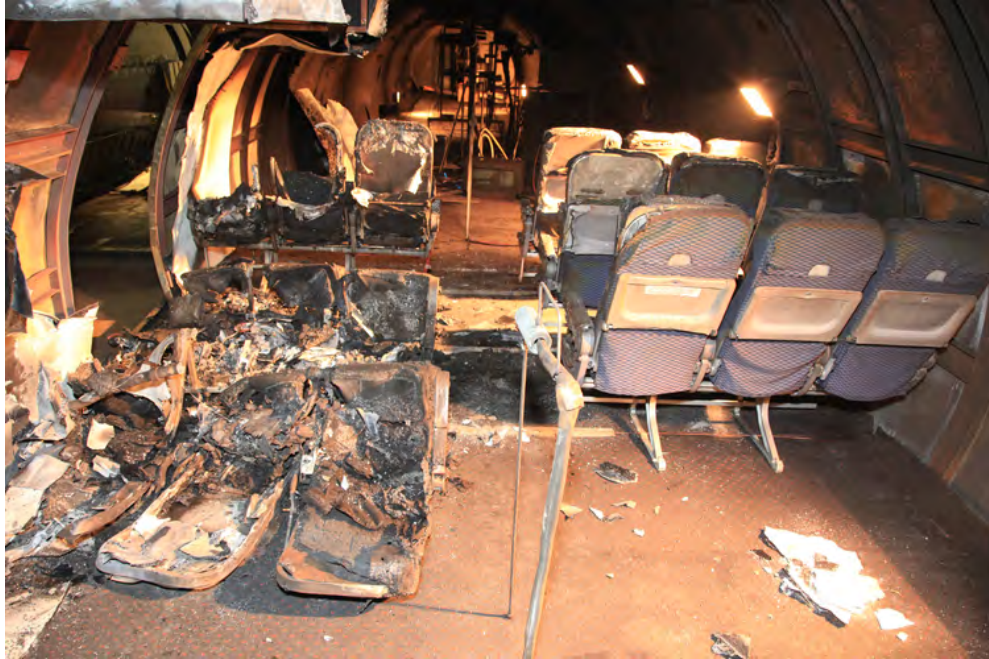
Figure 134. The WE-43 Repeat Test With Additional Magnesium Alloy Components, Aft View

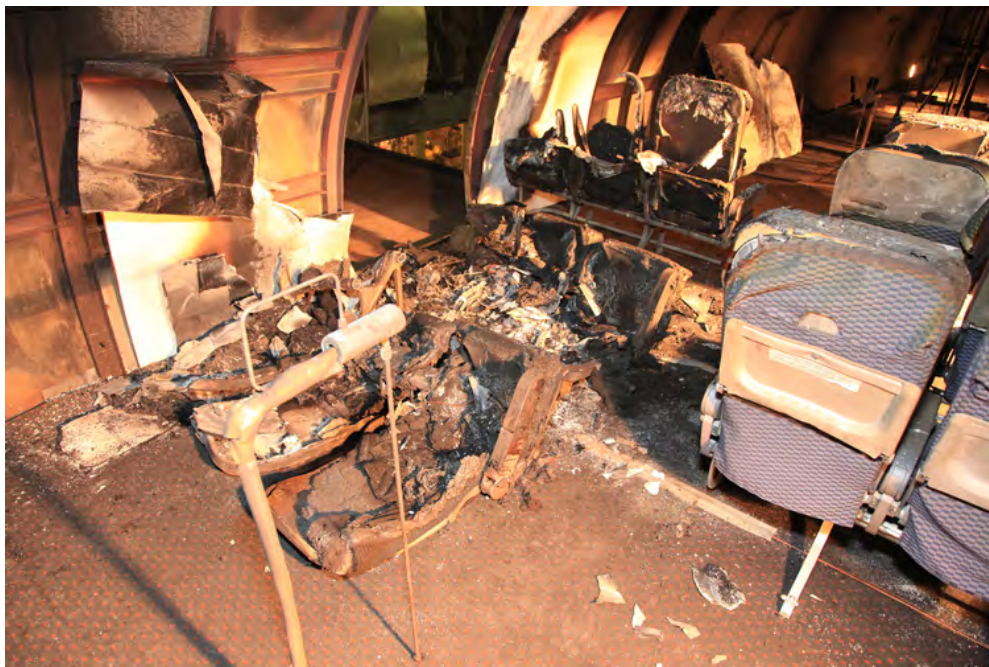
Figure 135. The WE-43 Repeat Test With Additional Magnesium Alloy Components, View of Portside Seats

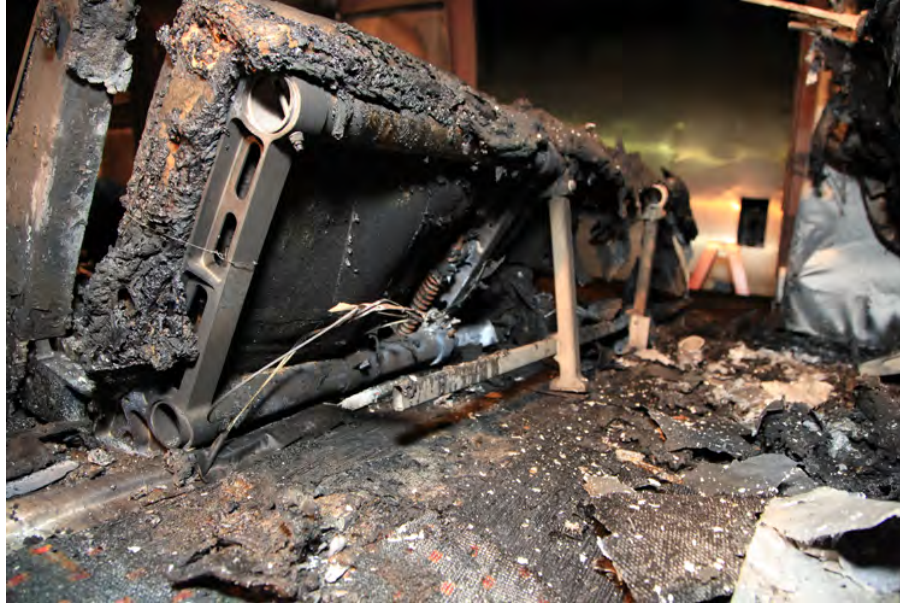
Figure 136. The WE-43 Repeat Test With Additional Magnesium Alloy Components, Close-Up of Portside Row 2 Seat Structure

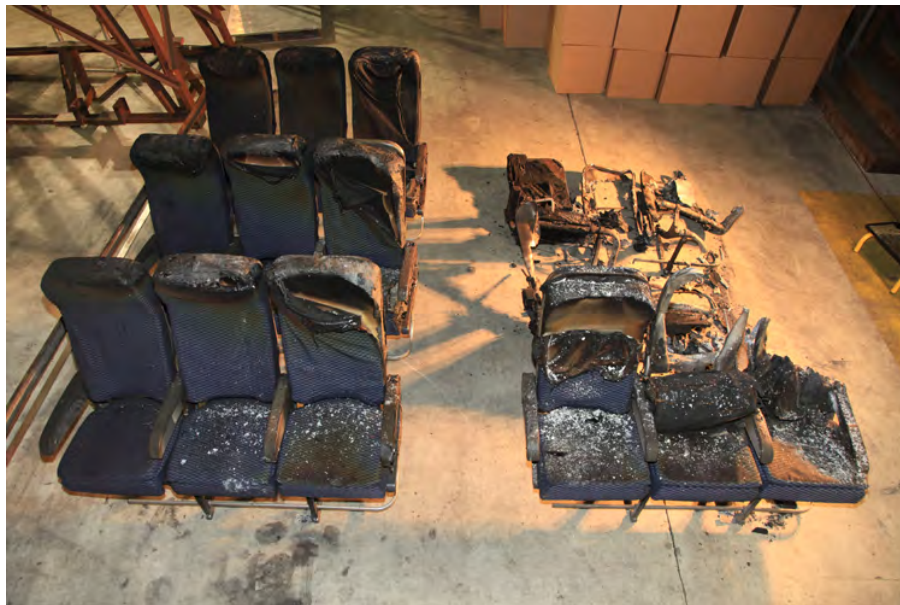
As standard practice, the seats were carefully removed from the test fuselage and placed on the test facility floor for further observation and documentation (figure 137). Once the seats were repositioned as they had been in the cabin, the damage pattern was observed to be similar to the previous test in which the portside row 2 and row 3 seat assemblies sustained the majority of the fire damage.

Figure 137. The WE-43 Repeat Test With Additional Magnesium Alloy Components, Seats on the Test Facility Floor

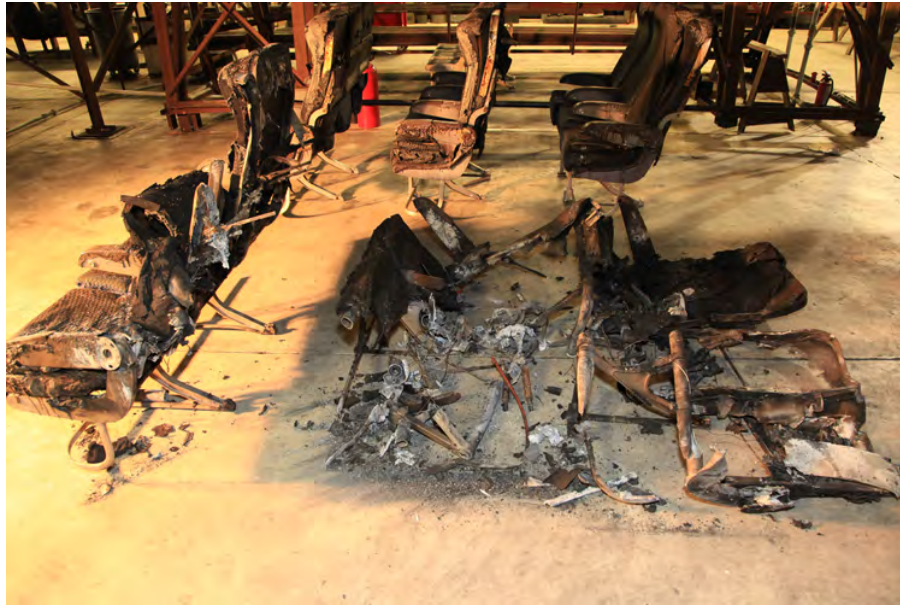
An inspection of the portside row 2 and row 3 seats revealed extensive melting and burning of the cross tubes and spreaders (figure 138). The damage indicated the possibility that the row 2 seat assembly collapsed rearward following melting/burning of the cross tube component, thereby igniting the row 3 seat assembly from below, and perhaps aiding in the melting of the row 3 seat cross tube components.

Figure 138. The WE-43 Repeat Test With Additional Magnesium Alloy Components, Damage to Portside Seat Assemblies

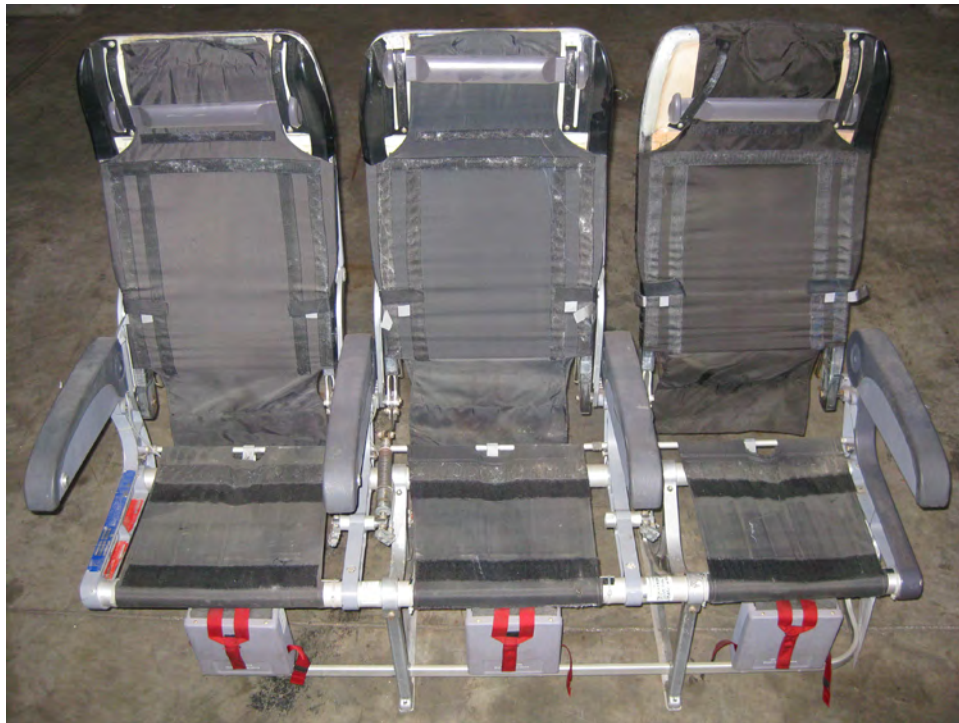
Figure A-1. The B/E 990 Standard Seat Components

The two initial full-scale baseline tests determined the flammability of the seatback assembly of the B/E Aerospace (B/E) 990 seats was poor. The seatback assembly was an atypical design, using a frame constructed of an epoxy-impregnated carbon fiber unidirectional tape with thermoplastic components in the headrest area. In addition, there was no metallic or aluminum support pan, but rather a nylon fabric that stretched across the frame to act as a suspension (figure A-1). The back cushion was very thin with minimal foam and appeared to contain a fiberfill material in place of the typical urethane foam.

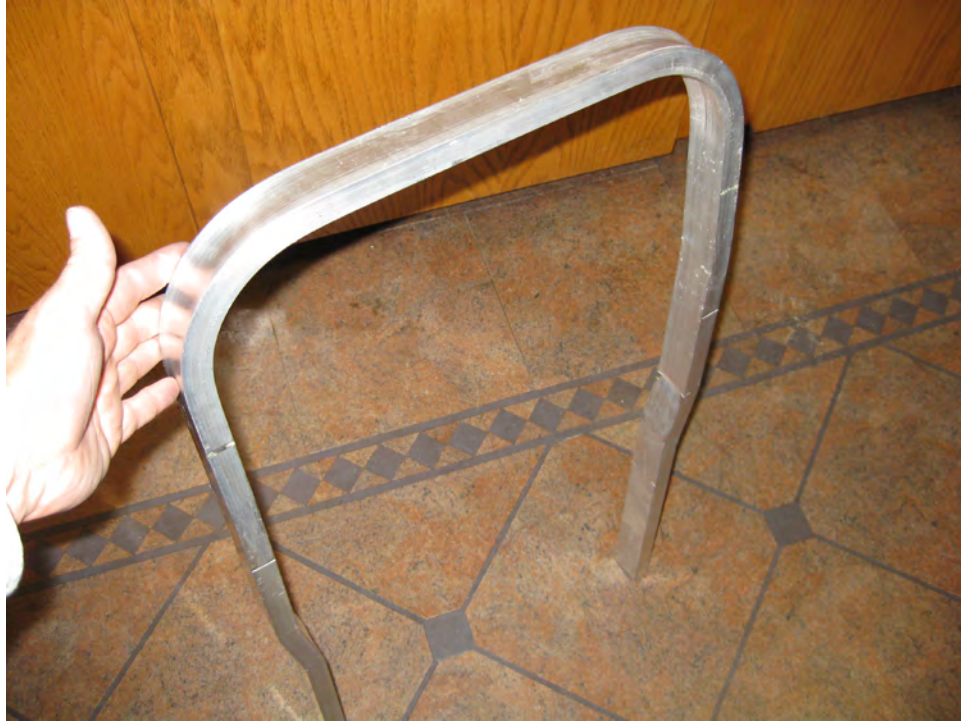
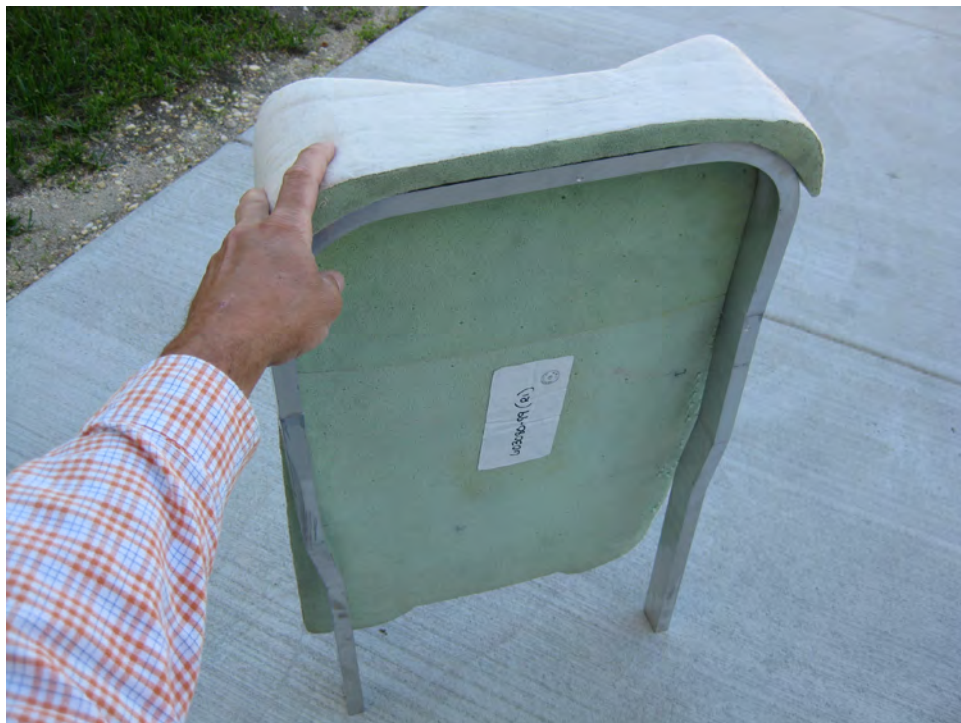
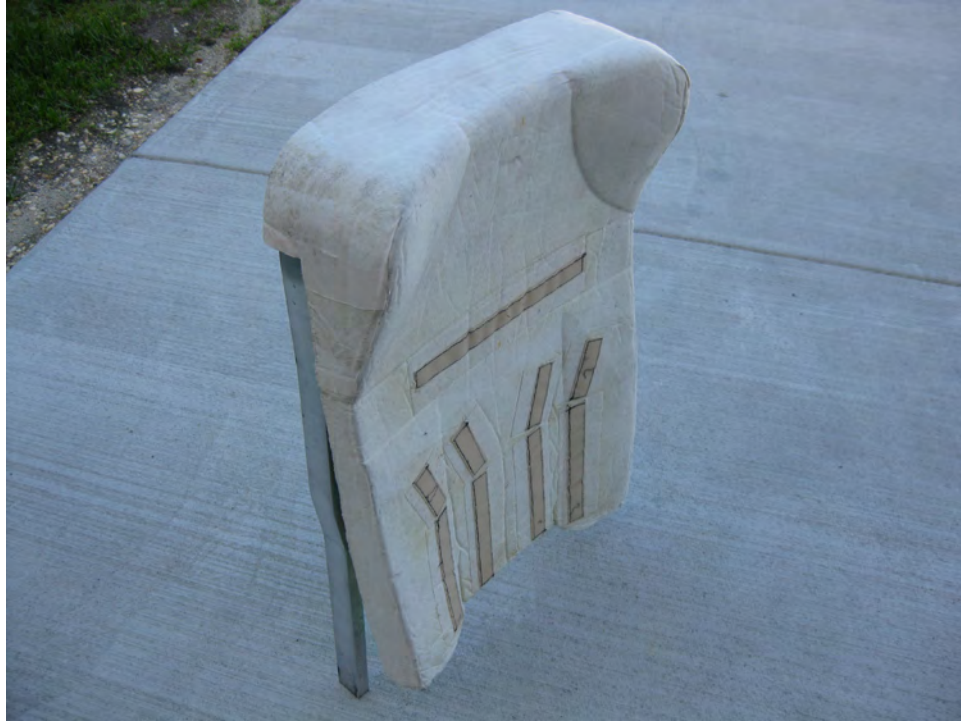
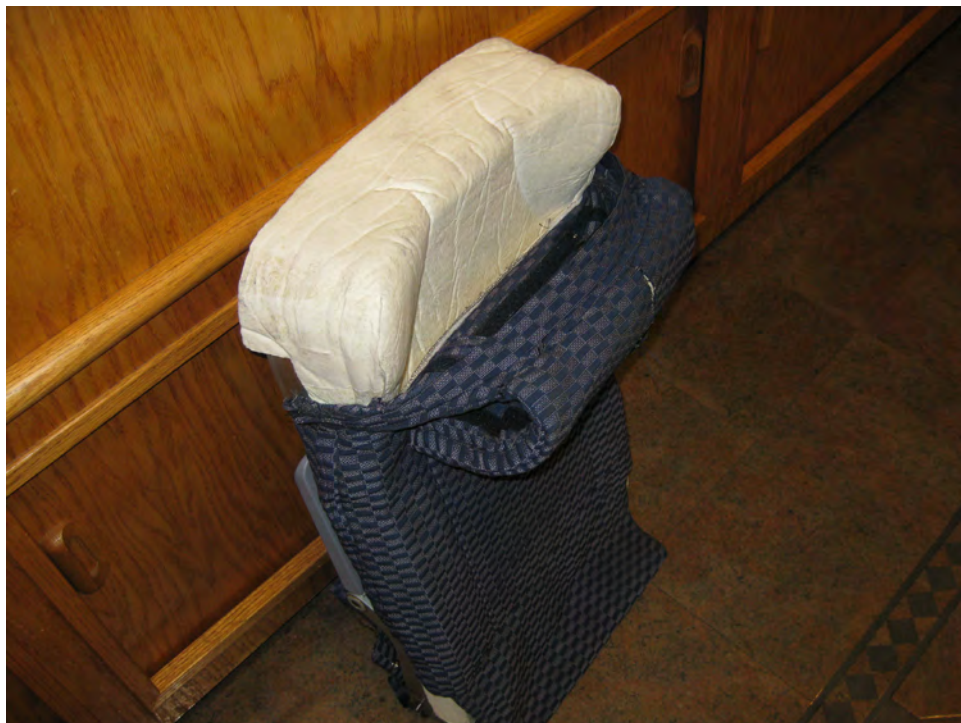
During the two baseline tests, the seatback assembly became involved in the fire very early in the test sequence, contributing to a rapid flashover event in which the conditions became nonsurvivable very quickly. It was agreed that under these conditions, it would be difficult to accurately measure the contribution of the magnesium components used in the seatframe during subsequent tests. For this reason, an alternate seatback was designed to fit the B/E 990 seat assembly. The alternate design used an aluminum frame and a fire-hardened foam cushion in place of the existing materials (figures A-2 through A-5).

Figure A-2. Aluminum Seatframe Used in Alternate Seatback Assembly

Figure A-3. Fire-Hardened Foam Used in Alternate Seatback Assembly

Figure A-4. Front View of Fire-Hardened Foam Used in Alternate Seatback Assembly

Figure A-5. Front View of Dress Cover Used in Alternate Seatback Assembly

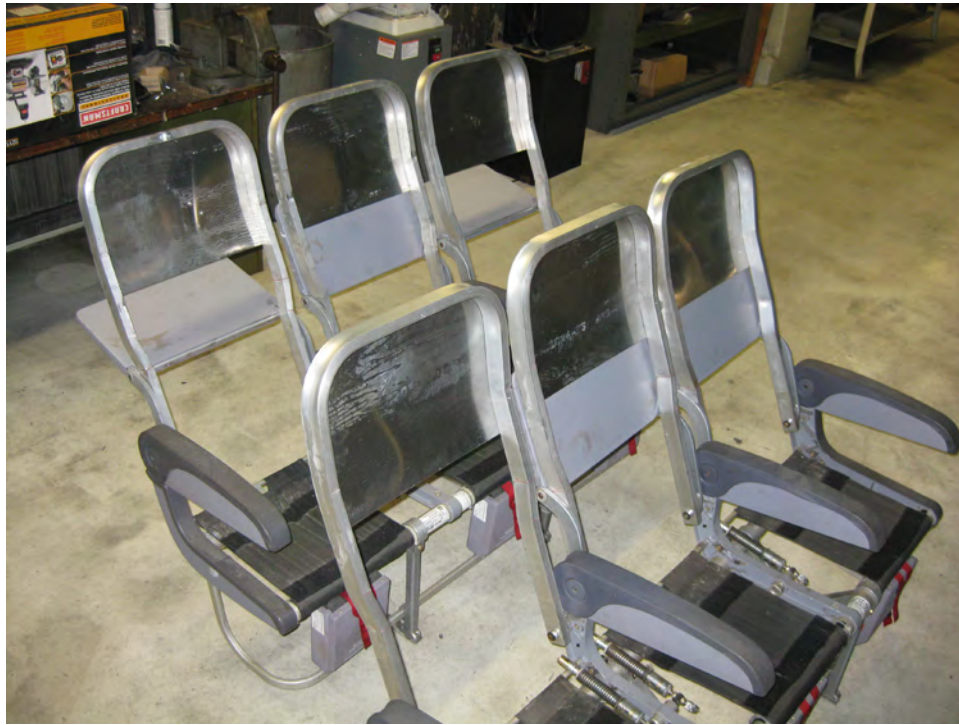
Figure A-6. Fabrication of Seat Assemblies Using Alternate Seatbacks

Additional details were designed and fabricated for use in the alternate seatback assembly, including front and back pan structures used to strengthen the frame. The completed seatback frames were then mass-produced and mounted to the B/E 990 triple coach seat lower frames (figure A-6). Components such as the tray tables and arms, as well as the map pockets were all retained from the original B/E 990 s eatback frames and incorporated into the alternate assemblies.

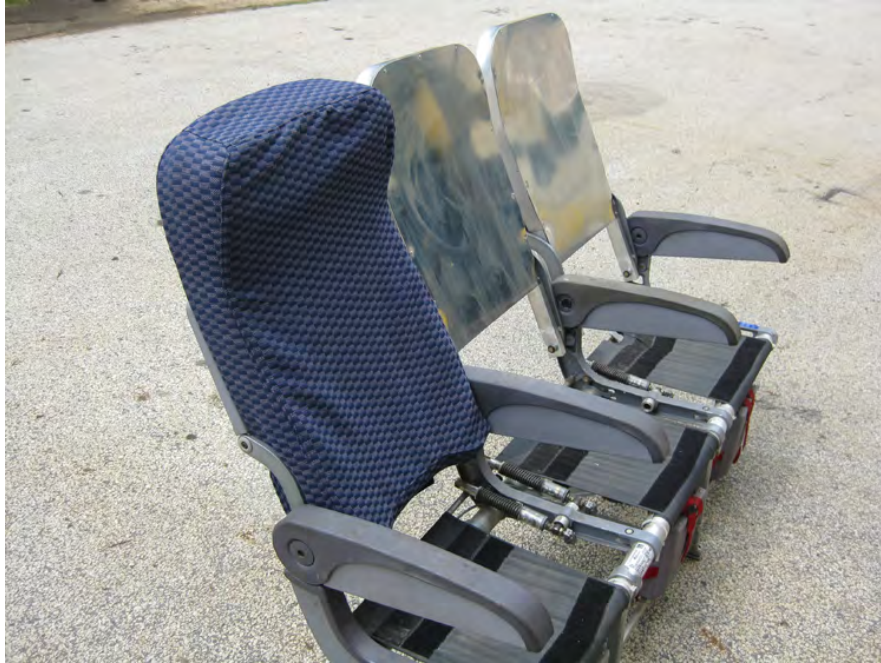
Figure A-7. Partially Completed Seat Assemblies Showing Front Pan Structure

The forward pan structure was then fabricated and installed on the back frames, and the final assembly involved mounting the foam cushioning and dress cover materials (figure A-7).

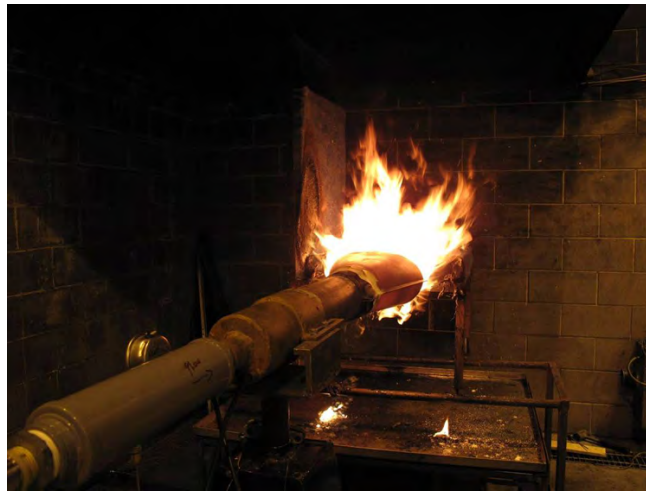
Figure A-8. Baseline Test 3 Cushion Sample During Laboratory Test (typical)

Prior to conducting the tests, the burner equipment was calibrated to ensure the output was within acceptable limits. Following the required 2-minute burner warm-up, the Baseline Test 3 sample cushions were rolled in front of the burner flames. The test requirement calls for a 2-minute exposure of the seat cushion materials to the burner flame. During the test, the burner flames were largely confined to the surface of the bottom cushion and did not rapidly spread to the back cushion (figure A-8). This result confirmed the superior performance of this cushion

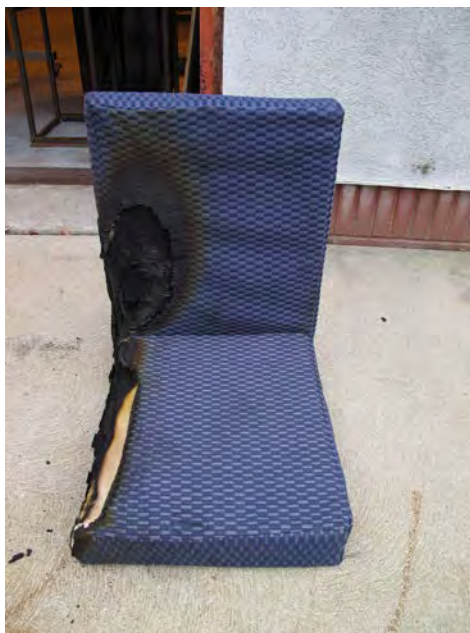
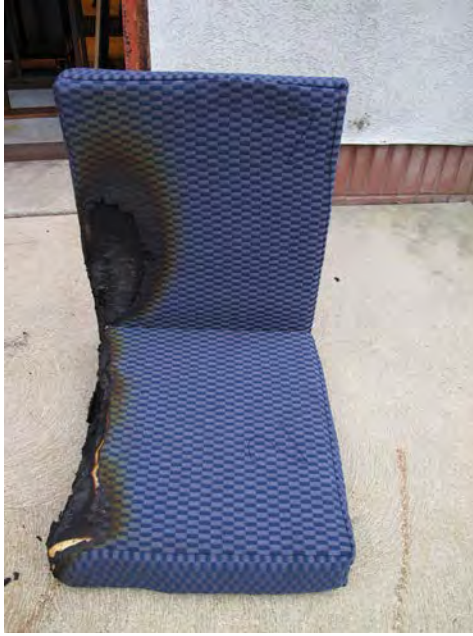
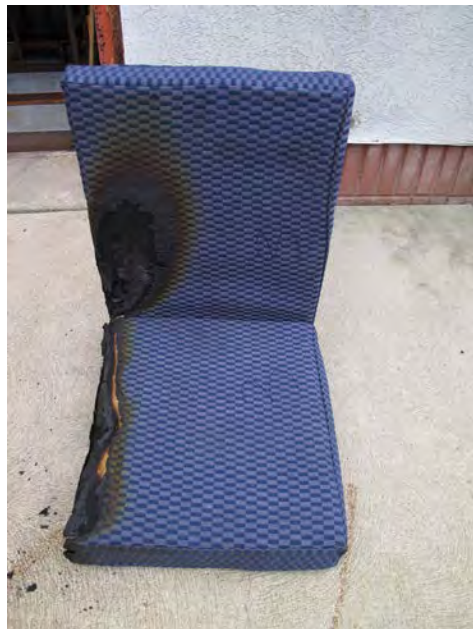
The tested samples were removed from the test apparatus and placed on the test facility floor for photographs (figures A-9 through A-11).

Figure A-9. Baseline Test 3 Standard Cushion Sample 1

Figure A-10. Baseline Test 3 Standard Cushion Sample 2

Figure A-11. Baseline Test 3 Standard Cushion Sample 3

The tabulated results, including weight percentage losses, are included in table A-1. The results clearly indicate acceptable weight losses associated with the cushion system, ranging from 6.3% to 8% weight loss for the bottom specimen, and 0.58% to 1.3% weight loss for the seatback specimen. The total percentage weight loss for the cushion set ranged from 4.27% to 5.14%, well below the maximum 10% acceptance criteria.

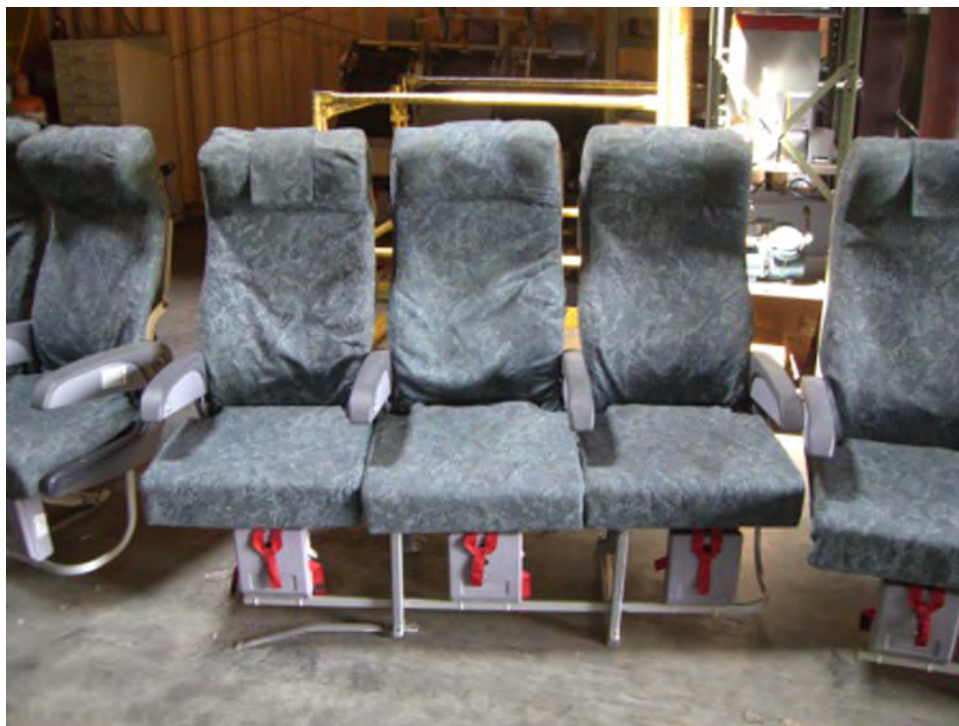
Figure B-1. Baseline Test 1 Triple Coach Seat With Olive-Colored Dress Cover

Surplus triple coach seats were purchased for conducting full-scale tests (figure B-1). The initial full-scale baseline test determined the flammability performance of the seats, which were constructed of standard, aluminum alloy primary seat components. Subsequent full-scale tests determined the performance of the seats when magnesium alloy was substituted in place of the aluminum alloy used in the primary components.

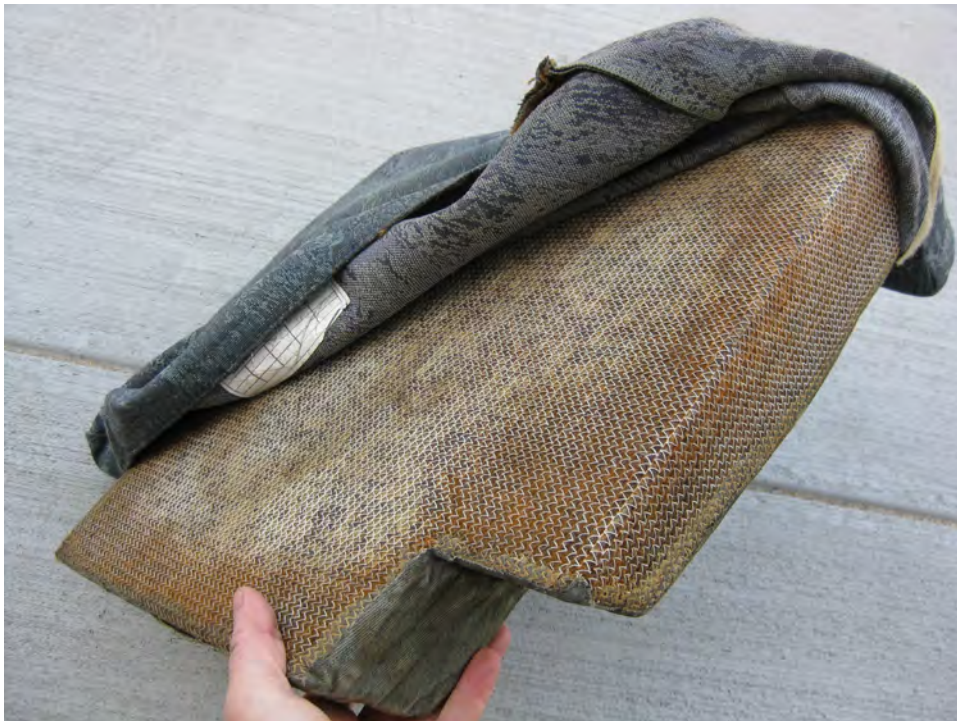
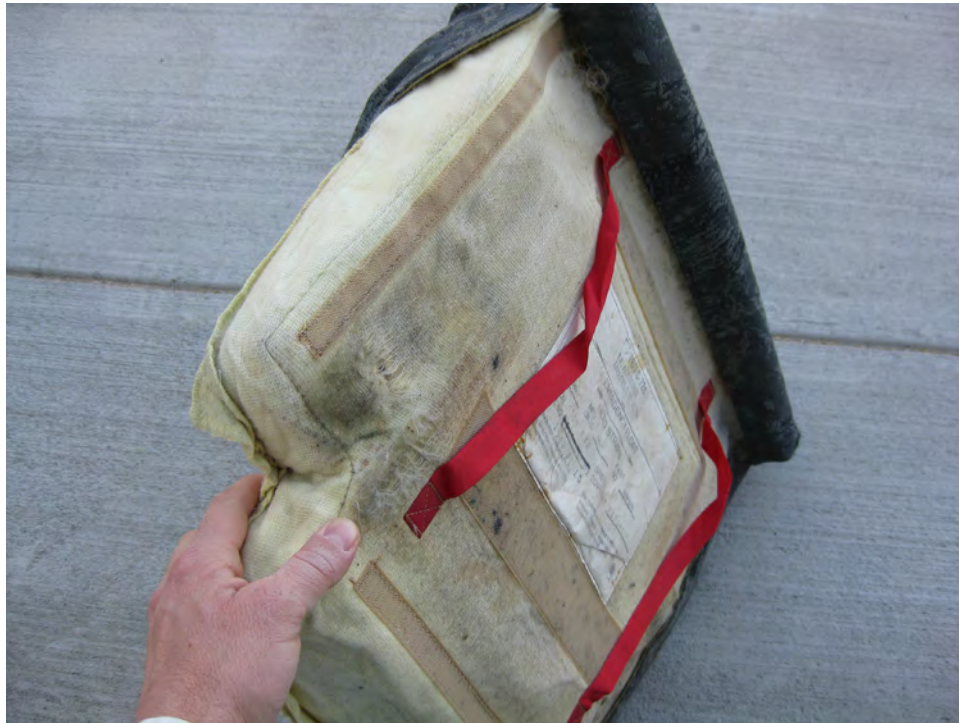
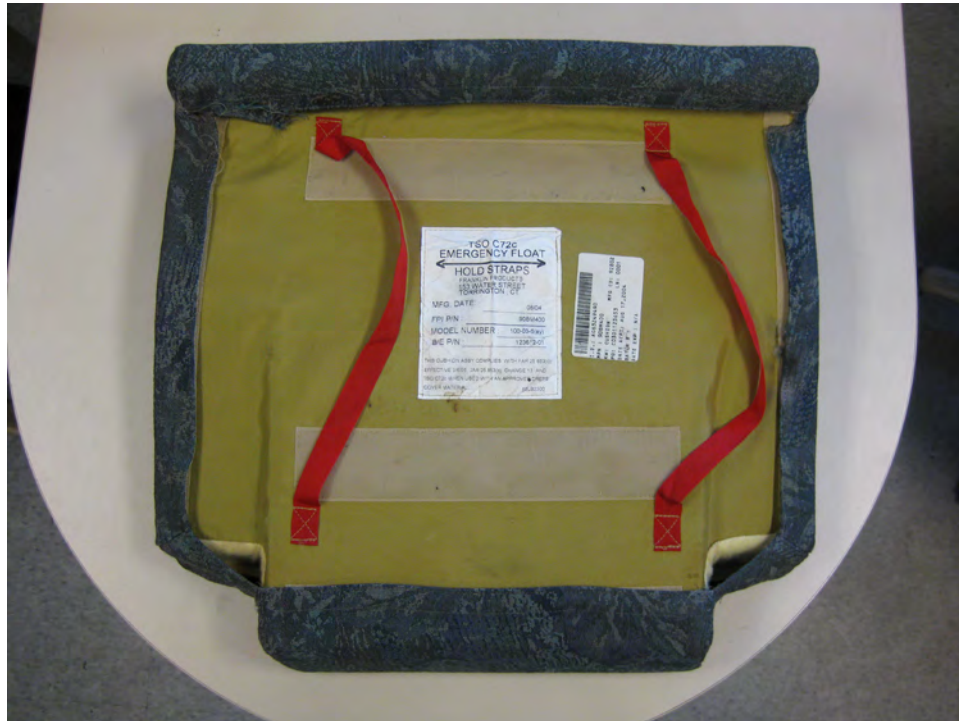
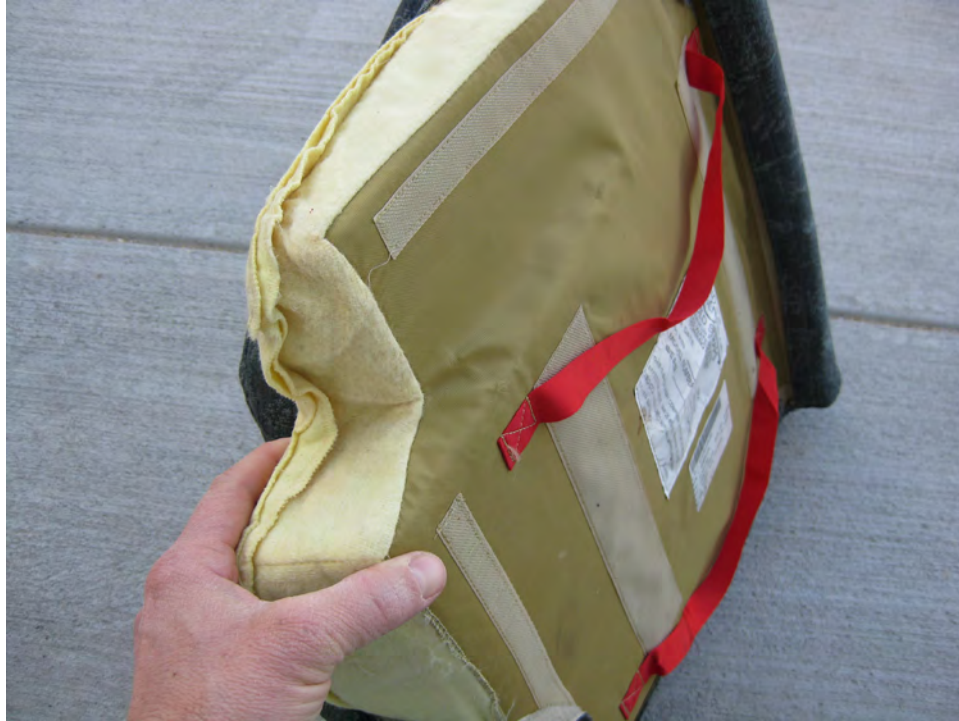
An inspection of the triple coach seat cushion materials used in the Baseline 1 full-scale test revealed that three different styles of bottom cushions were supplied. One style contained no obvious fire-blocking layer material (figures B-2 and B-3). Although no fire-blocking layer was observed, it was assumed that this particular seat cushion foam was a fire-hardened type, precluding the need for an additional fire-blocking layer. Another style used a fire-blocking layer with original B/E Aerospace labeling on the material (figures B-4 through B-6). A third style of seat cushion was also discovered, which used a fire-blocking layer manufactured by Franklin Products (figures B-7 through B-9).

Figure B-2. Baseline Test 1 Bottom Seat Cushion (style 1)

Figure B-3. Baseline Test 1 Bottom Seat Cushion (style 1) Revealing No Fire-Blocking Layer

Figure B-4. Bottom View of Baseline Test 1 Bottom Seat Cushion With B/E Aerospace Fire-Blocking Layer

Figure B-5. Side View of Baseline Test 1 Bottom Seat Cushion With B/E Aerospace Fire-Blocking Layer

Figure B-6. Close-Up of Baseline Test 1 Bottom Seat Cushion With B/E Aerospace Fire-Blocking Layer

Figure B-7. Baseline Test 1 Bottom Seat Cushion With Franklin Products Fire-Blocking Layer

Figure B-8. Side View of Baseline Test 1 Bottom Seat Cushion With Franklin Products Fire-Blocking Layer

Figure B-9. Close-Up of Baseline Test 1 Bottom Seat Cushion With Franklin Products Fire-Blocking Layer and Label

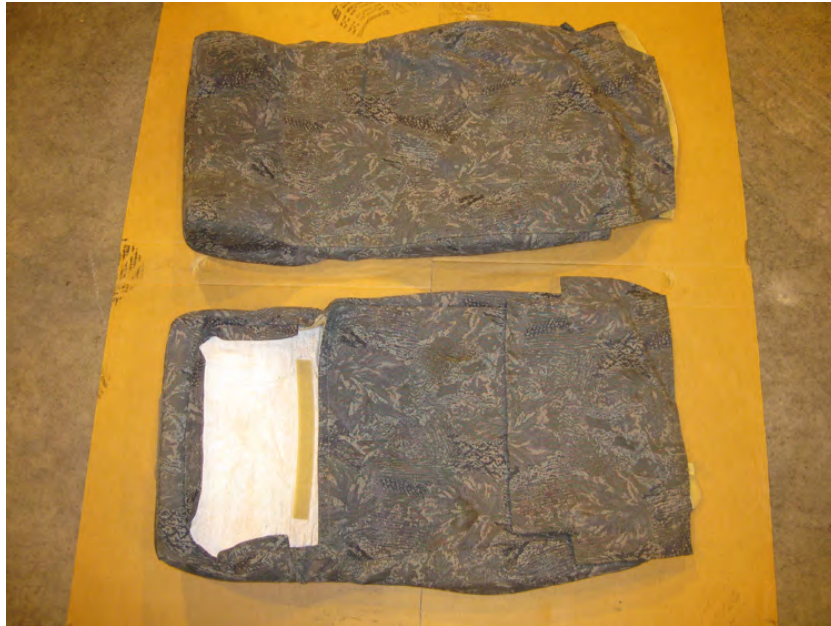
Figure B-10. Baseline Test 1 Back Cushion Containing Fiberfill Material

The cushion back materials used in the Baseline 1 full-scale test were also inspected, revealing the entire seatback system was not a typical design. The frame was constructed of an epoxy-impregnated carbon fiber unidirectional tape with a nylon fabric suspension system (no metallic pan component). The back cushion was very thin with minimal foam (figure B-10). The cushion appeared to contain a fiberfill material in place of the typical urethane foam.

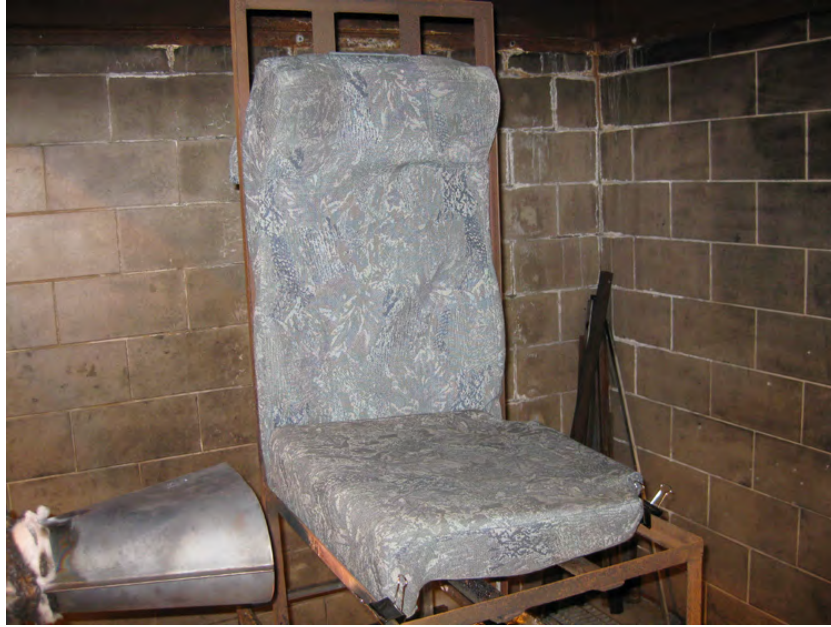
Figure B-11. Baseline Test 1 Cushions Attached to Laboratory-Scale Test Rig

A decision was made to rotate the bottom cushion 90° for all tests, so that the flat surface of the front of the cushion would face the test burner flames (figure B-11). This would prevent the burner flames from protruding under the contoured cushion, which would not typically occur if the samples were the proper shape and size. The back cushions were clamped to the vertical test frame to prevent collapse during the test.

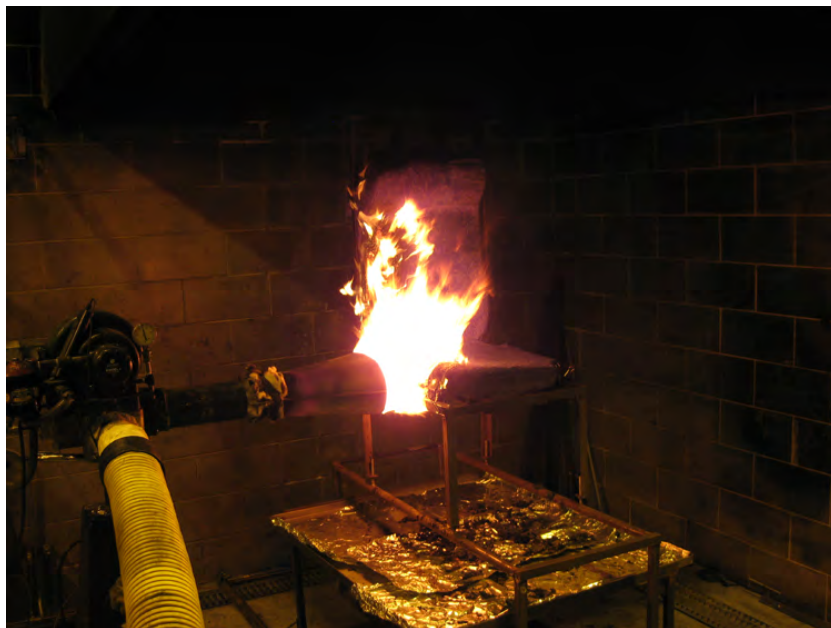
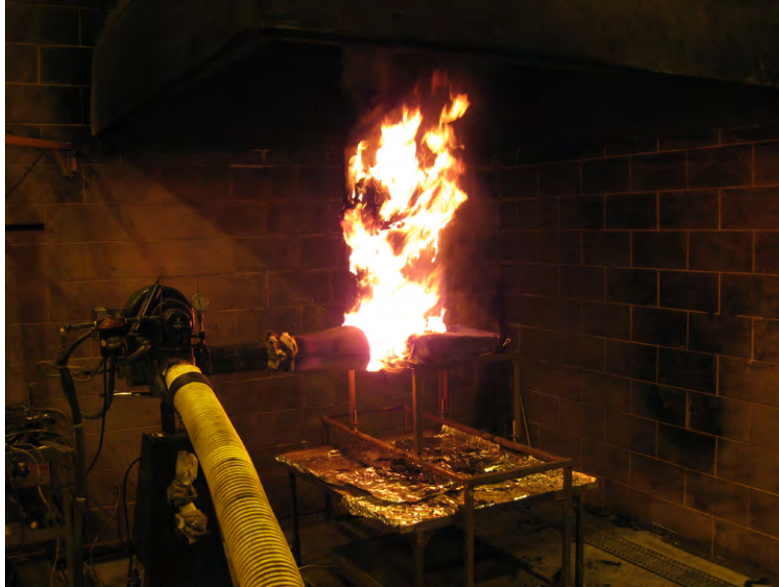
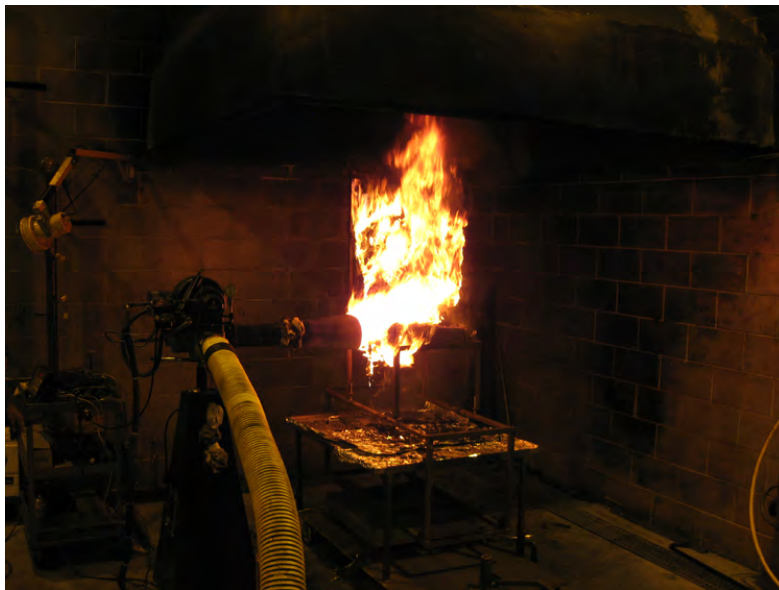
Following the required 2-minute burner warm-up, the Baseline Test 1 sample cushions were rolled in front of the burner flames. The burner flames quickly spread onto the surface of the cushion bottom and back materials (figures B-12 through B-14). Although there were three different types of bottom cushions being tested, they all appeared to burn similarly.

Figure B-12. Baseline Test 1 Bottom Seat Cushion During Laboratory-Scale Test (typical),
First Frame

Figure B-13. Baseline Test 1 Bottom Seat Cushion During Laboratory-Scale Test (typical),
Second Frame

Figure B-14. Baseline Test 1 Bottom Seat Cushion During Laboratory-Scale Test (typical),
Third Frame

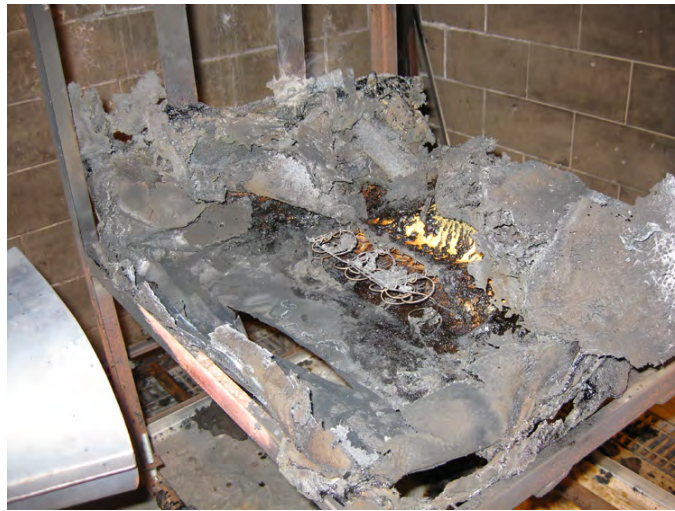
Figure B-15. Close-Up View of Baseline Test 1 Cushion Following Laboratory-Scale Test (typical)

During the tests, the seatback cushion was largely consumed, regardless of bottom cushion type, with remnant material slumped onto the remaining bottom cushion. Figures B-15 and B-16 show the remnants of two of the tests. The tabulated results, including weight percentage losses, are included in table B-1. The results clearly indicate high weight losses associated with the seatback cushion system, ranging from 55% to 66% of the initial weight. Although the bottom cushions performed much better when compared to the seatback cushions, only the style using the Franklin Products fire-blocking layer came close to the 14 CFR pass-fail requirement, which required 10% or less weight percentage loss. Although these tests were not run in accordance with the seat cushion flammability test specified in 14 CFR 25.853c Appendix F, Part II, due to the lack of standardized test samples, they were a representation of the general fire performance of the materials and confirmed the poor performance of the seatback cushion.

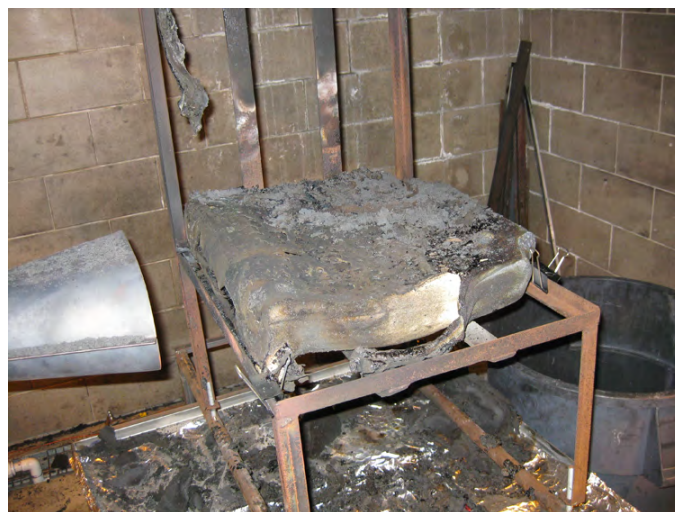
Figure B-16. Baseline Test 1 Cushion Following Laboratory-Scale Test (typical)

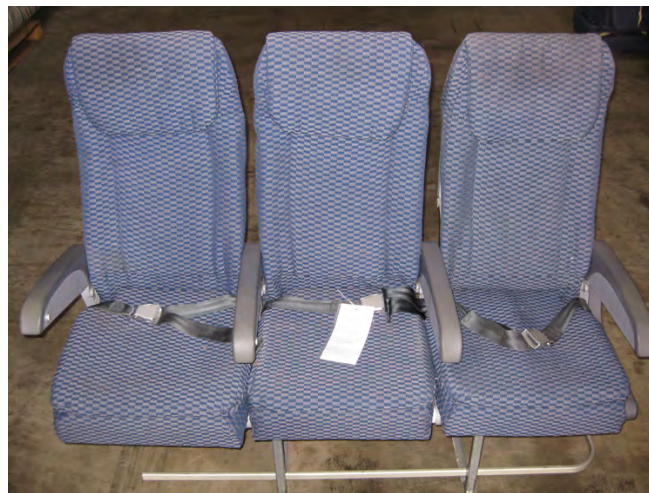
Figure B-17. Baseline Test 2 Triple Coach Seat With Blue-Colored Dress Cover

Following a review of the full-scale Baseline Test 1 results, it was agreed that the seating materials, in particular the seatbacks, performed very poorly. It was theorized that the adverse conditions generated inside the test fuselage during the Baseline 1 full-scale test were mostly due to the overall poor flammability performance of the seat cushion materials. A baseline test result in which nonsurvivable conditions were reached so quickly would make it difficult to evaluate the magnesium contribution during subsequent tests. For this reason, a repeat full-scale test was proposed using cushions constructed of known materials with desirable flammability characteristics in an effort to produce a more favorable baseline result for subsequent comparisons. To accomplish this, a donated set of cushions was obtained in which all of the bottom units included one style of fire-blocking layer, a felted type manufactured by Franklin Products (figures B-17 and B-18). The uniformity in bottom cushion type was in contrast to those used in the full-scale Baseline Test 1, which consisted of an array of cushion types.

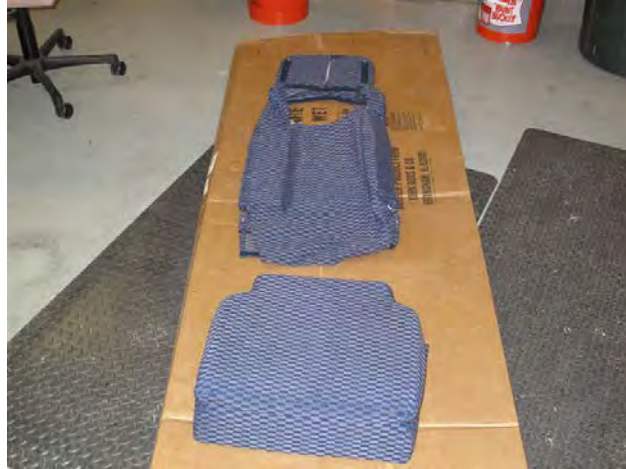
Figure B-18. Baseline Test 2 Bottom Seat and Seatback Cushions

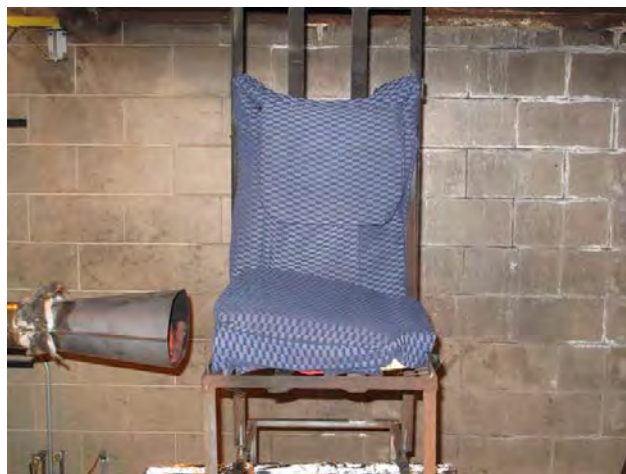
Figure B-19. Front View of Baseline Test 2 Cushions Prepared for Testing in Laboratory-Scale Test Rig

Similar to the Baseline Test 1 full-scale seat cushion materials, a decision was made to rotate the bottom cushion 90°, so that the flat surface of the front of the cushion would face the test burner flames (figure B-19). This would prevent the burner flames from protruding under the contoured cushion, which would not typically occur if the samples were the proper shape and size. The back cushions were clamped to the vertical test frame to prevent collapse during the test (figures B-20 through B-22).

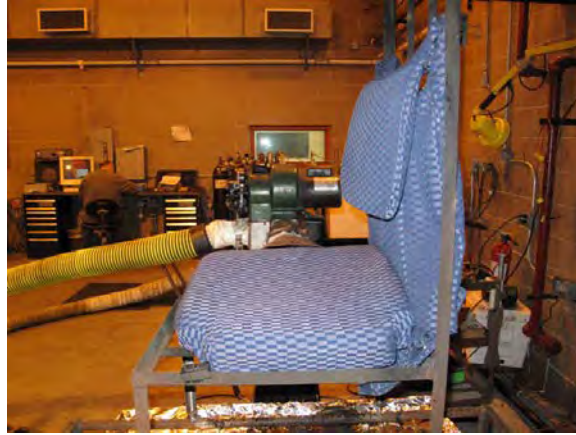
Figure B-20. Side View of Baseline Test 2 Cushions Prepared for Testing in Laboratory-Scale Test Rig

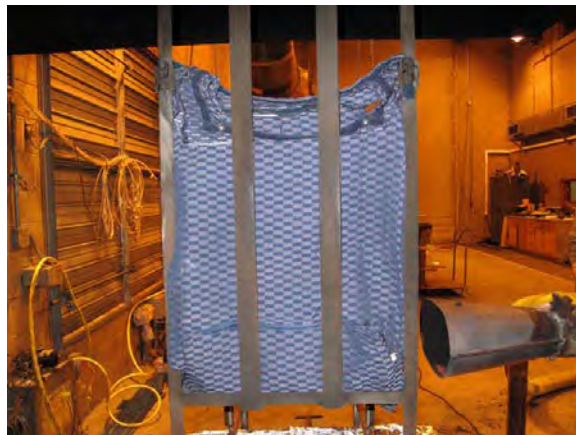
Figure B-21. Rear View of Baseline Test 2 Cushions Prepared for Testing in Laboratory-Scale Test Rig

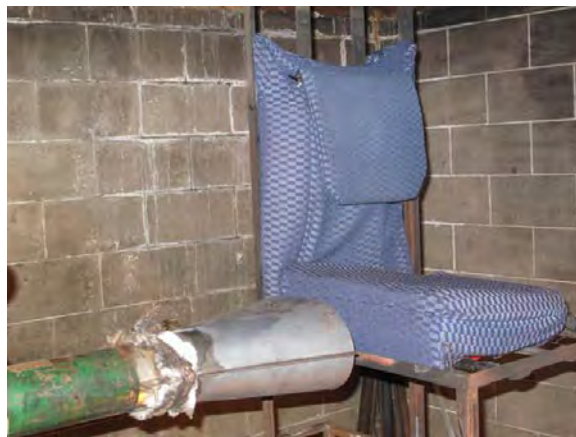
Figure B-22. Side View of Baseline Test 2 Cushions Prepared for Testing in Laboratory-Scale Test Rig

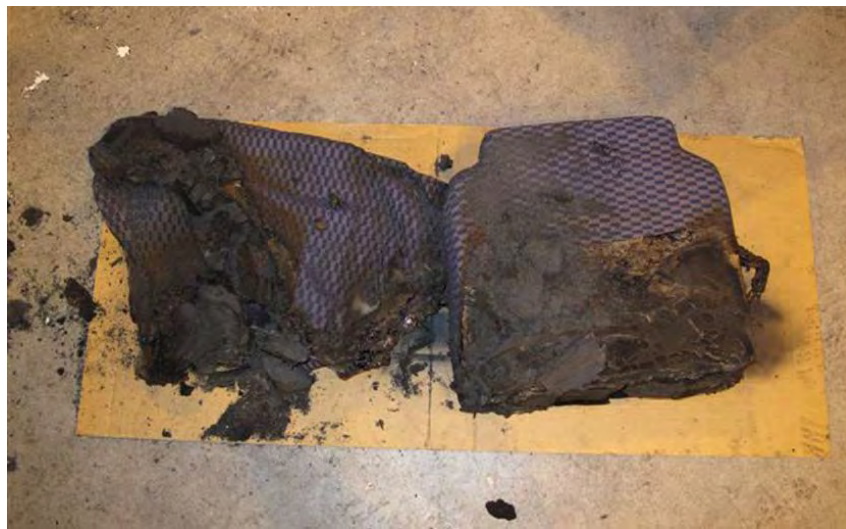
Figure B-23. Baseline Test 2 Cushion Samples Following Laboratory-Scale Test

Following the 2-minute burner warm-up, the seat cushion test assembly was rolled in front of the burner flames to begin the test. As in the Baseline Test 1 oil burner test, the back cushion was largely consumed, with remnant material slumped onto the remaining bottom cushion. Figure B-23 shows the cushion remnants of one of the tests. The tabulated results, including weight percentage losses are included in table B-2. The results again indicated high weight losses associated with the back cushion system, ranging from 30% to 42% of the initial weight. Although the bottom cushions performed much better when compared to the seatback cushions, the results still far exceeded the 14 CFR 25.853c Appendix F, Part II pass-fail requirement, which required 10% or less weight percentage loss. It should be noted again that these tests were not run in accordance with the seat cushion flammability test specified in 14 C FR 25.853c Appendix F, Part II, due to the lack of standardized test samples. However, the tests were at least an indication of the general fire performance of the materials and confirmed the poor performance of the back cushion.
